# UPPER WENATCHEE RIVER STREAM CORRIDOR ASSESSMENT AND HABITAT RESTORATION STRATEGY

August 2012

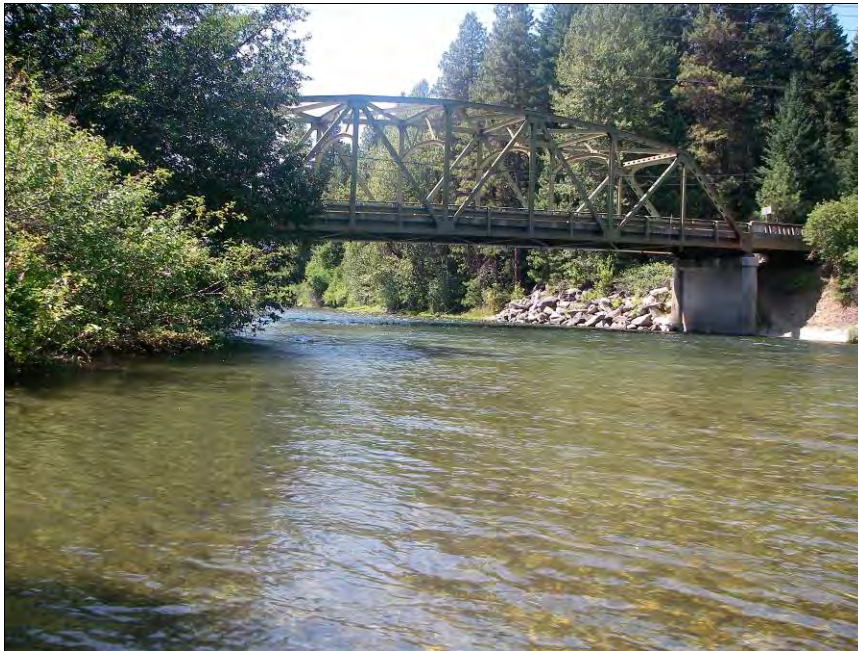
Hwy 207 crosses the Wenatchee River at RM 53.6 and disconnects the Nason Creek alluvial fan by reducing the potential range of lateral migration of lower Nason Creek. Riprap and the Hwy 207 bridge abutments constrain the Wenatchee River channel in the vicinity of the bridge. Private infrastructure near the upper portion of this reach experiences periodic flooding (Figure 105).

**Figure 116. Bank armoring and channel confinement near the Hwy 207 Bridge, Reach 10 (August 2011).**

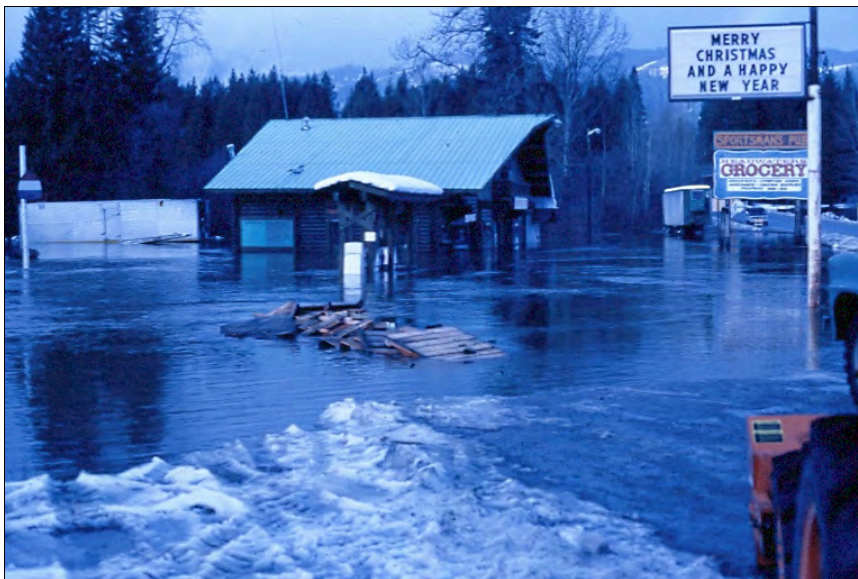
**Figure 117. The Headwaters Tavern experienced flooding after a winter rain-on-snow event in the 1990s. The Tavern is located on river-right downstream of the confluence with Nason Creek. Photo courtesy of Bryon Newell.**

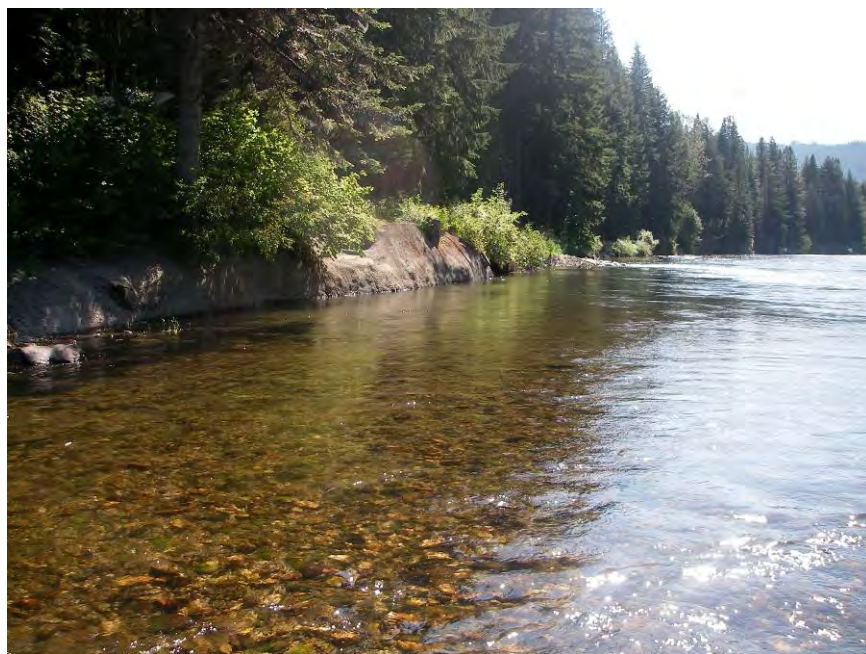
Scattered development and human infrastructure has altered natural channel processes throughout the upper portion of Reach 10, especially from RM 52.6 to RM 53.7. This includes recreational access, houses, businesses, roadways (HWY 207), and bank armoring. Channel confinement and bank armoring is responsible for most of the disturbance in the upstream portion of Reach 10 (Figure 115).

**Figure 127. View looking upstream at a concrete retaining wall that borders a residential property along river-right near RM 53.1 (August 2011).**

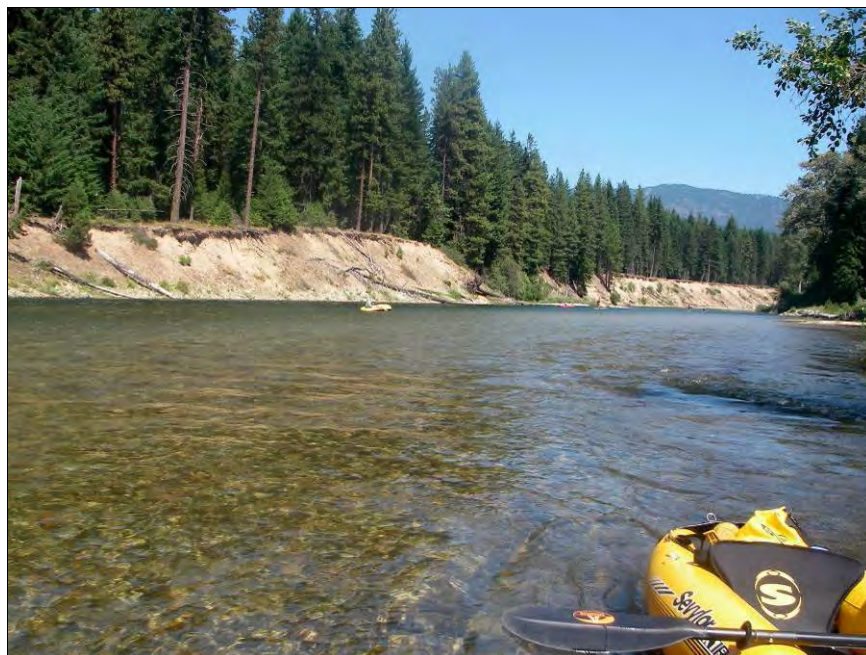
Bank erosion was primarily associated with the moderately steep banked terraces bordering much of Reach 10 along river-left (Figure 116).

**Figure 128.** Bank erosion was primarily associated with moderately steep bank terraces along Reach 10 on river-left (August 2011).

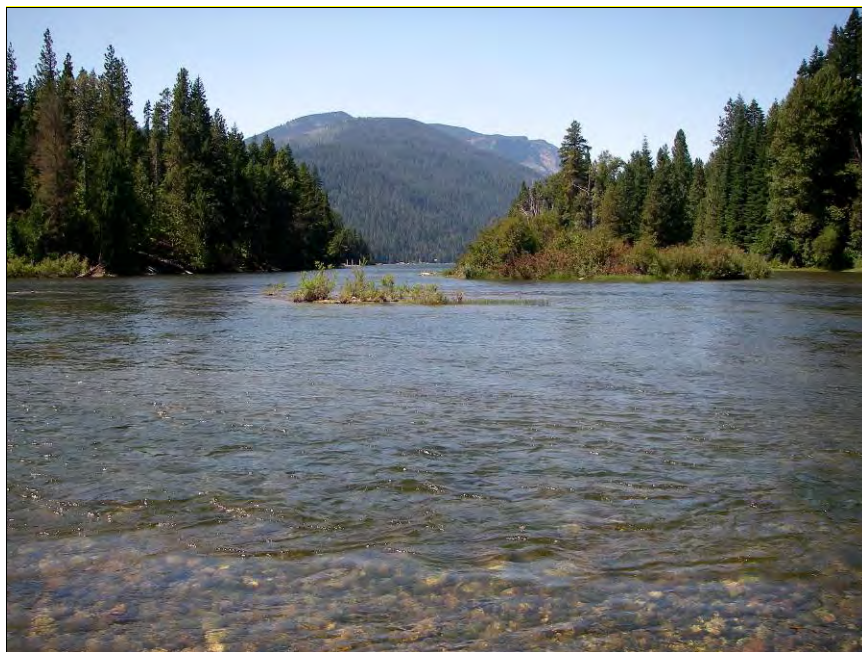
**Figure 131. View looking upstream towards Lake Wenatchee and the plane-bed channel of Reach 11 (August 2011).**

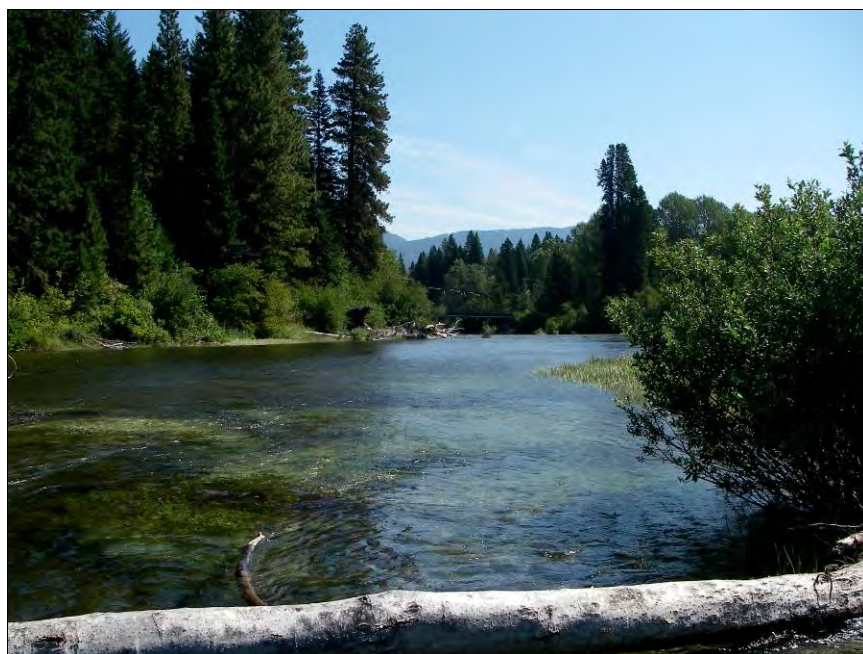
There was one side-channel in Reach 11. It was relatively short, shallow, and faster than the main channel glide (Figure 123). Old pilings, which are potentially remnants of past log-driving activities, remained embedded in the channel along the left bank. Lateral margins of the channel offer shallow water refuge along the frequently inundated and vegetated sloping streambank. A small backwater area, located approximately 130 feet upstream of the Nason Creek confluence,

**Figure 135. Side-channel habitat during moderate summer stream flow, Reach 11 (August 2011).**

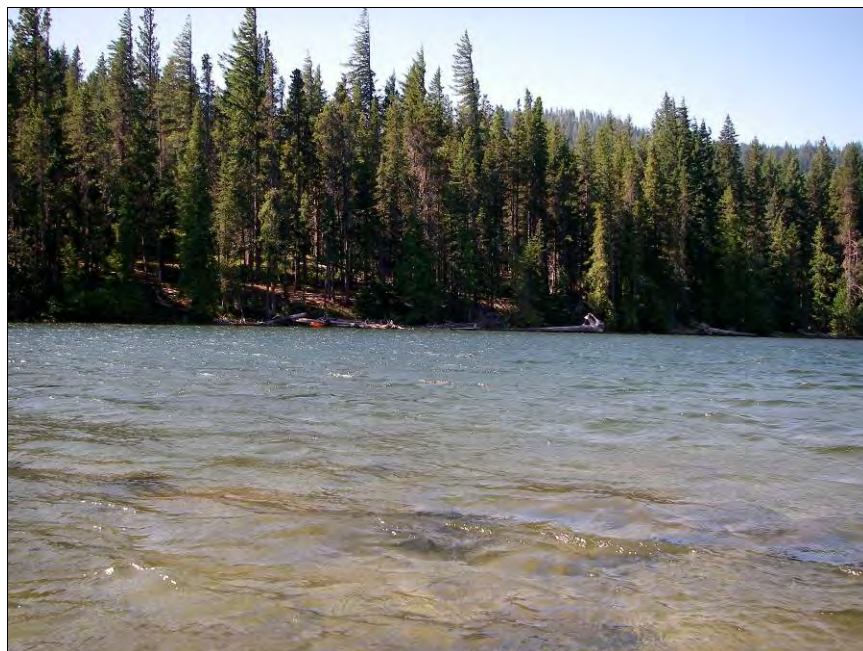
**Figure 136. Pool habitat in Reach 11 has accumulated moderate quantities of large wood along river-right (August 2011).**

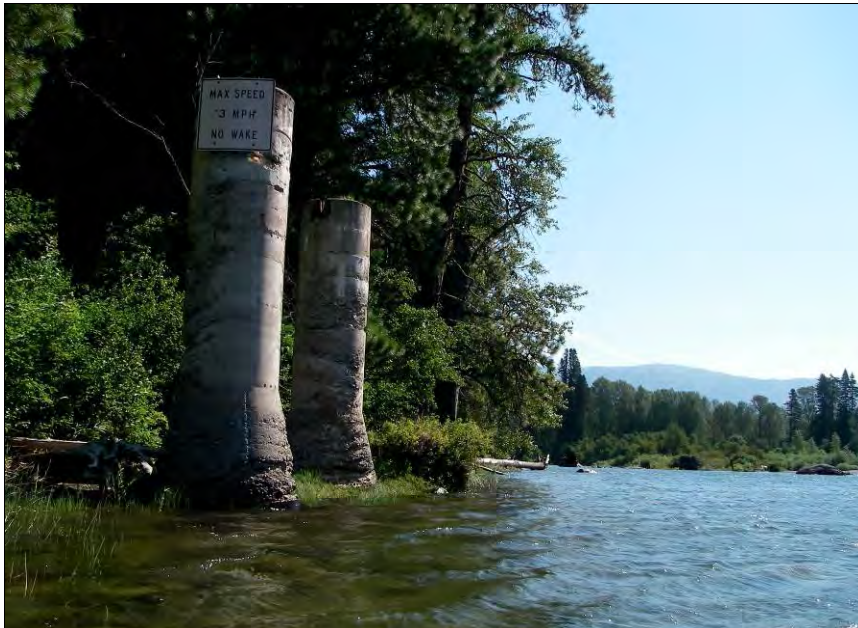
Remnant concrete pilings are located in the upper portion of this reach along both banks (Figure 127). At the upstream end on river-right, small trails and river access associated with the State Park limit understory growth.

Figure 139. Remnant concrete pilings on river-left, Reach 11 (August 2011).

Reach	Project Number	Project Name	Action Type	Description	Photo	
11	Project RM 53.85	Bridge pillar removal	Habitat reconnection via removal/modification of bank armoring, levees, roadways, or fill  Riparian restoration	Abandoned bridge piers from decommissioned bridge still remain on both banks. Remove piers and revegetate disturbed area.

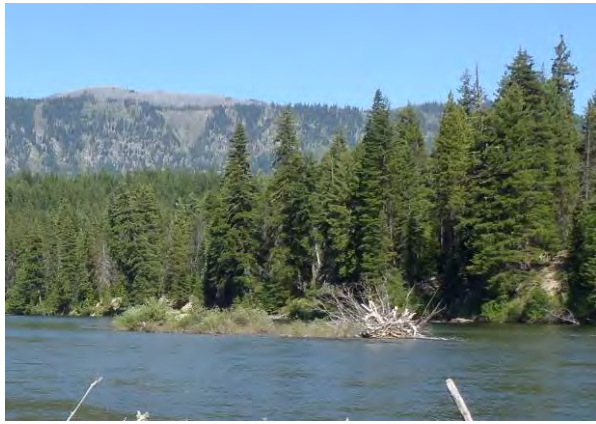
Mid-channel bar between RM 49.9 and 50 where an apex jam(s) could help maintain split flow and habitat complexity.

Reach	Project Number	Project Name	Action Type	Description	Photo	
9	Project RM 50	Fifty-mile Log Jams	Placement of structural habitat elements including large wood, log jams, or boulders	Log jams could add complexity and contribute to lateral channel dynamics between RM 49.7 and 50.1. Locations include a meander bend jam on the right-bank at RM 50.03, just downstream of the high steep bank; meander bend jams on river-left downstream of the outlet of the potential fifty-mile side channel project; apex jams at the head of the mid-channel bar between RM 49.9 and 50; and meander bend jams along the river-left bank between RM 49.7 and 49.9. Access to the river-left side can be obtained through USFS property and unsurfaced access roads. Access to the river-right side is undetermined.

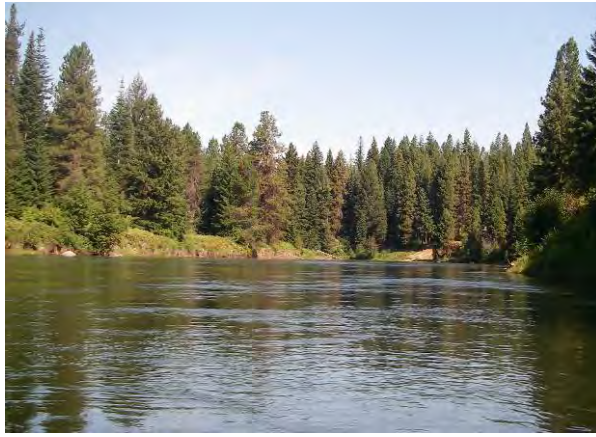
8	Project RM 49.5	Cottonwood Lane Habitat Complexity	Placement of structural habitat elements including large wood, log jams, or boulders	There is a long sequence of uniform pools and glides at the outside extent of the large bend at RM 49.5. Large wood pieces and complexes could be placed almost anywhere throughout this segment to enhance habitat cover and complexity. Houses along the river-left bank will affect access and feasibility.

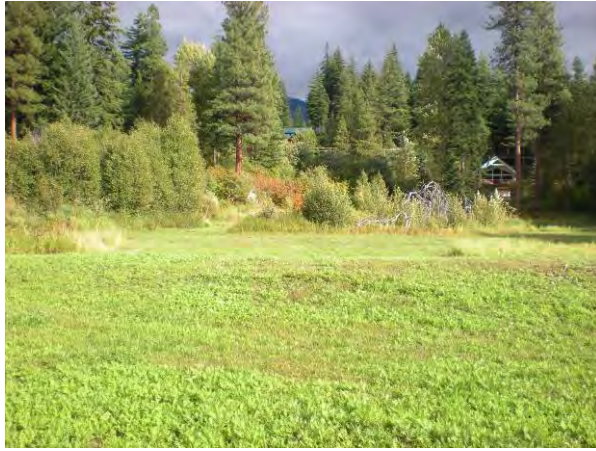
8	Project RM 49.3L	Cottonwood Lane Off-Channel Habitat	Off-channel habitat enhancement  Riparian restoration	There is a cleared low surface on river-left at RM 49.3 just upstream of the hatchery intake. There is an actively eroding low bank at the river with immature shrub vegetation. A backwater area could be excavated at this site to provide connected off-channel rearing habitat. Large wood could be added for cover and complexity within the backwater area and along the mainstem channel margin. There is good access off of Cottonwood Lane. Landownership is the Chiwawa Community Association.

Photo of cleared low surface area along river-left bank near RM 49.3.

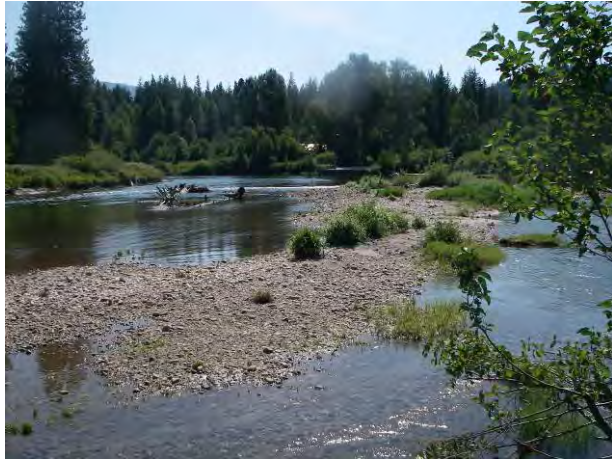
Reach	Project Number	Project Name	Action Type	Description	Photo	
8	Project RM 49.2	Intake Island Log Jams	Placement of structural habitat elements including large wood, log jams, or boulders	Just downstream of the hatchery intake there is a mid-channel island. On the river-right bank there is existing alcove habitat. Large wood and log jams could be placed in the alcove to enhance cover and complexity. Wood could also be placed on the left bank of the river-left channel around the island. Apex jam(s) could be considered on the island but potential impacts to the nearby hatchery intake structure would need to be evaluated. Access would be from Cottonwood Lane for left bank work and access is unknown along the right bank.

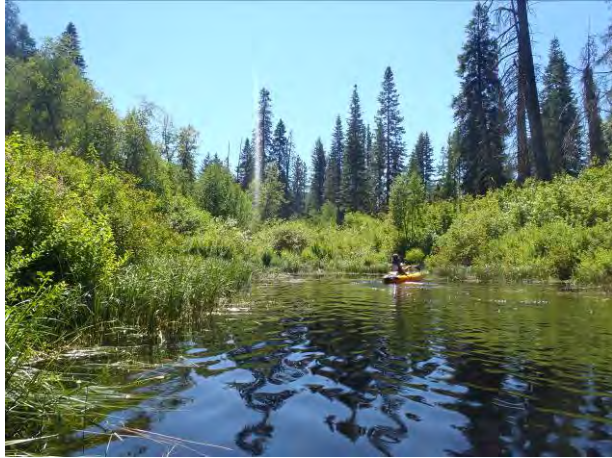
Left bank off-channel area near RM 49.1.

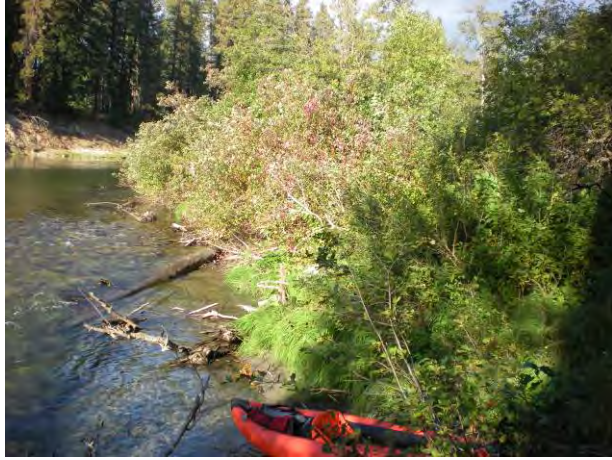
8	Project RM 48.85L	Chiwawa Fan Island Off-Channel Habitat	Off-channel habitat enhancement	There is an existing small alcove and channel scar outlet on the river-left bank near RM 48.8. This could be enlarged as a connected backwater channel, and could potentially be connected up with Project RM 49.1. Access is via federal land off of Cottonwood Lane.

View of outlet area of potential off-channel project area on river-left near RM 48.8.

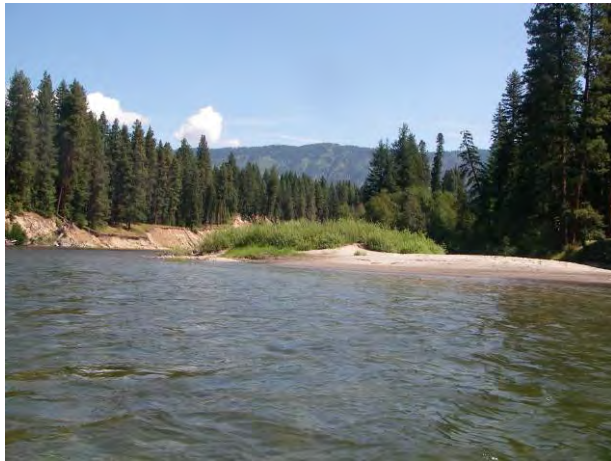
Reach	Project Number	Project Name	Action Type	Description	Photo	
8	Project RM 48.8	Chiwawa Fan Island Jams	Placement of structural habitat elements including large wood, log jams, or boulders	There is a mid-channel bar at RM 48.8. An apex log jam(s) here would help to maintain and enhance split flow conditions and habitat complexity. The river-right bank is a high sand terrace that would be a potential site for channel margin “colluvial jams” to enhance pool scour and habitat cover. Access to the left bank is via federal land off of Cottonwood Lane. Access to the right bank is via federal land off of Beaver Valley Road.

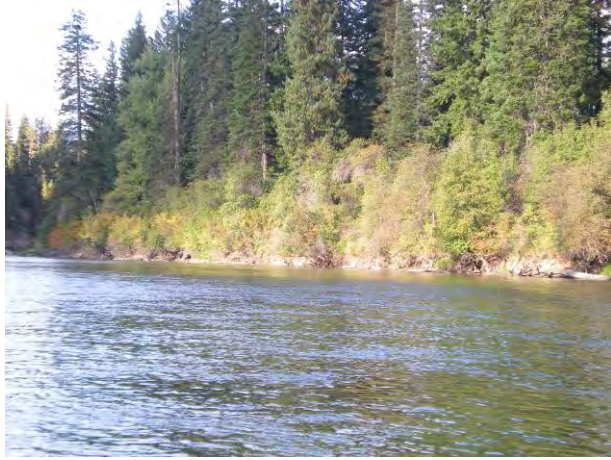
View looking upstream at river-left bank from near RM 48.5.

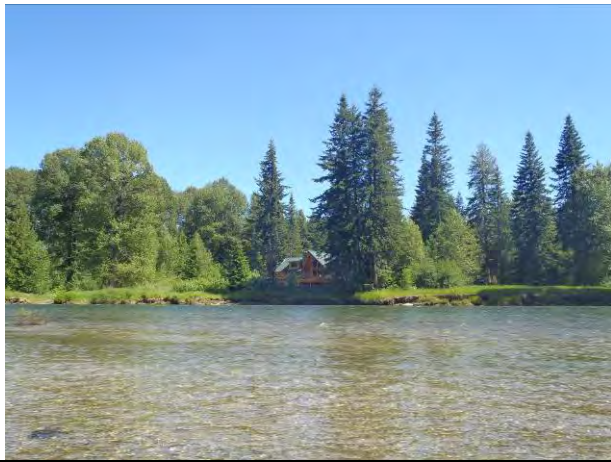
Reach	Project Number	Project Name	Action Type	Description	Photo	
7	Project RM 48.3L	Riparian and Streambank Restoration	Riparian restoration	There is a cleared riparian and streambank area along the river-left bank associated with a streamside residence. Re-plant with native riparian forest vegetation and streambank shrubs and trees. Wood could be added for interim stability along the eroding streambank.

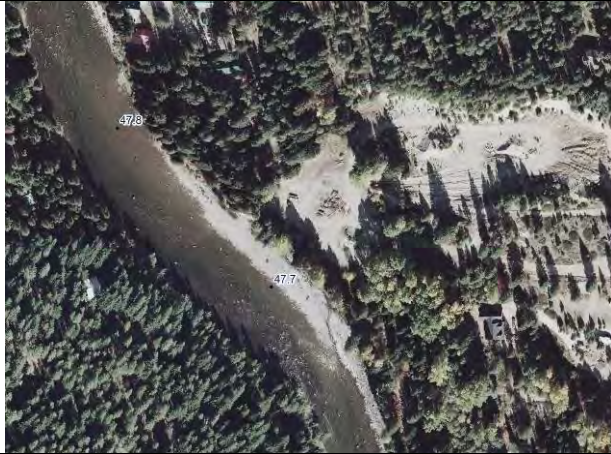
Aerial photo of county gravel pit near Schugart Flat.

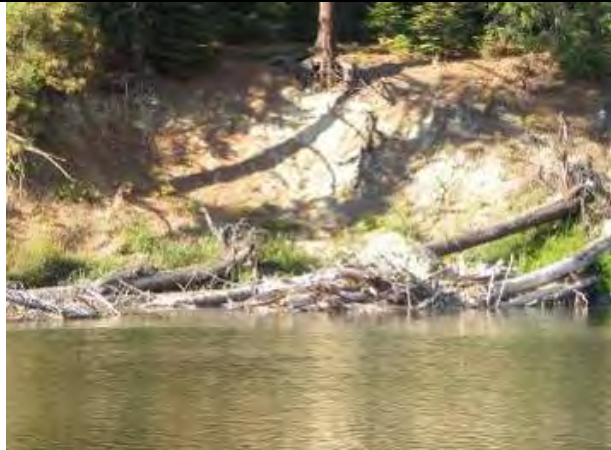
Example of a natural “colluvial” jam from a site further upstream near RM 48.8.

5	Project RM 45.8L	Gravel Pit Colluvial Jams	Placement of structural habitat elements including large wood, log jams, or boulders	There is a high bank on river-left adjacent to a Chelan County gravel pit. Riparian conditions on the slope and at the top of the bank are degraded and are in a cleared or early seral stage condition. There are opportunities here to create “colluvial” jams to mimic jams that would have formed historically through riparian tree recruitment from slope failures.

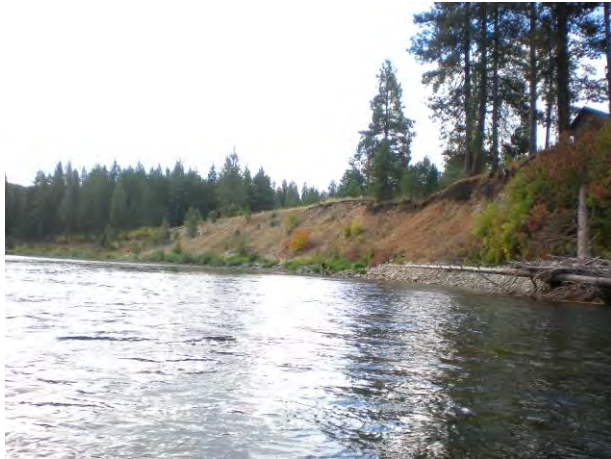
Reach	Project Number	Project Name	Action Type	Description	Photo	
5	Project RM 45.1R	45-Mile Margin Jams and Riparian Enhancement	Riparian restoration  Placement of structural habitat elements including large wood, log jams, or boulders	On river-right there is a high unvegetated eroding bank that extends from RM 45.3 to RM 45.15. Riparian restoration work on the bank and at the top of bank would enhance long term riparian processes. Channel margin “colluvial” jams could be placed to enhance margin habitat complexity. There is a good location for a meander bend jam further upstream on the right bank near RM 45.28. There is opportunity for riparian enhancement at this location as well. This area is private land and there are nearby houses.

View of cleared river-right bank at RM 45.1

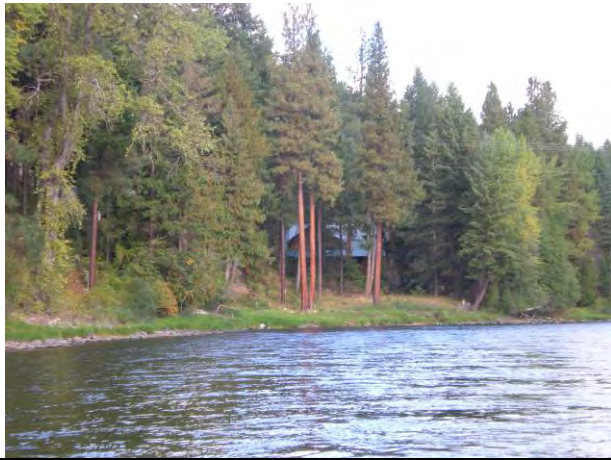
Location of potential meander-bend jam on river-right near RM 45.28
5	Project RM 44.9L	Camp 12 Apex Jam	Off-channel habitat enhancement  Placement of structural habitat elements including large wood, log jams, or boulders	There is an opportunity to enhance activation of a left-bank side channel at the bend near RM 44.9. An apex log jam on the existing bar would create a split flow condition and would enhance lateral channel dynamics as well as instream cover and complexity. There is bedrock (conglomerate) just downstream of the project site. Private land.

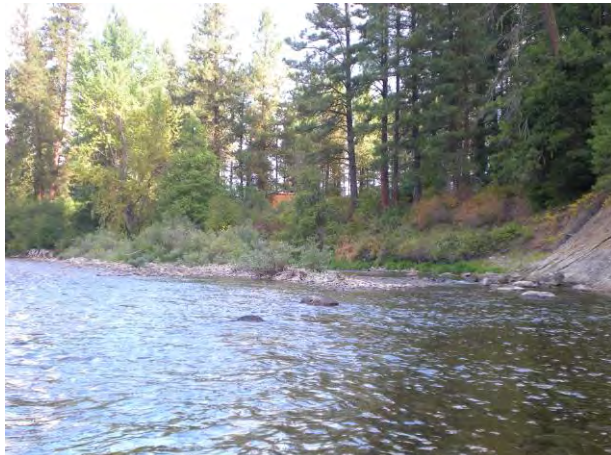
Upstream view of left bank project area and existing shallow gravel bar.

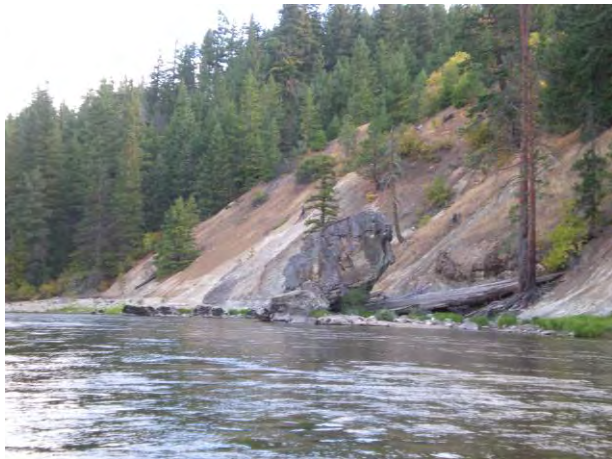
Reach	Project Number	Project Name	Action Type	Description	Photo	
5	Project RM 44.3	Powerline Riparian and Margin Habitat Enhancement	Placement of structural habitat elements including large wood, log jams, or boulders  Riparian restoration	<p>Just downstream of the powerline crossing (RM 44.4) and extending downstream to RM 44.13, there are potential sites for channel margin and riparian enhancement. Potential log jam sites to enhance local pool scour, habitat complexity, and cover include: 1) on river-left where an existing house-sized boulder could be utilized to help ballast a large jam, 2) on river-right near RM 44.35 (1-2 jams), 3) “colluvial” jams along the tall bank on river-left from RM 44.1 to RM 44.3, and 4) a bar apex jam on river-right near RM 44.2 to enhance side-channel activation.</p> <p>There are also opportunities for riparian work on both sides of the stream. There is a narrow riparian buffer on river-right (ag fields) and riparian clearing along river-left associated with residential development in the Ponderosa Estates community.</p>

Upstream view of river-left bank and house-sized boulder near RM 44.4.

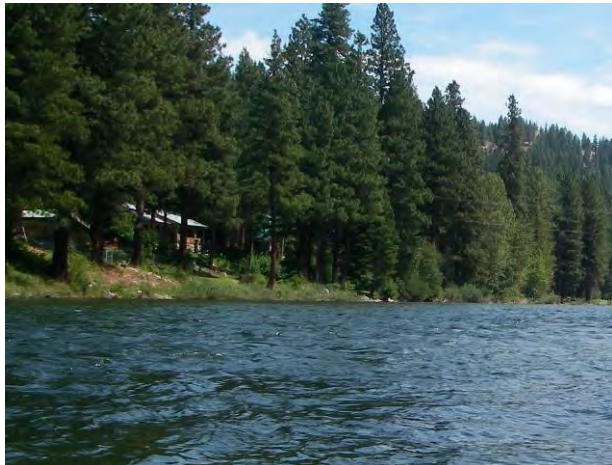
Reach	Project Number	Project Name	Action Type	Description	Photo	
5	Project RM 43.5L	Ponderosa Estates Riparian and Channel Margin Enhancement	Habitat reconnection via removal/modification of bank armoring, levees, roadways, or fill  Riparian restoration	There is streamside residential development (Ponderosa Estates community) extending along the left bank from upstream of RM 44.1 down to RM 43.2. Many of the homes have clearing of riparian vegetation and rock or concrete walls to protect banks from erosion. Look for opportunities to enhance riparian conditions and to restore bank margin complexity through removal/modification of bank armoring or replacement with bioengineering approaches.

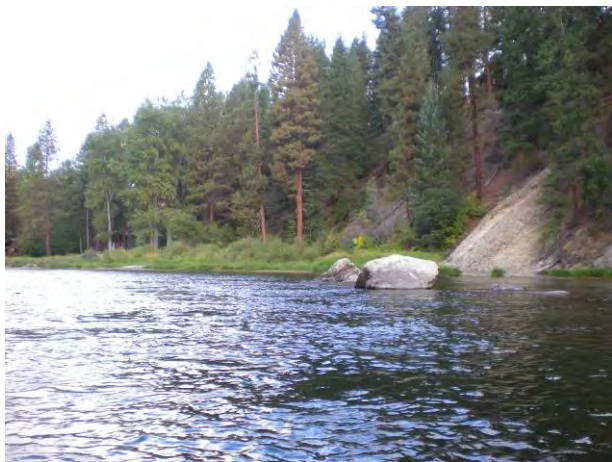
Upstream view of river left bend near RM 43.1.

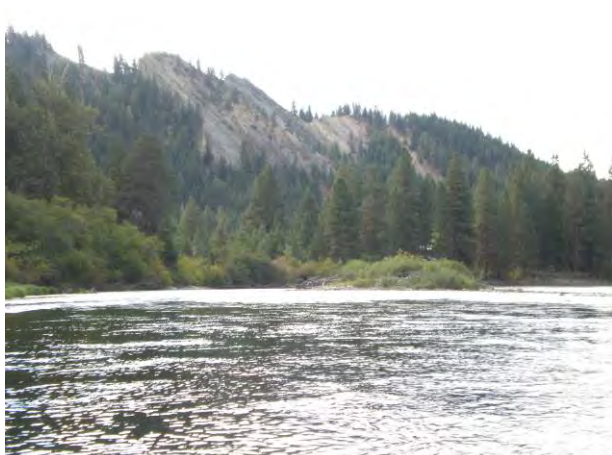
4	Project RM 42.9	Mule Tail Flats Log Jams	Placement of structural habitat elements including large wood, log jams, or boulders	This area extends from RM 42.8 to RM 43.05. There is a series of gravel bars that offer a good opportunity for construction of bar apex log jams that would enhance lateral channel dynamics, split flow conditions, and improve local pool scour, cover, and habitat complexity. There are also opportunities for meander bend jams along the left bank from RM 42.8 to 42.9. Access would be through private lands from Mule Tail Flats Road.

View looking downstream at gravel bar complex near RM 42.9.

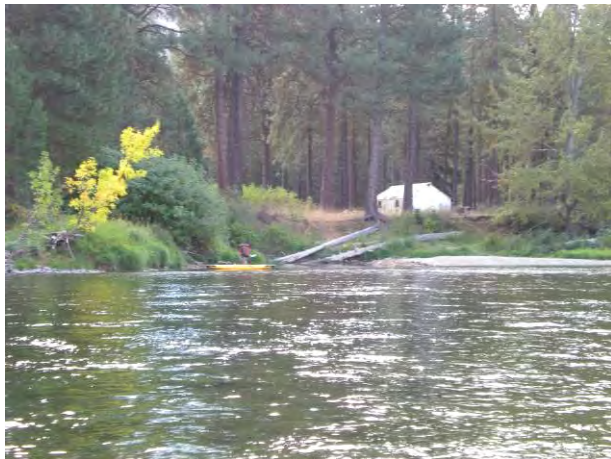
Reach	Project Number	Project Name	Action Type	Description	Photo	
4	Project RM 42.7L	Primitive Park Alcove Enhancement	Placement of structural habitat elements including large wood, log jams, or boulders  Off-channel habitat enhancement  Riparian restoration	There is existing small alcove habitat on river left between RM 42.65 and RM 42.73. Adding individual pieces and small log jams would enhance cover and complexity. There is also opportunity for riparian restoration in this area.

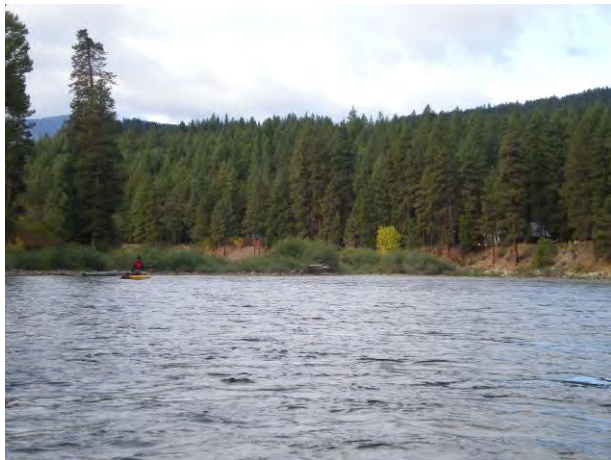
View looking downstream at island complex between RM 42.4 and 42.5.

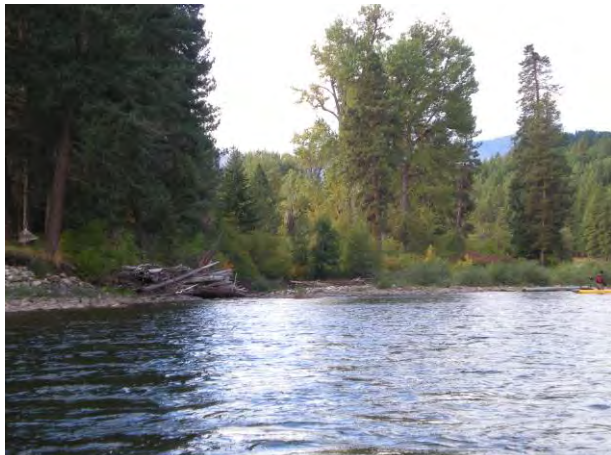
4	Project RM 42.3L	Primitive Park Side Channel Enhancement	Habitat reconnection via removal/modification of bank armoring, levees, roadways, or fill  Off-channel habitat enhancement  Riparian restoration	There is potential side-channel reconnection potential along the left bank through the low surface extending from RM 42.2 to 42.45. Private lands prevented full field inspection of this surface but LiDAR suggests there has been fill placed in a channel scar and that this feature could be restored as a side-channel; either a flood flow channel or possibly an active low flow channel.

View looking downstream at left bank at potential upstream entry point for side-channel (near RM 42.5).

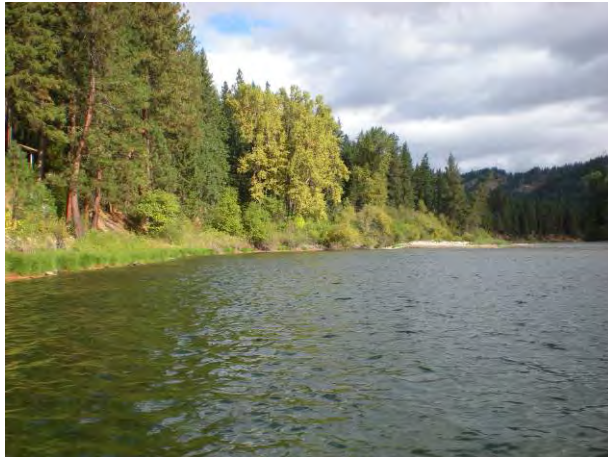
Reach	Project Number	Project Name	Action Type	Description	Photo	
4	Project RM 42.1R	Railroad Bridge Apex Jams	Placement of structural habitat elements including large wood, log jams, or boulders	There is a shallow gravel bar along river-right upstream of the railroad bridge. Bar apex jams could enhance lateral channel dynamics, split flow conditions, and habitat complexity and cover. Meander bend jams could be placed along the right bank downstream of the gravel bar to enhance local pool scour, complexity, and cover.

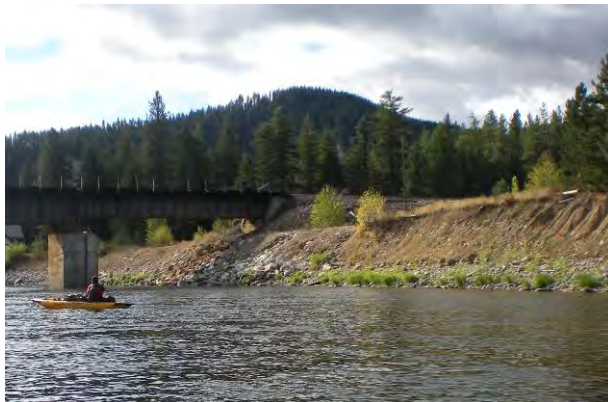
View looking downstream at river-right bank at railroad crossing near RM 41.9.

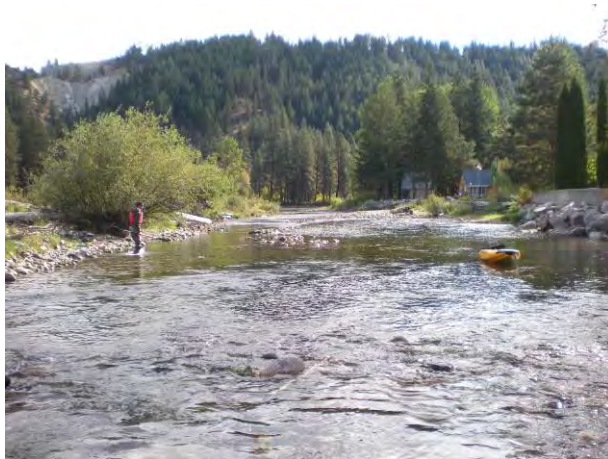
3	Project RM 41.7R	Meacham Road Side Channel Enhancement	Habitat reconnection via removal/modification of bank armoring, levees, roadways, or fill  Off-channel habitat enhancement  Riparian restoration	There is a side-channel on river-right downstream of the railroad bridge. There is a large bar apex jam on the island apex forming the side channel. The river-right bank within and downstream of the side-channel is armored with concrete and rip-rap, which extends from RM 41.8 to 41.5. Look for opportunities to remove or modify bank armoring and to enhance margin complexity. Log jams could be placed throughout this side-channel and along the channel margin downstream. There are private residences close by. Many of these parcels could also benefit from riparian restoration, where possible.

View looking downstream within side-channel near RM 41.8.

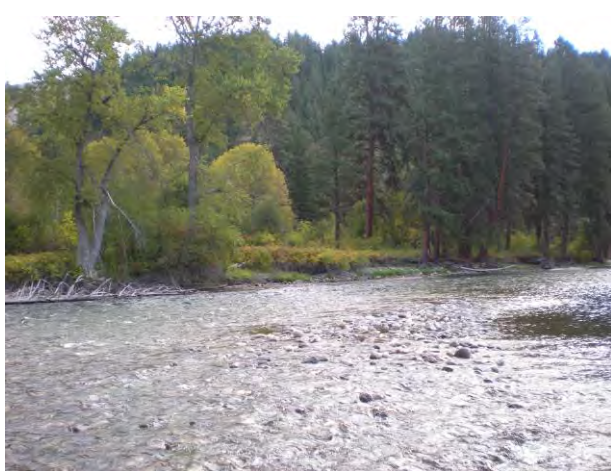
Reach	Project Number	Project Name	Action Type	Description	Photo	
3	Project RM 41.5L	Wenatchee Pines Off-Channel Habitat Enhancement	Off-channel habitat enhancement  Placement of structural habitat elements including large wood, log jams, or boulders	There is a low floodplain surface on river left prior to the sharp bend at RM 41.5. There is the potential here for development of off-channel habitat. The surface is likely too high for reasonable excavation of a connected flow-through side-channel, but there may be the possibility of a connected backwater extending upstream from the downstream end. There are also opportunities for meander bend jams along the left bank at the upstream and downstream ends of this project area.

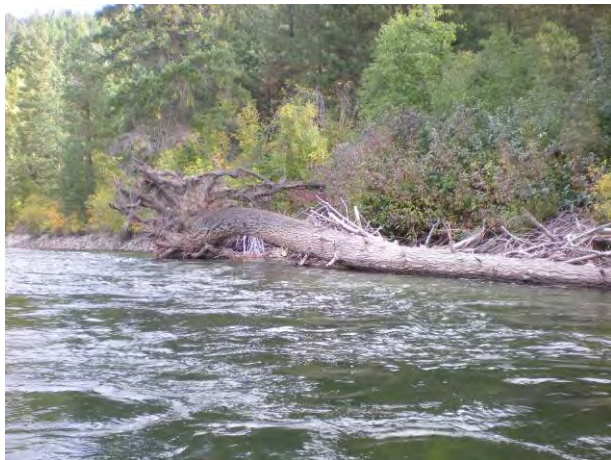
View looking upstream at river-left bank at existing rootwad near RM 41.3.

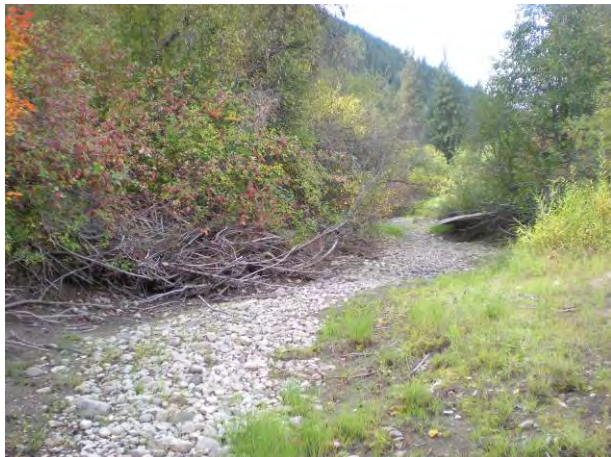
3	Project RM 41.1	RM 41.1 Side Channel Enhancement	Off-channel habitat enhancement  Placement of structural habitat elements including large wood, log jams, or boulders	There is an existing high flow side-channel along river left between RM 41.1 and 41.2. Select excavation, particularly at the upstream end, combined with a bar apex jam, could activate this side channel at lower flows. There is also the potential for a meander bend jam on the left bank downstream of the side-channel outlet.

View of side-channel near RM 41.2.

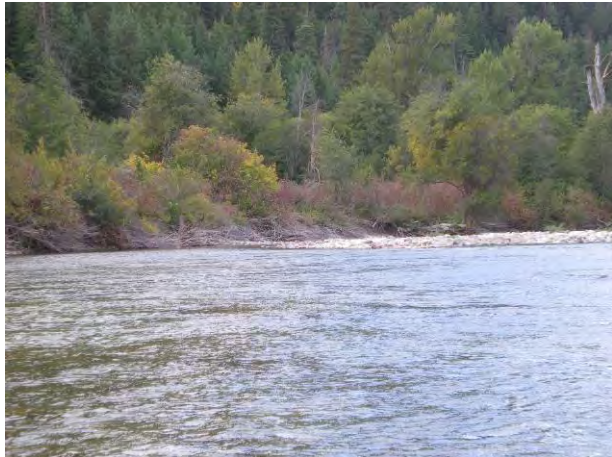
Reach	Project Number	Project Name	Action Type	Description	Photo	
3	Project RM 41L	RM 41 Jams	Placement of structural habitat elements including large wood, log jams, or boulders	There is a good location for a bar apex jam on an existing shallow gravel bar near RM 41 that would enhance lateral channel dynamics, split flow conditions, and improve local pool scour, cover, and habitat complexity. There are also good locations for 1 or 2 meander bend jams downstream along the left bank at the outside of the bend.

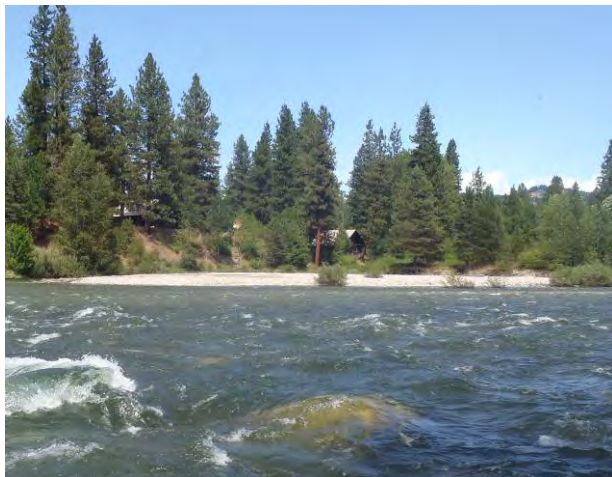
View looking downstream at left bank at potential bar apex and meander log jam locations near RM 41.
3	Project RM 40.8R	Meacham Flats Off-Channel Enhancement	Off-channel habitat enhancement	There is an existing alcove and side-channel on river-right at the outside of the bend at RM 40.8. This may be a good location to create a groundwater-fed channel that extends up-valley across the large Meacham Flats bar. Channel scrolling features visible on the LiDAR suggest the presence of hyporheic flow across the bar that could supply a groundwater channel. Additional investigation (groundwater monitoring) would be needed. An investigation of the location of bedrock would also assist with determining whether the necessary channel elevations could be achieved. This site offers a good opportunity for creating off-channel habitat because residential development and associated bank armoring along the upstream meander bend will prevent natural river processes from creating off-channel habitat on its own.

View of river-right bank at bend at RM 40.8.

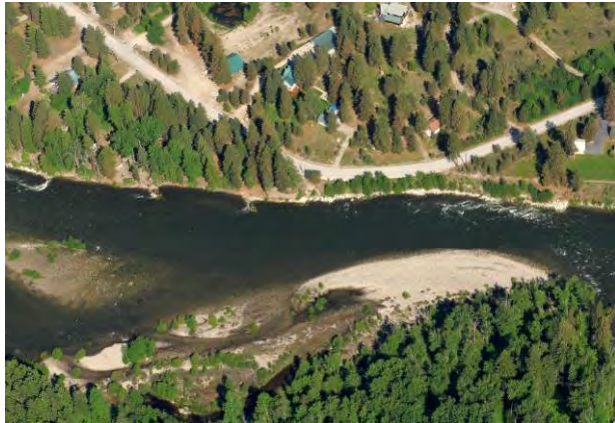
Reach	Project Number	Project Name	Action Type	Description	Photo	
3	Project RM 40.6R	High Valley US Riparian & Margin Habitat Enhancement	Habitat reconnection via removal/modification of bank armoring, levees, roadways, or fill  Riparian restoration	The river-right bank from RM 40.25 to RM 40.75 is dominated by riprap, rock spurs, and degraded riparian vegetation conditions associated with River Road and residential development. Look for opportunities to remove or modify riprap using log jams and bioengineering approaches to streambank stabilization. Replant riparian areas where possible.

<p>Oblique aerial view of river-right bank with riprap and rock spurs near RM 40.7.</p> <p>View looking downstream at ripraped river-right bank near RM 40.7.</p>
3	Project RM 40.5L	RM 40.5 Alcove Enhancement	Off-channel habitat enhancement  Placement of structural habitat elements including large wood, log jams, or boulders	There is an existing alcove on river-left at the outside of the bend at RM 40.5. Wood could be added to the existing alcove to enhance habitat cover and complexity. There may be additional potential off-channel work on this low surface but the surface is relatively high and there is a lot of bedrock; further investigation would be necessary to evaluate additional off-channel potential.

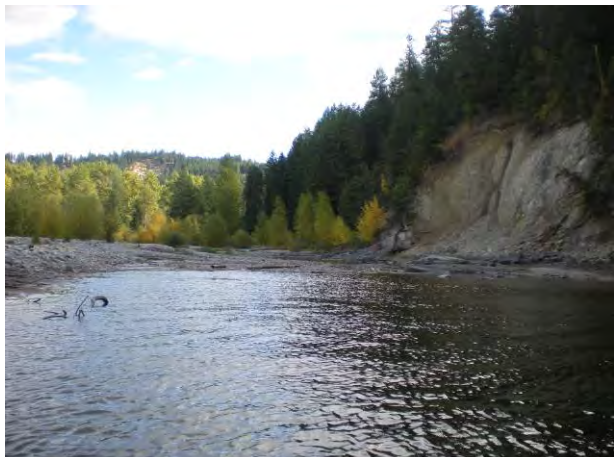
View looking upstream at river-left alcove/backwater at RM 40.5.

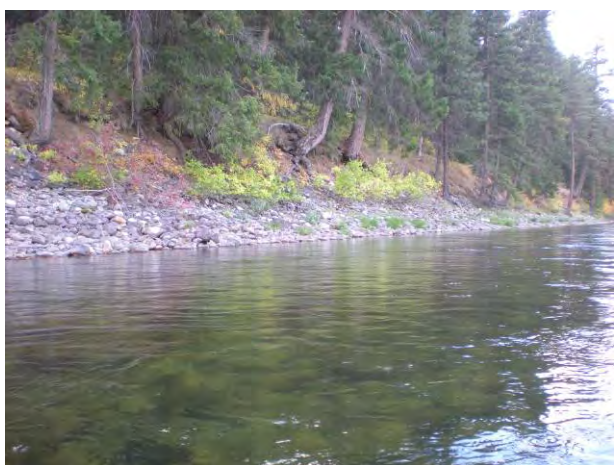
Reach	Project Number	Project Name	Action Type	Description	Photo	
3	Project RM 40.4L	RM 40.4 Meander Bend Jams	Placement of structural habitat elements including large wood, log jams, or boulders	There is a good opportunity for 1-2 meander bend log jams along the river-left bank near RM 40.4. The existing habitat lacks channel margin complexity. Jams would increase pool scour, cover, and complexity. Access may be difficult and may have to be obtained from across the river.

View of river-left bank near RM 40.4 that lacks channel margin complexity.
3	Project RM 40L	RM 40 Meander Bend Jams	Placement of structural habitat elements including large wood, log jams, or boulders	There is a good opportunity for several meander bend log jams along the river-left bank between RM 39.9 and 40.2. The existing habitat lacks channel margin complexity. Jams would increase pool scour, cover, and complexity. Access may be difficult and may have to be obtained from across the river.

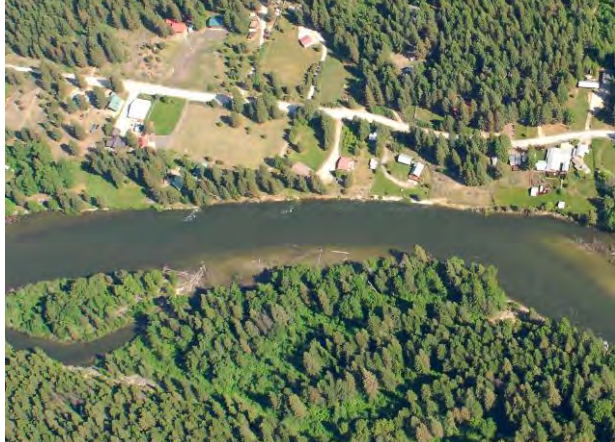
3	Project RM 39.7R	High Valley DS Riparian & Margin Habitat Enhance	Habitat reconnection via removal/modification of bank armoring, levees, roadways, or fill  Riparian restoration	The river-right bank from RM 39.5 to RM 39.9 is dominated by riprap, rock spurs, and degraded riparian vegetation conditions associated with streamside residential development. Look for opportunities to remove or modify riprap using log jams and bioengineering approaches to streambank stabilization. Replant riparian areas where possible.

Oblique aerial view at river-right bank and residential development near RM 39.7.

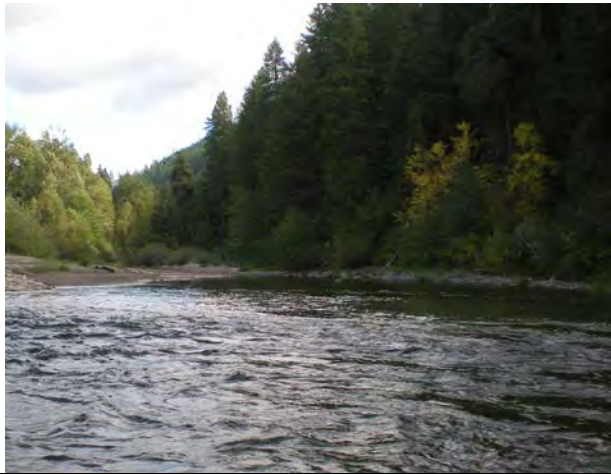
Reach	Project Number	Project Name	Action Type	Description	Photo	
3	Project RM 39.6L	RM 39.6 Off-Channel Enhancement	Off-channel habitat enhancement  Placement of structural habitat elements including large wood, log jams, or boulders	There is an existing side-channel and alcove habitat on the left bank between RM 39.5 and RM 39.7. Wood jams could be added to these existing off-channel areas to enhance local pool scour, cover, and complexity. Mainstem wood placements in this area would be challenging given the high stream energy at this location.

Existing alcove habitat on river-right near RM 39.7.
3	Project RM 39.4L	RM 39.4 Meander Bend Jams	Placement of structural habitat elements including large wood, log jams, or boulders	There is a good opportunity for 1-3 meander bend log jams along the river-left bank between RM 39.3 and 39.5. The existing habitat lacks channel margin complexity. Jams would increase pool scour, cover, and complexity. Access may be difficult and may have to be obtained from across the river.

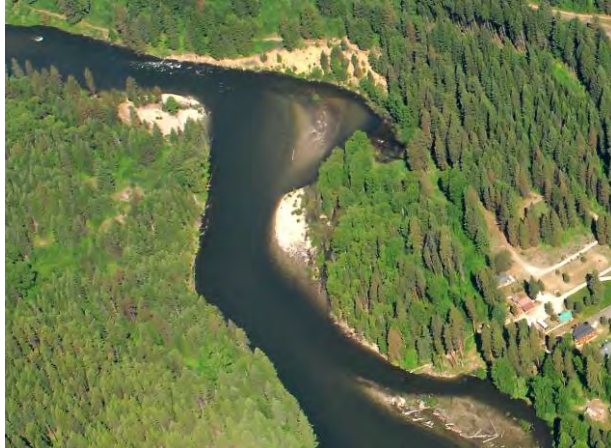
Oblique aerial view looking downstream near RM 39.4. The project opportunity area is along the left bank upstream of the left-hand bend in the river.

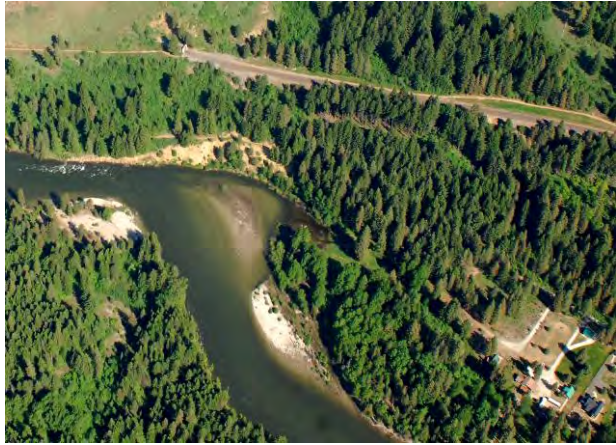
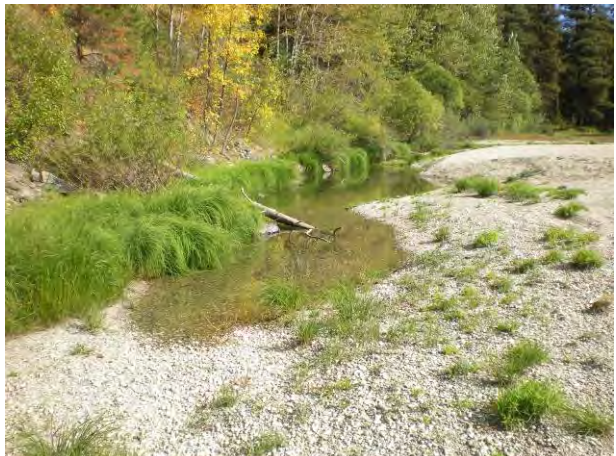
Reach	Project Number	Project Name	Action Type	Description	Photo	
3	Project RM 39.3R	Zimmerman Off-Channel and Mainstem Enhancement	Off-channel habitat enhancement  Placement of structural habitat elements including large wood, log jams, or boulders	There is a large gravel bar and existing backwater/alcove near RM 39.2 at the crux of the bend. One option here includes excavating additional backwater habitat along the hillslope/terrace toe at the inside of the bend; however, due to the high rate of observed sediment deposition in this area, there may be a risk of filling with sediment over time. There is also the potential for creating a groundwater-fed channel within this floodplain surface that extends up to near the main channel at RM 39.5. More investigation is needed to evaluate groundwater flow potential. On the large existing gravel bar, there is the potential to create active split flow conditions through construction of a bar apex jam on the bar and other wood placements for bar roughness.

<p>Oblique aerial view looking downstream at project area near RM 39.3.</p> <p>Existing low water backwater at crux of bend near RM 39.2.</p>

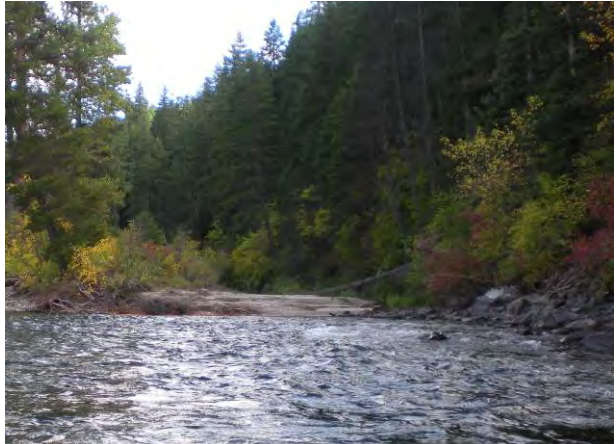
Project RM 39L	Tunnel Alcove Enhancement	Off-channel habitat enhancement  Placement of structural habitat elements including large wood, log jams, or boulders	This is a high flow side-channel between RM 38.9 and 39 that has a small low water alcove at the downstream end. Wood could be placed for cover habitat within the alcove. Excavation and a bar apex jam at the top end could also be considered to establish a low-flow active side-channel here; although there may be filling risk because of the relative difference in gradient compared to the mainstem. Access may have to be gained from across the river.

Upstream view of alcove at downstream end of river-left high flow side-channel near RM 38.9.

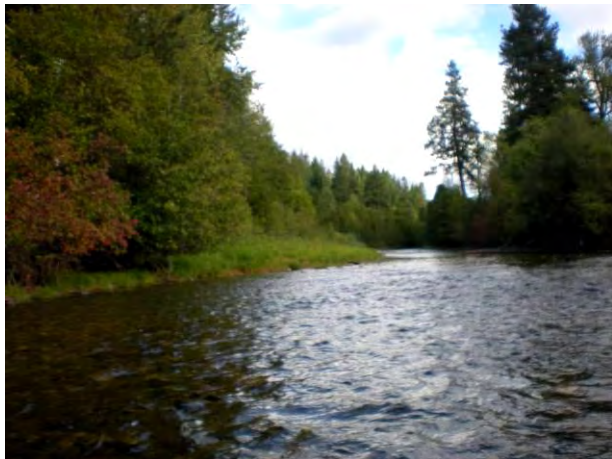
Reach	Project Number	Project Name	Action Type	Description	Photo	
3	Project RM 38.9R	Deadhorse Island Side-Channel Enhancement	Off-channel habitat enhancement  Placement of structural habitat elements including large wood, log jams, or boulders	This large mainstem side-channel presents a good opportunity for placement of log jams within the active channel that are out of the way of river recreationists. Wood placements could be conducted throughout the side-channel. Upstream of the island along the river-right bank are good locations for wood jams to enhance cover habitat and complexity. Bar apex jams could be placed on the bar at the apex of the island although there are existing jams in this area. Bar apex jams could also be considered for the mainstem gravel bar at the downstream end near RM 38.7. Jams here would enhance split flow conditions, pool scour, cover, and complexity. Potential access from closed forest road along river-right.

Outlet of river-right mainstem side-channel near RM 38.7.
