# UPPER WENATCHEE RIVER STREAM CORRIDOR ASSESSMENT AND HABITAT RESTORATION STRATEGY

August 2012

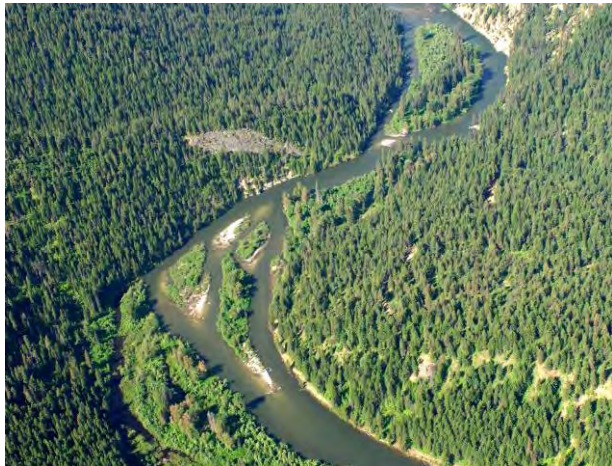
1-2		Protect and Maintain	Protect and maintain	Protect and Maintain is the highest priority action for the lower two reaches. These reaches are in relatively healthy condition and are within US Forest Service lands. There are multiple split flow conditions and abundant side-channel and off-channel habitats. Channel margin habitat is high quality, with overhanging riparian vegetation and high complexity. There are log jams and other wood pieces. Riparian areas are in more mature seral stages compared to upstream areas and are on a trajectory towards late seral conditions where they will eventually be able to provide adequate shade and LWD recruitment. There is abundant and high quality spawning habitat within pool tail-outs, riffles, and glides.

Oblique downstream aerial view of Reach 2 near RM 36-37.
1-2		Key Piece Supplementation	Placement of structural habitat elements including large wood, log jams, or boulders	A potential project opportunity identified for these lower reaches is to add large key pieces of wood that would be available to initiate log jam formation and enhance lateral channel dynamics, pool scour, cover, and complexity. The very large key pieces needed to form log jams are much less abundant than historical conditions and it is believed that re-introducing key pieces would create a positive habitat response by collecting additional wood, sorting sediment, and providing direct habitat benefits. Access is difficult so key pieces would likely have to be flown in and placed by helicopter. In some areas, existing access roads may be able to be utilized.

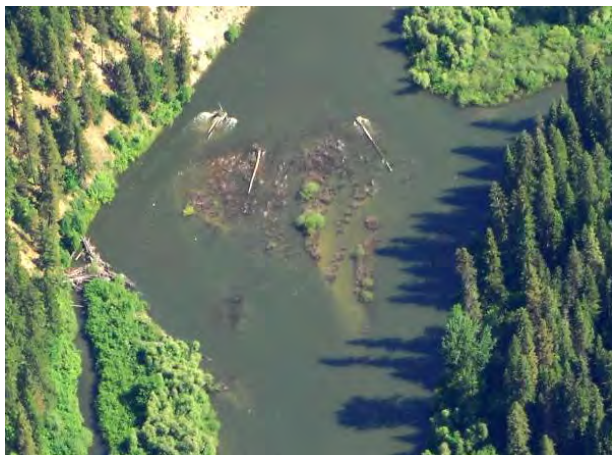
Example of bar in Reach 1 where large key pieces would help to encourage jam formation, island development, and split flow conditions.
