Beaver Creek

REACH ASSESSMENT

December 2017

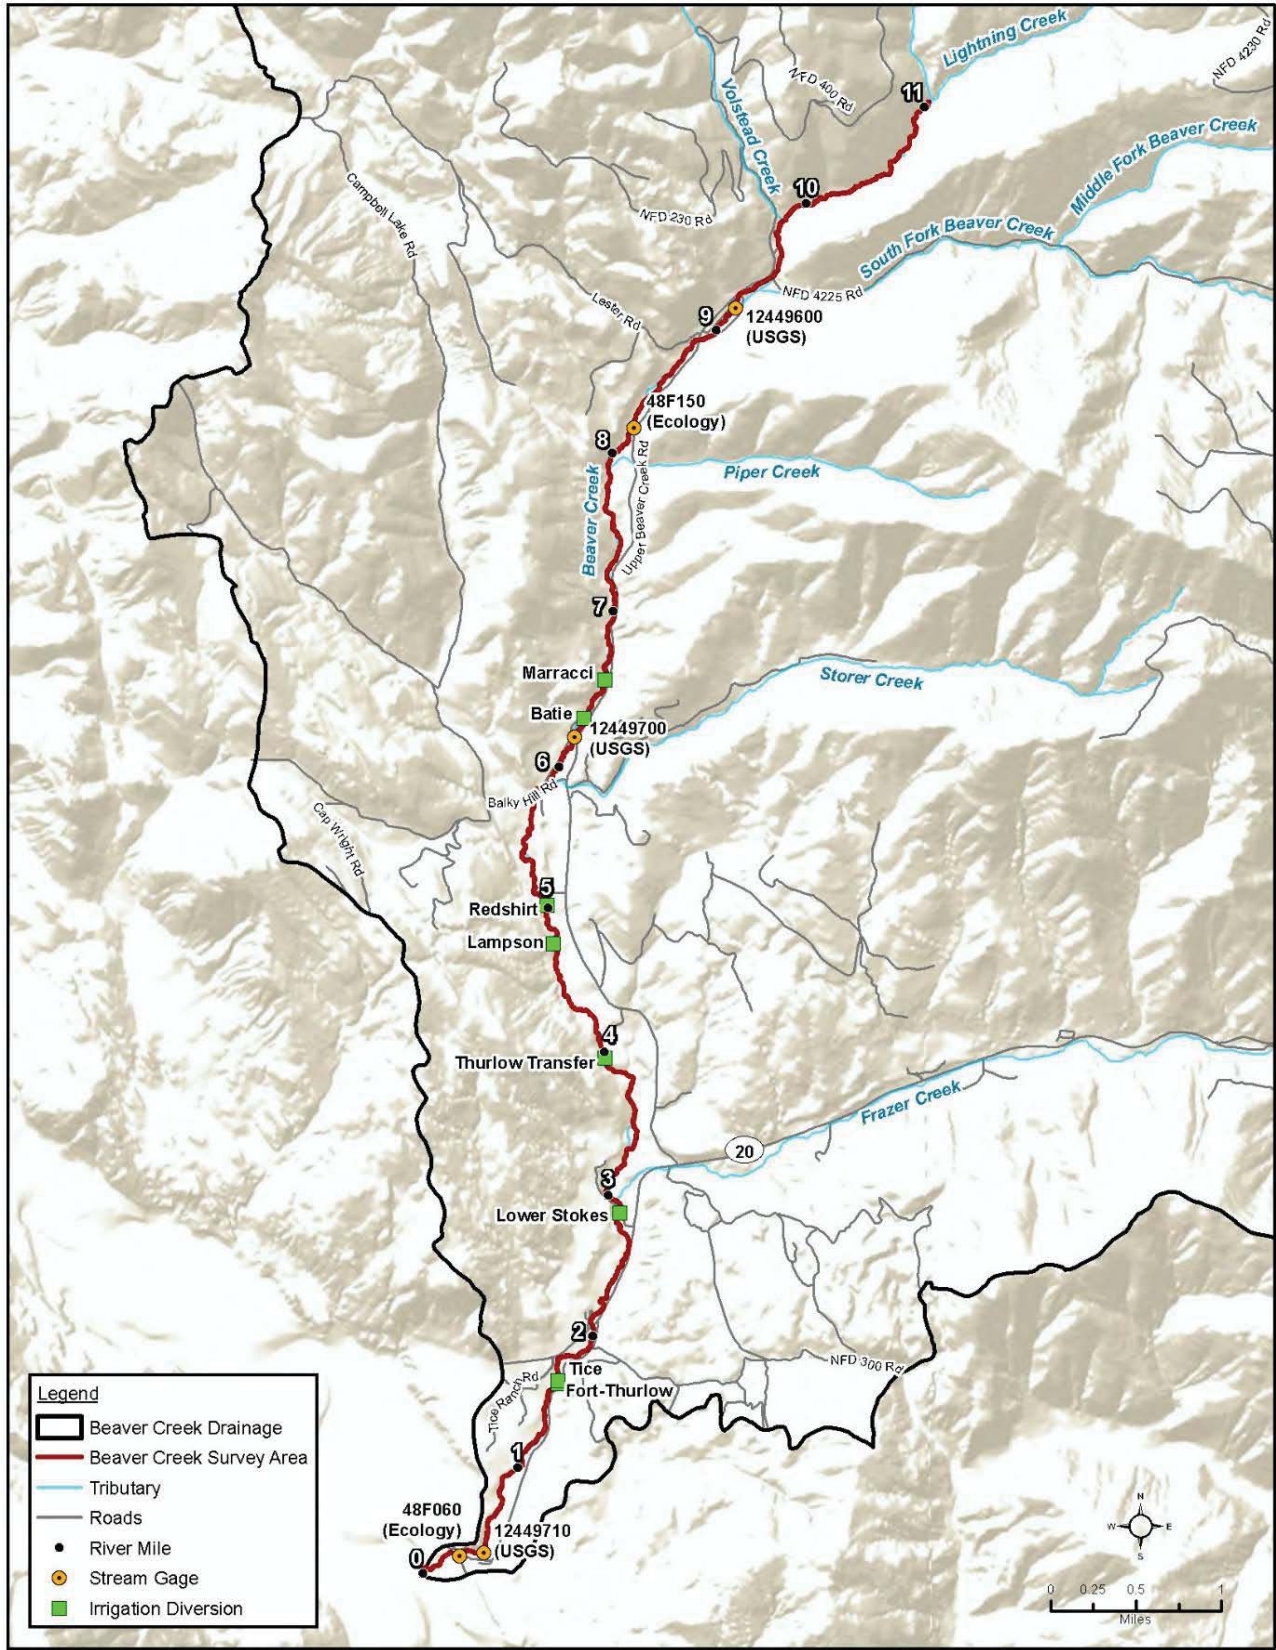
Figure 2-4. Diversions and Stream Gages within the Beaver Creek Reach Assessment Survey Area

Currently, there are nine active diversions on Beaver Creek within the Study Area, shown by river mile in Table 2-1. Figure 2-4 shows the diversion structures and stream gages (see Section 2.5) in the Survey Area. Passage studies have been conducted to evaluate the completed passage improvements (Connolly et al 2010; Hopkins 2013; USBR 2013a). However, the continued long-term fish passage effectiveness of the replaced diversion structures has been identified as a concern requiring potential ongoing maintenance (UCRTT 2014).

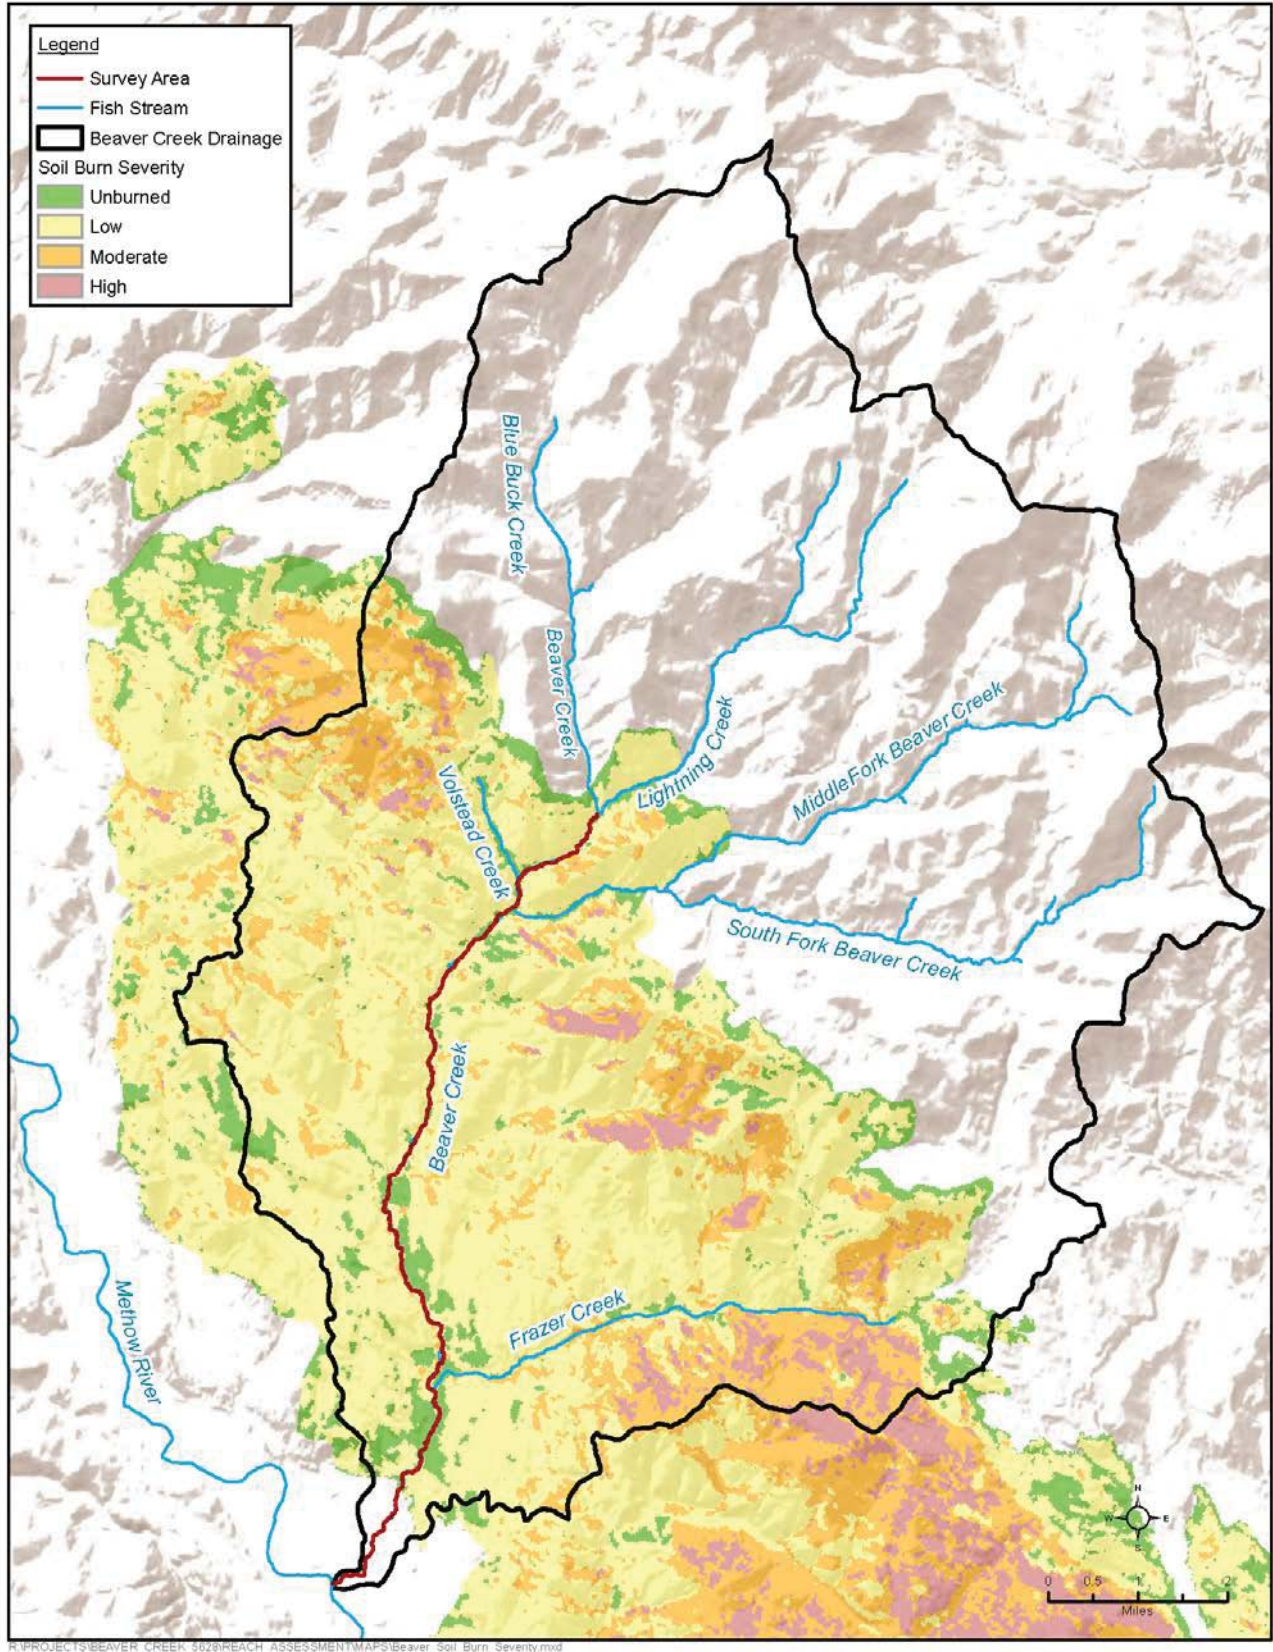
Figure 2-7 Soil Burn Severity in Beaver Creek following the 2014 Carlton Complex Fire

In 2014, the Carlton Complex Fire started with lightning strikes on July 14 that created four separate fires that joined together on July 20 and ultimately burned roughly 256,000 acres (TU 2015). Figure 2-7 shows the soil burn severity in the Beaver Creek drainage as a result of Carlton Complex Fire (BAER 2014). For the most part, the 2014 Carlton Complex Fire did not overly impact the fish-bearing tributaries within the burn boundaries, with the exception of Beaver Creek, where the fire extended over 42 percent of the Beaver Creek drainage area, with 12 percent of the area having moderate to high severity, mostly along Frazer Creek (Johnson and Molesworth 2015; TU 2015). When the areas of the two fires are combined, the majority of the land in the Beaver Creek drainage has burned over the past decade (Watson and Crandall 2015). The photographs in Figure 2-8 show an example of a burned riparian area of Beaver Creek after the 2014 Carlton Complex Fire (left), and an area representative of post-fire riparian understory regrowth (right, photograph taken in 2017).

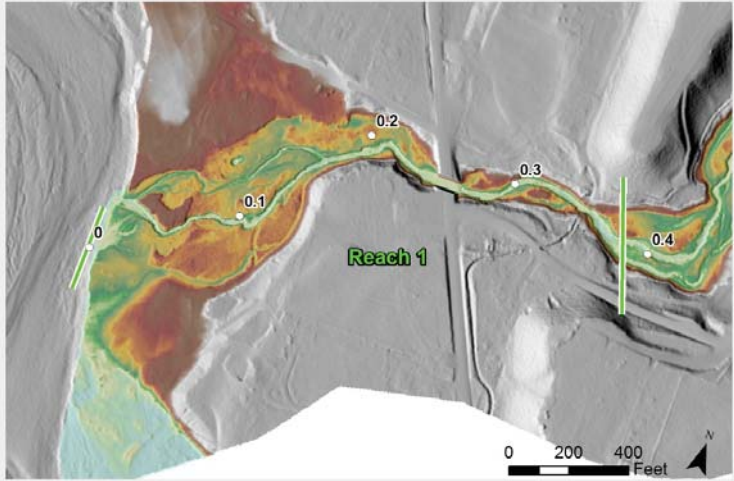
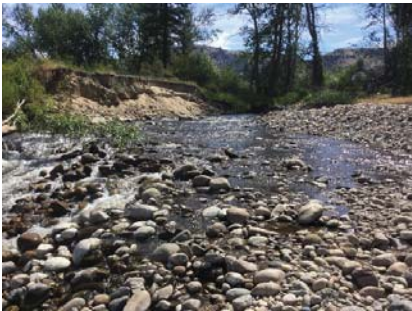
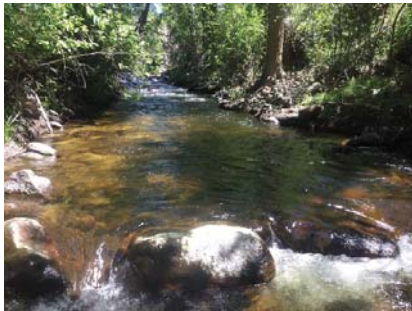
Table 4-3. Reach 1 Physical Characteristics, Location Map, and Photos

Reach 1: This is a relatively short reach from the confluence with the Methow River to RM 0.4; key features include the alluvial fan and the Methow Valley Highway (SR 153) crossing near RM 0.3. The Lower Beaver Creek Road parallels the creek to the east upstream of the Methow Valley Highway (SR 153). The channel in this reach is 2 percent gradient, deeply incised, and lacks instream habitat complexity and cover. Most of the channel banks downstream of the Methow Valley Highway (SR 153) crossing show signs of active erosion. There are multiple side channels across the fan in this reach but they are hydrologically disconnected at most flows due to channel incision. The planform of Reach 1 is relatively straight with limited sediment storage in sparse bars. This reach was not burned in the 2014 Carlton Complex Fire.

Valley Setting	Alluvial fan	
Channel Morphology	Pool-riffle	
Migration Type	Irregular lateral	
Rosgen Type	G3	
Gradient	2.0%	
Sinuosity	1.16	
Bankfull Width (feet)	17.4	
Width-to-Depth Ratio	5	
Floodprone Width (feet)	21	
Entrenchment Ratio	1.21	
Substrate (dominant (%), subdominant (%))	Cobble (52%), gravel (25%) ^{1/}	
Bank Condition	Armored (0.0%), eroding (44.6%)	
Floodplain Disconnected	51.7%	
LWD (pieces/mile)	30.4	
Jams (jams/mile)	0	
Pools (pools/mile)	27.9	
Unit Stream Power (watts/meter)	269	
Habitat Units	Pool (25%), glide (0%), riffle (69%), rapid (6%), cascade (0%)	
REI Score	12

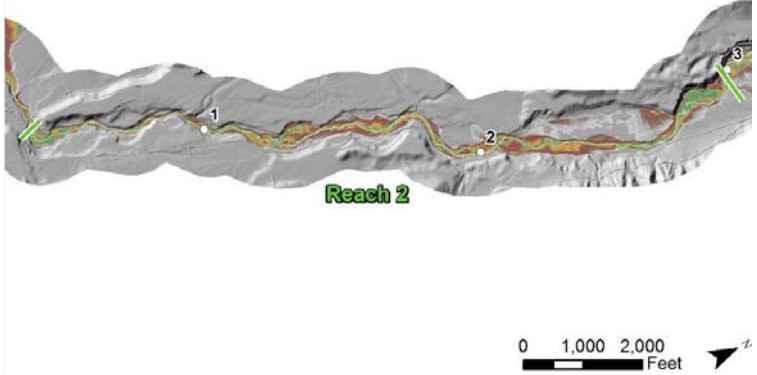
Table 4-4. Reach 2 Physical Characteristics, Location Map, and Photos

Reach Length (miles)	2.82	
Valley Setting	Broad, terraced	
Channel Morphology	Pool-riffle	
Migration Process	Irregular lateral	
Rosgen Type	C3	
Gradient	2.0%	
Sinuosity	1.22	
Bankfull Width (feet)	24.4	
Width-to-Depth Ratio	9	
Floodprone Width (feet)	54	
Entrenchment Ratio	2.25	
Substrate (dominant (%), subdominant (%))	Cobble (45%), gravel (21%) ^{1/}	
Bank Condition	Armored (0.9%), eroding (3.8%)	
Floodplain Disconnected	39.8%	
LWD (pieces/mile)	6.4	
Jams (jams/mile)	3.5	
Pools (pools/mile)	10.6	
Unit Stream Power (watts/meter)	253	
Habitat Units	Pool (11%), glide (7%), riffle (71%), rapid (10%), cascade (0%)	
REI Score	15

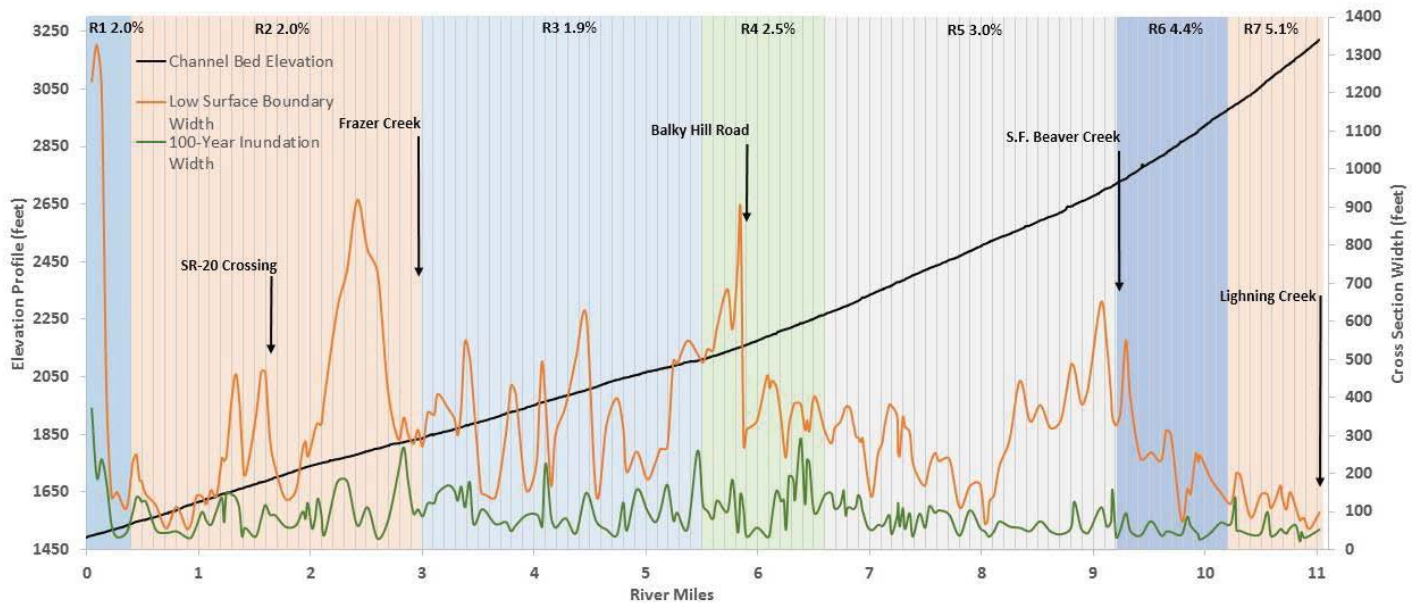
Figure 4-4 shows the longitudinal profile of the Beaver Creek channel bed elevation, derived from the topobathymetric LiDAR data, along with valley and floodplain characteristics including the 100-year inundation width (described in Section 4.4.1) and the low surface boundary width. The location of the seven geomorphic reaches, their average channel gradient, and the location of tributary junctions and road crossings are shown on the figure for reference. The channel gradient of Beaver Creek remains relatively consistent throughout reaches 1 through 4 ranging from 2.0 to 2.5 percent. The gradient increases throughout Reaches 5 through 7 from 3.0 to 5.1 percent. These reaches also have a relatively narrow 100-year inundation width and low surface boundary width, except for a segment from RM 8.2 to 9.4 that has a relatively wide valley bottom.

Figure 4-4. Longitudinal Profile of Channel Bed Elevation, 100-year Inundation Width and Low Surface Boundary Width

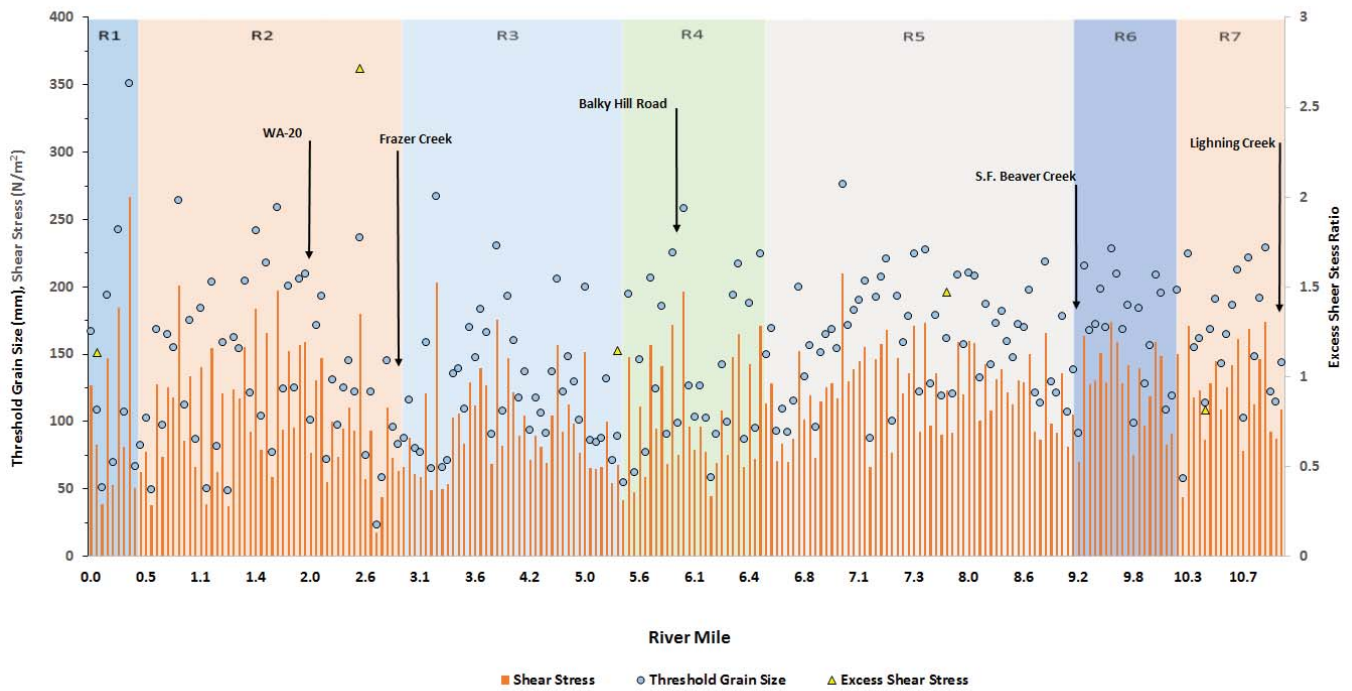
Hydraulic characteristics and flow competence were evaluated using HEC-RAS model outputs including unit stream power, shear stress, excess shear stress, and threshold of motion grain size, also referred to as incipient motion. Figure 4-8 shows the longitudinal variation in hydraulic conditions throughout the Survey Area with reach breaks, road crossings and tributary junctions shown for reference. In general, the hydraulic characteristics are in agreement with the observed sediment size distributions in that there are relatively consistent hydraulic characteristics throughout the Survey Area with an increase in shear stress and threshold grain size in the two upstream reaches (Reaches 6 and 7). Reach 2 has the lowest shear stress and threshold grain size values.

Figure 4-8. Shear Stress, Threshold Grain Size, and Excess Shear Stress by River Mile in Beaver Creek

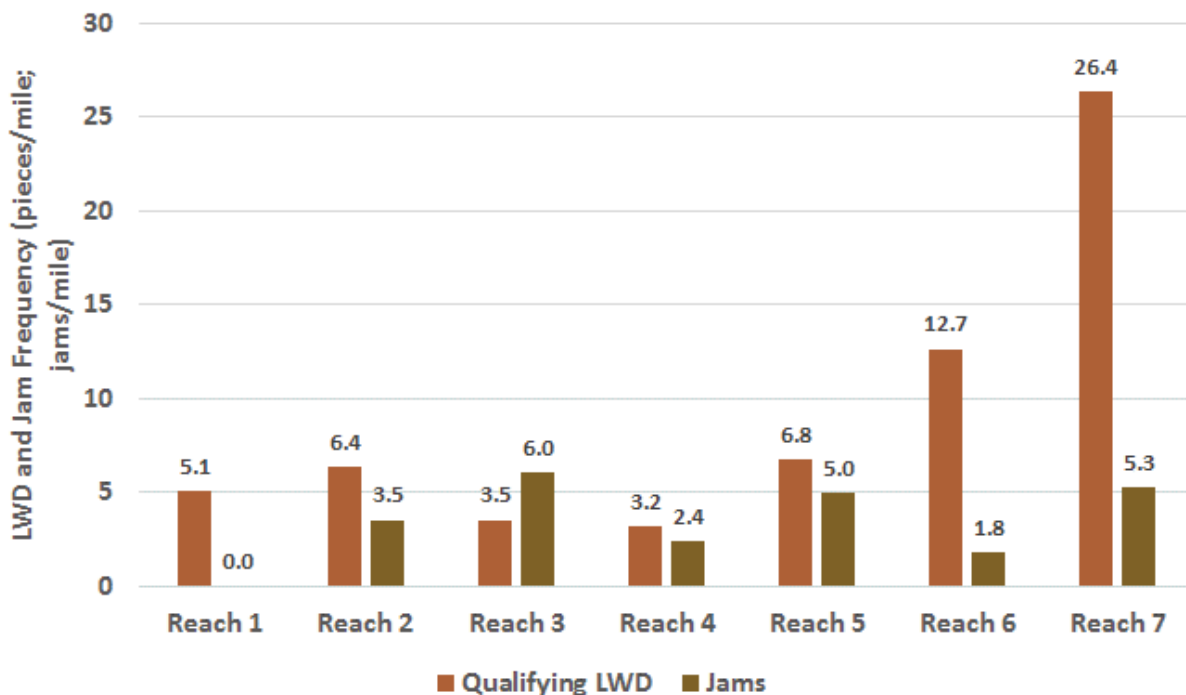
LWD within the bankfull channel was inventoried during Project field surveys following the USFS Level II protocols (USFS 2016). All medium (greater than 12 inch diameter and 35 feet length) and large (greater than 20 inch diameter and 35 feet length) LWD was tallied within each habitat unit. These sizes of LWD are referred to as qualifying and were used to determine the LWD frequency in pieces per mile. The quantity of LWD ranged from 3.2 pieces per mile in Reach 4 to 26.4 pieces per mile in Reach 7, as shown in Figure 4-9. The quantity of log jams ranged from no jams in Reach 1 to 6 jams per mile in Reach 3 (Figure 4-9). The quantity of LWD in Reaches 1 through 6 is below the federal target of 20 pieces per mile (USFWS 1998). In addition, Fox and Bolton (2007) determined that standard was low for larger eastern Washington streams (16 to 164 feet bankfull width) in unmanaged forested basins which had an average of 42.5 pieces per mile. The quantity of LWD in all reaches is well below the Fox and Bolton (2007) standard pieces per mile. The REI analysis in Appendix D contains additional LWD information.

Figure 4-9. Frequency of Qualifying LWD and Log Jams by Reach in Beaver Creek

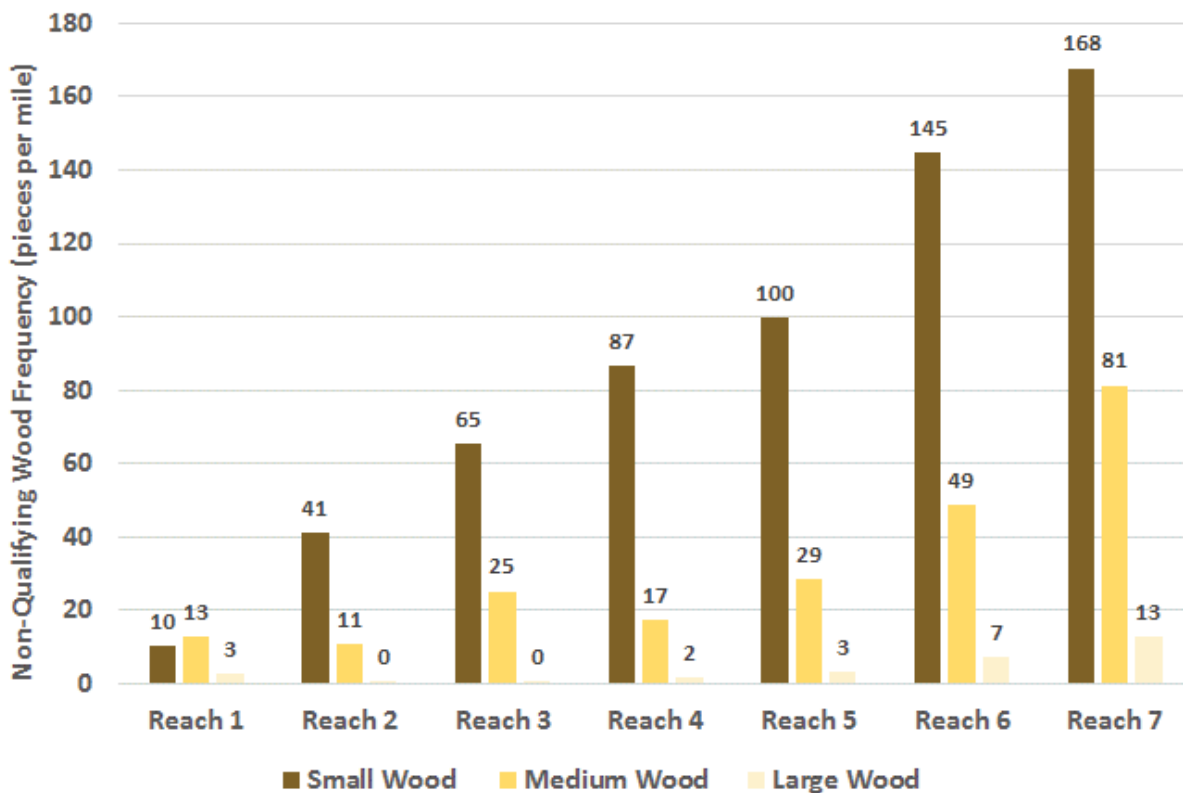
functions in Beaver Creek. Most of the wood in in Beaver Creek is in the small size class ranging from 6 to 12 inches in diameter and greater than 10 feet in length. As shown in Figure 4-10, the vast majority of wood in Beaver Creek does not meet the size criteria for LWD of greater than 12 inches in diameter and 35 feet in length identified for federal targets of properly functioning (USFWS 1998).

Figure 4-10. Distribution of Size Classes of Non-Qualifying Wood by Reach in Beaver Creek

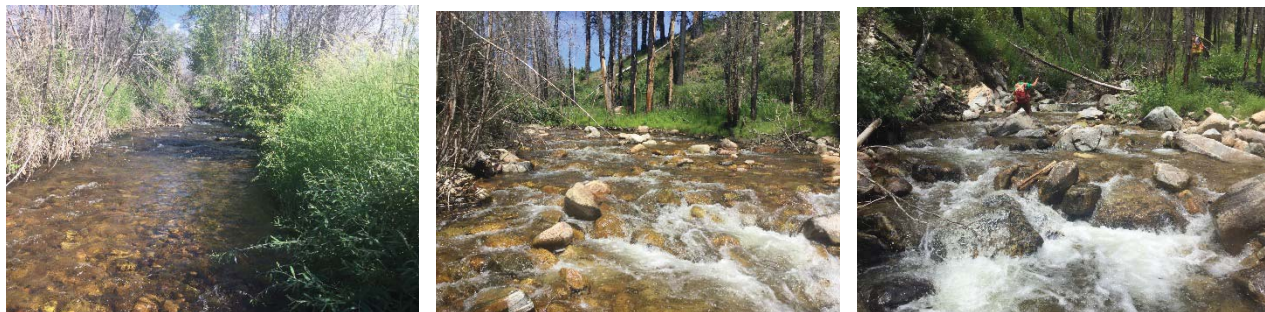
Figure 4-12 shows the distribution of habitat units by reach in Beaver Creek. Fast water riffle habitat units dominate the lower reaches of Beaver Creek (Reaches 1 through 4) ranging from 69 to 76 percent of the total, while rapid habitat units dominate the upper reaches (Reaches 5 through 7) ranging from 65 to 75 percent of the total. Reach 7 had the highest proportion of cascade habitat units at 8 percent of the total. The photographs in Figure 4-13 show typical riffle, rapid, and cascade habitat units in the Survey Area.

Figure 4-13. Photographs of Typical Fast Water Habitat Units Including a Riffle near RM 4.4 in Reach 3 (left), a Rapid near RM 7.8 in Reach 5 (center), and a Cascade in RM 10.6 in Reach 7 (right).

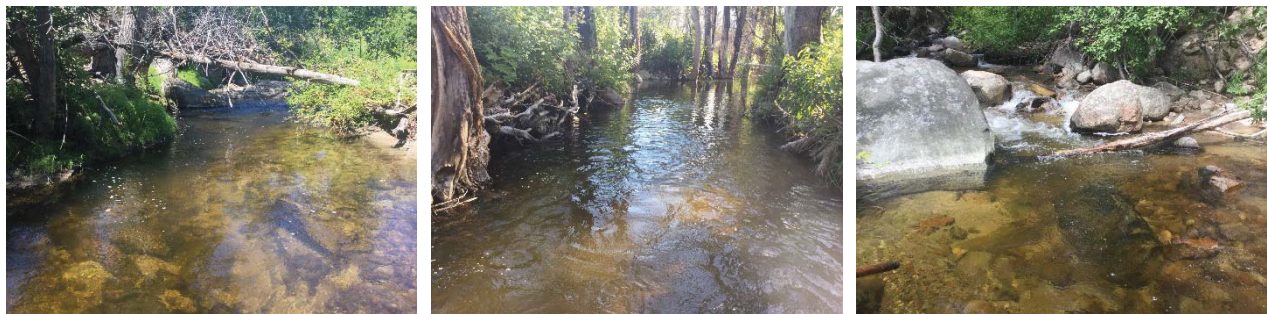
For this Project, deep pools were defined as those with a residual pool depth of greater than 2 feet. Reach 1 had the greatest frequency of deep pools at 7.6 per mile (a total of 3). Typically, deep pools are defined as those over 3 feet deep; however, pool depth is scaled by stream size, and since the Beaver Creek bankfull width is relatively small, ranging from 13.4 to 20.4 feet, a depth of over 2 feet was selected for determining deep pools. The photographs in Figure 4-15 show typical scour pool, plunge pool, and dam pool habitat units in the Survey Area.

Figure 4-15. Photographs of Typical Pools Including a Scour Pool near RM 2.6 in Reach 2 (left), and Dam Pool near RM 3.2 in Reach 3 (center), and a Boulder Plunge Pool near RM 11.0 in Reach 7 (right)

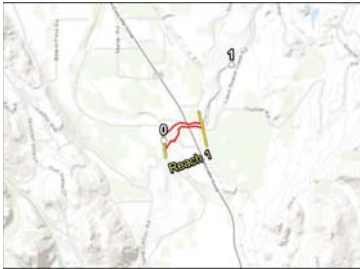
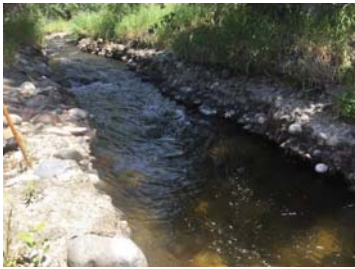
Project Area 1 – RM 0.0 to 0.4	<ul style="list-style-type: none"> - Remove non-native plants - Riparian planting - Remove bank armoring - Install LWD structures (whole trees, jams, etc.) - Remove and/or relocate floodplain infrastructure - Perennial side channel creation/enhancement - Secondary channel (non-perennial) creation/enhancement - Alcove creation/enhancement - Pool creation/enhancement - Channel realignment/reconstruction 	<p>Main channel incised and lacks complex instream habitat and cover. Multiple existing side channels disconnected from main channel at bankfull flows.</p> <p>Install large wood habitat structures at frequent spacing in main channel to aggrade channel, create habitat complexity and cover, and access to side channels; minor excavation at inlet to side channels may be needed.</p> <p>Remove bank armoring and abandoned bridge abutments upstream of the Methow Valley Highway crossing.</p> <p>Potential for main channel realignment into existing side channel or channel reconstruction downstream of the Methow Valley Highway crossing.</p>	1

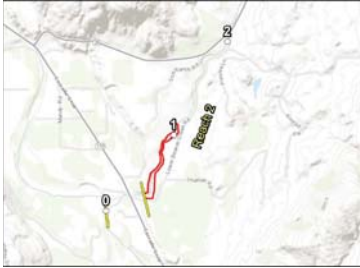
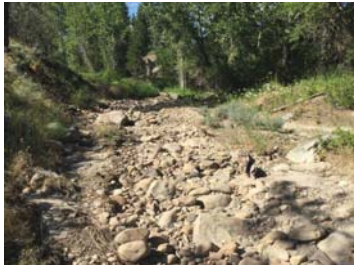
Project Area 2 – RM 0.4 to 1.1	<ul style="list-style-type: none"> - Remove non-native plants - Riparian planting - Install LWD structures (whole trees, jams, etc.) - Reconnect/enhance cold water springs - Alcove creation/enhancement - Groundwater fed off-channel habitat enhancement - Pool creation/enhancement - Evaluate fish passage at diversions 	<p>Main channel is valley confined, with a small number of side channels inundated at 2-yr flow.</p> <p>Install large wood habitat structures in main channel to create habitat complexity and hydraulic diversity through scour pool creation and improved sediment sorting.</p> <p>Construct perennial side channels/alcoves for juvenile rearing habitat.</p> <p>Monitor and maintain fish passage at diversion, as needed.</p> <p>Evaluate the potential to incorporate groundwater flows on the left bank near the downstream end of the project area where the Fort-Thurlow irrigation return flows in a relic side channel.</p>	2

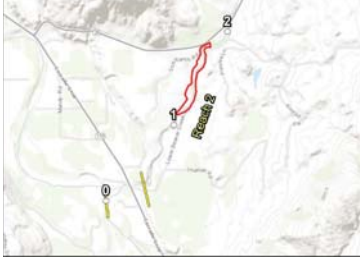
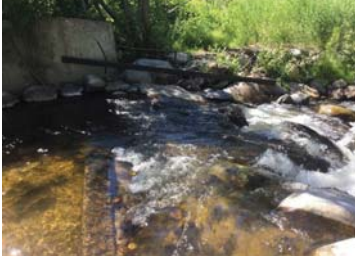
Project Area 3 – RM 1.1 to 1.8	<ul style="list-style-type: none"> - Remove non-native plants - Riparian planting - Install LWD structures (whole trees, jams, etc.) - Perennial side channel creation/enhancement - Secondary channel (non-perennial) creation/enhancement - Wetland creation/enhancement - Alcove creation/enhancement - Pool creation/enhancement - Evaluate fish passage at diversions 	<p>Single thread channel, slightly incised, with disconnected side channels present in lower portion of project area. Seasonal juvenile barrier at Fort-Thurlow diversion.</p> <p>Install large wood habitat structures to enhance scour pools, and encourage floodplain connectivity to create habitat complexity and hydraulic diversity.</p> <p>Construct large perennial side channels in lower portion of project area for juvenile rearing.</p> <p>Monitor and maintain fish passage, at the Fort-Thurlow Diversion, as needed.</p>	3

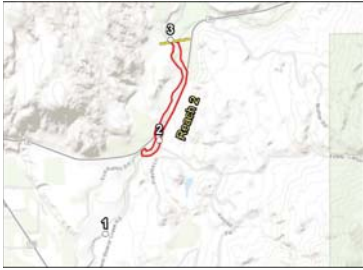
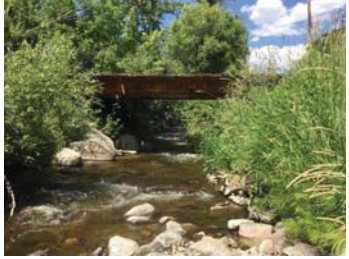
Project Area 4 – RM 1.8 to 3.0	<ul style="list-style-type: none"> - Remove non-native plants - Riparian planting - Bank stabilization with LWD and bioengineering - Install LWD structures (whole trees, jams, etc.) - Remove and/or relocate floodplain infrastructure - Perennial side channel creation/enhancement - Secondary channel (non-perennial) creation/enhancement - Wetland creation/enhancement - Alcove creation/enhancement - Pool creation/enhancement 	<p>Slightly more sinuous main channel in broad valley. Highway 20 and private driveway crossings result in disrupted floodplain connectivity. Large available floodplain in upper project area.</p> <p>Install large wood habitat structures to enhance scour pools to create habitat complexity and place structures to encourage floodplain inundation.</p> <p>Construct large seasonal side channels in lower portion of project area for high-flow refugia.</p> <p>Construct perennial alcove at Frazer Creek confluence.</p> <p>Evaluate alternatives at the Highway 20 and private drive bridge crossings to remove bank armoring and increase floodplain connectivity.</p> <p>Install large wood structures in conjunction with minor excavation to reconnect floodplain in upper project area.</p>	4

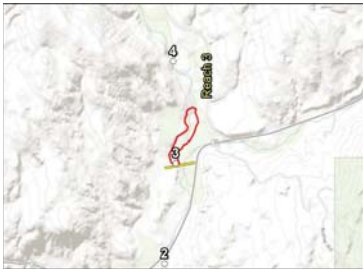
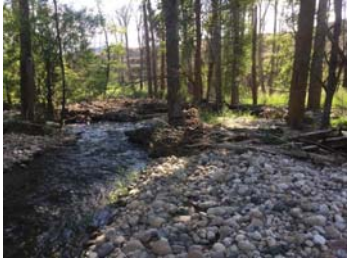
Project Area 5 – RM 3.0 to 3.5	<ul style="list-style-type: none"> - Remove non-native plants - Riparian planting - Install LWD structures (whole trees, jams, etc.) - Remove and/or relocate floodplain infrastructure - Reconnect/enhance cold water springs - Perennial side channel creation/enhancement - Secondary channel (non-perennial) creation/enhancement - Wetland creation/enhancement - Alcove creation/enhancement - Groundwater fed off-channel habitat enhancement - Pool creation/enhancement - Reconnect/enhance abandoned meander 	<p>Braided main channel in lower section of project area due to large jam complex. Long disconnected side channels on valley right in middle and upper sections of project area.</p> <p>Install large wood structures in conjunction with minor excavation to reconnect side channels in middle and upper project areas.</p> <p>Install large wood habitat structures to enhance scour pools for habitat complexity and place structures to encourage increased floodplain inundation for hydraulic diversity.</p> <p>Create perennial alcove(s) in middle section of project area.</p> <p>Evaluate potential to incorporate groundwater flows throughout this project area.</p>	8

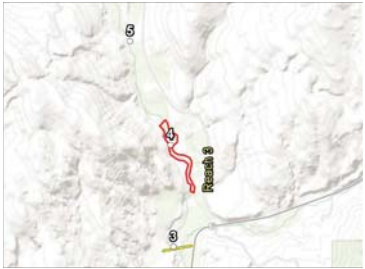
Project Area 6 – RM 3.5 to 4.2	<ul style="list-style-type: none"> - Remove non-native plants - Riparian planting - Install LWD structures (whole trees, jams, etc.) - Remove and/or relocate floodplain infrastructure - Reconnect/enhance cold water springs - Perennial side channel creation/enhancement - Secondary channel (non-perennial) creation/enhancement - Wetland creation/enhancement - Alcove creation/enhancement - Groundwater fed off-channel habitat enhancement - Pool creation/enhancement 	<p>Little known about this project area as access was not granted at time of field survey.</p> <p>From a desktop assessment, there appear to be multiple locations for opportunities to reconnect small floodplain areas with wood placement. Locations for perennial and/or seasonal side channels and/or alcoves.</p> <p>Options for perennial and/or seasonal side channel reconstructions.</p> <p>Install large wood habitat structures in main channel to create habitat complexity and hydraulic diversity.</p> <p>Evaluate the potential to incorporate groundwater flows particularly on the left bank floodplain near RM 3.5.</p> <p>Monitor and maintain fish passage, as needed, at the Thurlow Transfer Diversion.</p>	9

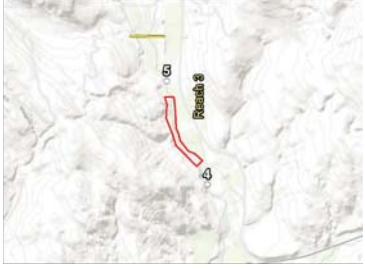
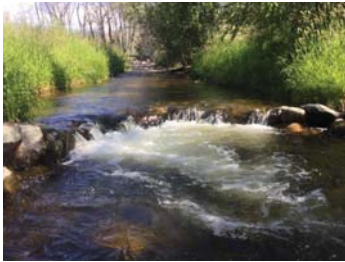
Project Area 7 – RM 4.2 to 4.8	<ul style="list-style-type: none"> - Install LWD structures (whole trees, jams, etc.) - Perennial side channel creation/enhancement - Secondary channel (non-perennial) creation/enhancement - Wetland creation/enhancement - Alcove creation/enhancement - Groundwater fed off-channel habitat enhancement - Pool creation/enhancement - Evaluate fish passage at diversions 	<p>Project area includes the Lower Schoolhouse restoration project. The channel is moderately confined with short braided sections throughout.</p> <p>Install large wood habitat structures in areas that have not received restoration actions to increase floodplain connectivity upstream of existing project to create habitat complexity and hydraulic diversity.</p> <p>Construct perennial alcoves in areas that have not received restoration actions throughout project area for juvenile rearing.</p> <p>Monitor and maintain fish passage, as needed, at the Lamson Diversion</p>	10

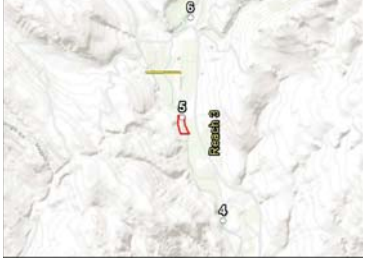
Project Area 8 – RM 4.8 to 5.0	<ul style="list-style-type: none"> - Remove non-native plants - Riparian planting - Install LWD structures (whole trees, jams, etc.) - Remove and/or relocate floodplain infrastructure - Pool creation/enhancement 	<p>Little known about this project area as access was not granted at time of field survey.</p> <p>Based on a desktop assessment, there appear to be multiple opportunities to reconnect small floodplain areas with wood placement.</p> <p>Install large wood habitat structures in main channel to create habitat complexity and hydraulic diversity.</p>	11

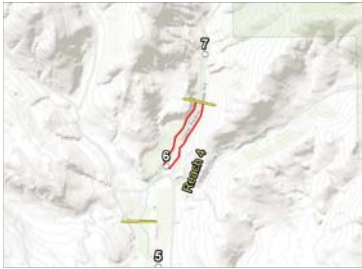
Project Area 11 – RM 6.0 to 6.6	<ul style="list-style-type: none"> - Road grading and drainage improvements - Road decommissioning or abandonment - Remove non-native plants - Riparian planting - Install LWD structures (whole trees, jams, etc.) - Remove and/or relocate floodplain infrastructure - Perennial side channel creation/enhancement - Secondary channel (non-perennial) creation/enhancement - Wetland creation/enhancement - Alcove creation/enhancement - Pool creation/enhancement - Reconnect/enhance abandoned meander - Evaluate fish passage at diversions 	<p>Project area includes Upper Beaver Creek Habitat Improvement project, with large section of floodplain disconnected by Upper Beaver Creek Road, channel that has been relocated to valley right, and Beatty diversion at top of project area that is possible juvenile barrier. Evaluate success of previous restoration and modify, if needed, to increase function. Monitor and maintain fish passage, as needed, at the Beatty diversion.</p> <p>Install large wood habitat structures to increase pool habitat through scour pool formation and place to encourage floodplain inundation for increased habitat complexity and hydraulic diversity.</p> <p>Evaluate alternatives to relocate Upper Beaver Creek Road to reconnect relic channels, increase sinuosity, habitat complexity, and floodplain connectivity.</p> <p>Construct seasonal side channels for high-flow refugia.</p> <p>Construct perennial alcoves for juvenile rearing habitat.</p>	6

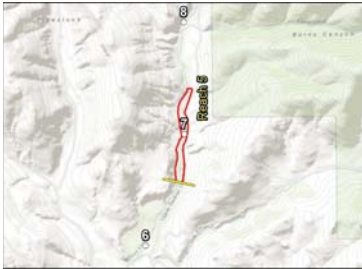
Project Area 12 – RM 6.6 to 7.4	<ul style="list-style-type: none"> - Road grading and drainage improvements - Road decommissioning or abandonment - Bank stabilization with LWD and bioengineering - Install LWD structures (whole trees, jams, etc.) - Remove and/or relocate floodplain infrastructure - Perennial side channel creation/enhancement - Secondary channel (non-perennial) creation/enhancement - Wetland creation/enhancement - Alcove creation/enhancement - Groundwater fed off-channel habitat enhancement - Pool creation/enhancement 	<p>Project area has a mixture of public and private ownership and has multiple relict channel scars and side channels currently disconnected, with increased bank erosion from fire, and Parmley diversion within project area.</p> <p>Install large wood habitat structures for increased pool habitat and place for increased floodplain inundation to create habitat complexity and hydraulic diversity.</p> <p>Possible excavation of inlets to old side channels with large wood habitat structures to increase habitat complexity.</p> <p>Evaluate alternatives to relocate Upper Beaver Creek Road to remove existing bank armoring and artificial confinement in order to increase floodplain connectivity.</p> <p>Construct a series of perennial side channels and alcoves for high-flow refugia and juvenile rearing.</p>	12

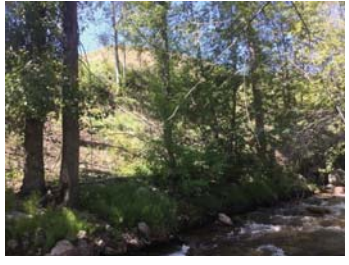
Project Area 13 – RM 7.4 to 8.1	<ul style="list-style-type: none"> - Road grading and drainage improvements - Install LWD structures (whole trees, jams, etc.) - Reconnect/enhance cold water springs - Perennial side channel creation/enhancement - Secondary channel (non-perennial) creation/enhancement - Alcove creation/enhancement - Pool creation/enhancement 	<p>Channel confined in tight valley, limited floodplain and side channels, exposed bedrock throughout project area.</p> <p>Install large wood habitat structures to increase scour pool habitat for habitat complexity.</p> <p>Place large wood structures to aggrade channel for increased floodplain connectivity and to access relic side channels at more frequent flows.</p> <p>Construct perennial alcove at Piper Creek confluence for juvenile rearing and high-flow refugia.</p> <p>Improve road drainage systems at Burns Creek and other areas of the Upper Beaver Creek Road to reduce chronic sediment inputs.</p>	13

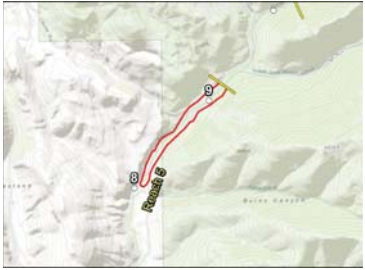
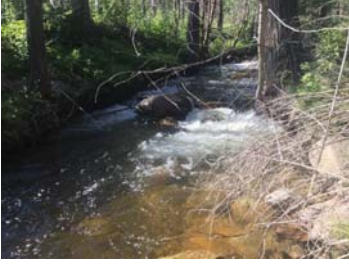
Project Area 14 – RM 8.1 to 9.2	<ul style="list-style-type: none"> - Road grading and drainage improvements - Install LWD structures (whole trees, jams, etc.) - Remove and/or relocate floodplain infrastructure - Perennial side channel creation/enhancement - Secondary channel (non-perennial) creation/enhancement - Wetland creation/enhancement - Alcove creation/enhancement - Groundwater fed off-channel habitat enhancement - Pool creation/enhancement 	<p>Single thread channel with increased floodplain availability, disconnected side channels present, and historic road grade that is disrupting hydrologic floodplain connectivity.</p> <p>Install large wood habitat structures to aggrade channel, increase floodplain connectivity, and create habitat complexity and hydraulic diversity.</p> <p>Evaluate alternatives to improve the upper Beaver Creek Road crossing and abandoned crossing downstream to increase floodplain connectivity.</p> <p>Construct perennial side channel/alcoves for juvenile rearing.</p> <p>Possible excavation and large wood installation to reconnect relic side channels.</p>	14

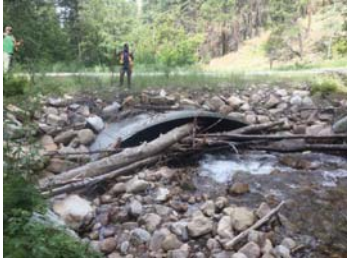
Project Area 15 – RM 9.2 to 9.8	<ul style="list-style-type: none"> - Recreation Management - Road grading and drainage improvements - Install LWD structures (whole trees, jams, etc.) - Remove and/or relocate floodplain infrastructure - Groundwater fed off-channel habitat enhancement - Pool creation/enhancement - Evaluate fish passage at diversions 	<p>Single thread channel in confined valley, with little available floodplain, and undersized culvert at NF-4225 crossing.</p> <p>Install large wood habitat structures to create habitat complexity and hydraulic diversity</p> <p>Replace or repair culvert at NF-4225 crossing to improve the passage of flow, sediment, and woody debris to reduce the risk of catastrophic failure.</p> <p>Evaluate alternatives for recreation management to reduce impacts.</p>	18

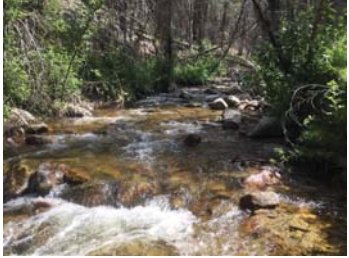
Project Area 16 – RM 9.8 to 10.2	<ul style="list-style-type: none"> - Recreation Management - Road grading and drainage improvements - Install LWD structures (whole trees, jams, etc.) - Alcove creation/enhancement 	<p>Single thread channel in confined valley, with sparse floodplain availability and limited access. Install large wood habitat structures in lower portion of project area to create habitat complexity.</p> <p>Construct large perennial alcove at Volstead Creek confluence for juvenile rearing habitat.</p> <p>Hand-fell existing trees or helicopter place woody debris in upper portion of project area to increase habitat complexity.</p> <p>Evaluate alternatives for recreation management to reduce impacts.</p> <p>Improve NF-200 Road crossings on Volstead Creek to reduce chronic sediment inputs or relocate road.</p>	19

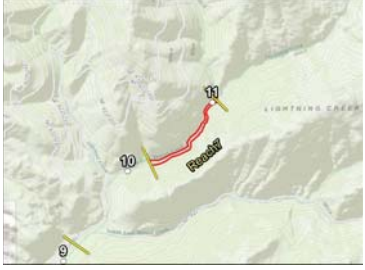
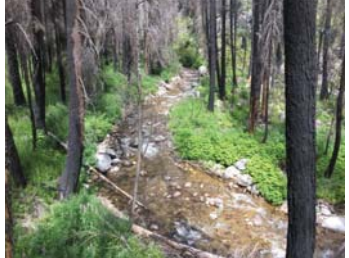
Project Area 17 – RM 10.2 to 11.0	<ul style="list-style-type: none"> - Recreation Management 	<p>Single thread channel in confined valley, with sparse floodplain availability and limited access. Evaluate alternatives for recreation management to reduce impacts.</p>	21
