Chewuch River Reach Assessment

Yakama Nation Fisheries Program

JUNE 2010

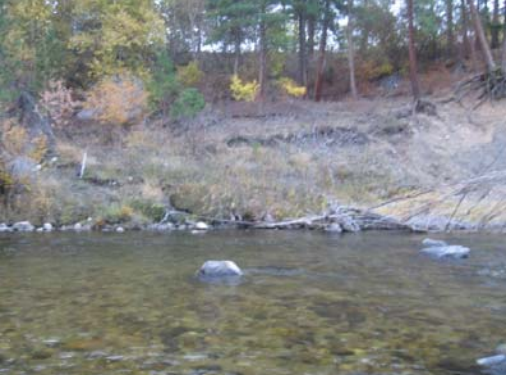
Reach	Project Number	Sub-Unit	Strategy Category	Project Name	Description	Photo
2a	Project RM 2.44L	Inner Zone 2 (IZ-2)	Instream Habitat Enhancement	LWD enhancement	This project is located at a pool tail-out just upstream of a riffle crest. The river left bank is low near 2.44, with low-velocity habitat along the bank. A LWD jam would create and maintain pool scour and enhance existing in-stream habitat.

<p>View to the east at the river left bank near RM 2.44 at a potential LWD location. November 2009.</p>
2a	Project RM 2.68L	Outer Zone 5 (OZ-5)	Off-Channel Habitat Enhancement	Wetland habitat enhancement	At the downstream end of OZ-5, a long, narrow wetland occupies an area that was an active side-channel in 1954. There does not appear to be an upstream surface connection. The wetland appears to be groundwater fed with a downstream surface water connection with the main channel near RM 2.65. The outlet channel has a passable gradient and likely provides access to quality off-channel habitat in its current condition. There is an opportunity to increase habitat cover and complexity in the off-channel complex using LWD. Passage conditions at the outlet should also be further investigated to ensure year-round passage.

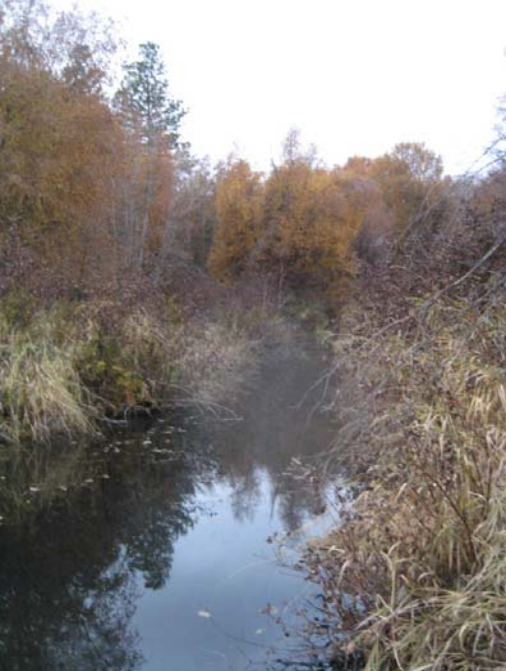
<p>View to the north in the upstream direction at a wetland located at the down-stream end of OZ-5 near RM 2.65. November 2009.</p>

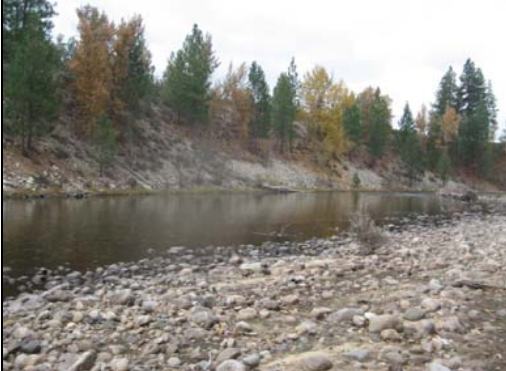
2a	Project RM 4.45L	Inner Zone 1 (IZ-1)	Instream Habitat Enhancement	LWD enhancement	A long pool runs along the outside of the bend along river left in this area. LWD structures along the river left bank would encourage scour to enhance pool formation, provide cover and increase habitat quality. The proposed location is at the toe of the glacial terrace, which is composed of unconsolidated alluvial material. There is a home built near the top of the bank. Excess erosion of the bank may be undesirable at this location.

<p>View to the southeast in the downstream direction at a potential LWD jam location along river left near RM 4.45. November 2009.</p>
2a	Project RM 4.65L	Inner Zone 1 (IZ-1)	Reconnect Stream Channel Processes	Side-channel habitat reconnection	This project combines elements of Projects RM 5.3L and 5.25L. There is a high-flow cut-off channel on the inside of a meander bend extending between RM 4.5 and 7.73, similar to Project RM 5.25. However, this high-flow channel is well defined and experiences more frequent ground disturbing flow similar to Project RM 5.3. Sand deposition at this site is similar to RM 5.3L. A combination of excavation and LWD placement could increase low flow connection and habitat in this side-channel.

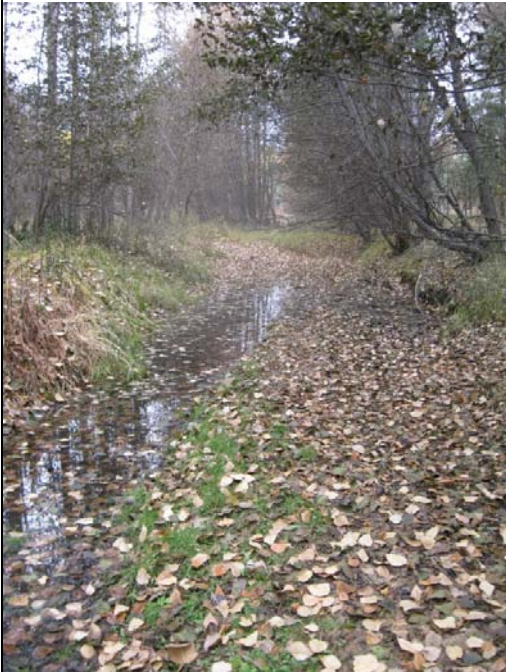
<p>View to the northwest in the upstream direction at groundwater collected in a high-flow channel near RM 4.5. November 2009.</p>

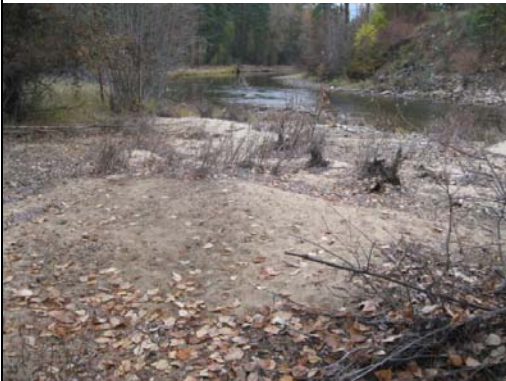
<p>View to the south in the downstream direction at the outflow of a network of high-flow channels near RM 5.21. November 2009.</p>

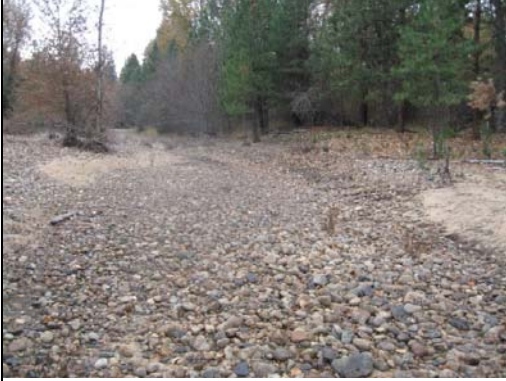
2a	Project RM 5.3L	Inner Zone 1 (IZ-1)	Off-Channel Habitat Enhancement	Side-channel habitat enhancement	This project involves enhancing existing side-channel habitat in a large high-flow side channel that extends between RM 5.1 to 5.5. At the upstream end, the side-channel is well-defined and frequently scoured by high energy flows. The low water surface is about 3 ft below the bed of the side channel. Bed material fines to sand near the downstream end of the side channel and there is a large deposit of sand at the outlet. Enhancing flow in the channel could increase velocities and maintain a sand-free bed that is suitable for salmonid habitat. The upstream end would require some excavation to create a split flow condition, or increase the frequency of flow through the side channel. LWD near the inlet to the side-channel could also enhance low-flow connection.

<p>View to the southeast in the downstream direction at the upstream end of a large high-flow channel near RM 5.47. November 2009.</p>

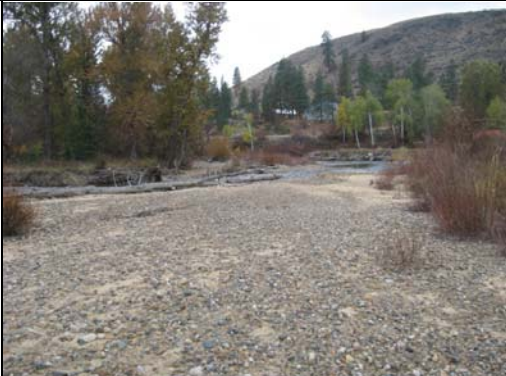
2a	Project RM 5.37C	Inner Zone 1 (IZ-1)	Reconnect Stream Channel Processes	Re-establish channel LWD dynamics	At this location, flow splits around a stable gravel bar. This is a natural wood deposition area. The project would involve creating new or enhancing existing bar apex LWD jams to re-establish inner zone dynamics and enhance cover habitat and complexity.

<p>View to the north in the upstream direction at a split flow location where some wood has naturally accumulated. November 2009.</p>

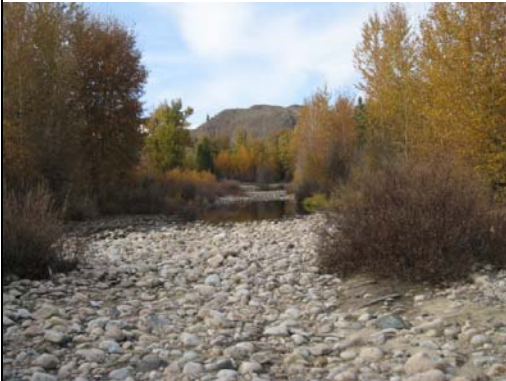
Reach	Project Number	Sub-Unit	Strategy Category	Project Name	Description	Photo
2b	Project RM 6.65C	Inner Zone 1 (IZ-1)	Reconnect Stream Channel Processes	Re-establish channel LWD dynamics.	Between RM 6.5 and 6.8 lateral channel migration has formed large gravel point bars, high-flow channels, and scour-pools. Several log jams at bar apexes and on the outsides of bends would increase side-channel connectivity and enhance inner zone processes such as scour, lateral channel dynamics, and future LWD recruitment.

<p>View to the south in the downstream direction at a side-channel that is active during high flow near RM 6.8. November 2009.</p>
2b	Project RM 6.7R	Outer Zone 1 (OZ-1)	Off-Channel Habitat Enhancement	Wetland habitat enhancement	A meander scar provides wetland habitat made up of several small beaver ponds in this area. The upstream inlet is at RM 6.82, and the downstream outlet is at RM 6.62. At the inlet, the bank is high and there is no evidence of frequent conveyance of flood water. Where the channel scar hits the toe of the hillslope, groundwater fills low areas and the surface is wet and consists of a series of beaver ponds. This wet area becomes a more well-defined channel network in the downstream direction. A combination of LWD, channel excavation, and habitat enhancement would be used to enhance process dynamics and habitat connectivity as well as habitat quality through this area.

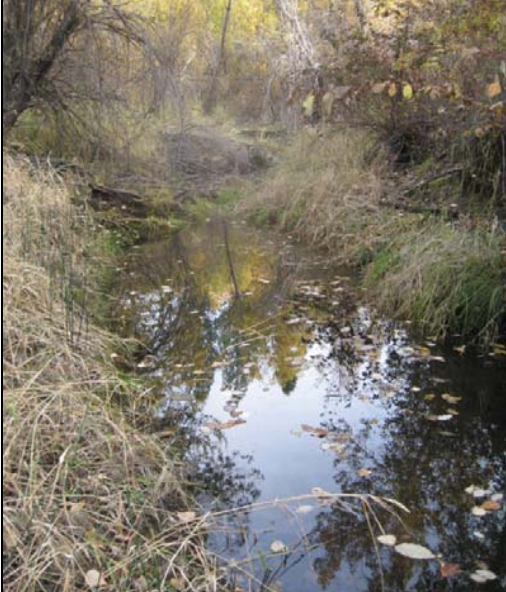
<p>View of off-channel wetland occupying a meander scar at the extreme west side of the floodplain near RM 6.82. November 2009.</p>

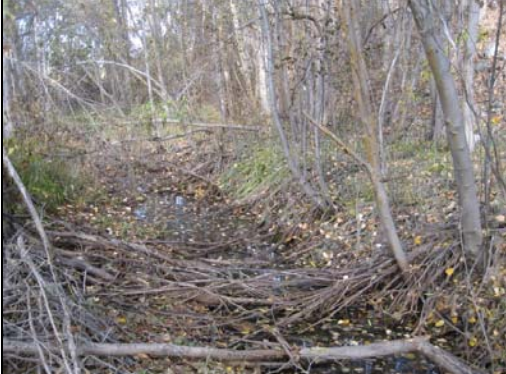
2b	Project RM 6.8L	Outer Zone 2 (OZ-2)	Off-Channel Habitat Enhancement	Wetland habitat enhancement	In this area there is a network of high-flow channels that appear to receive infrequent flood inundation. Habitat and process connection could be enhanced by excavating off-channel habitat. A groundwater gallery might potentially draw enough sub-surface water to create perennial flow at the downstream end of the project.

<p>Floodplain wetlands near RM 6.75 that could be enhanced to provide off-channel habitat. November 2009.</p>

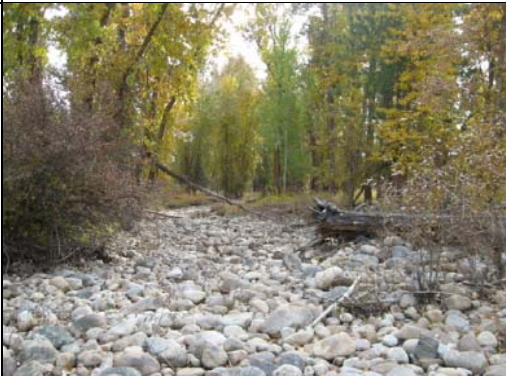
3a	Project RM 7.42L	Inner Zone 2 (IZ-2)	Reconnect Stream Channel Processes	Side-channel habitat reconnection	An apex log jam and selected excavation would enhance flows into a high-flow cut-off channel across the floodplain margin of a large cobble point bar between RM 7.37 and 7.48. A log jam at the upstream end would create scour and encourage a split flow condition. LWD would also provide habitat cover and complexity.

<p>View to the south in the downstream direction at the inflow to a side-channel along river-left near RM 7.48 (November 2009).</p>

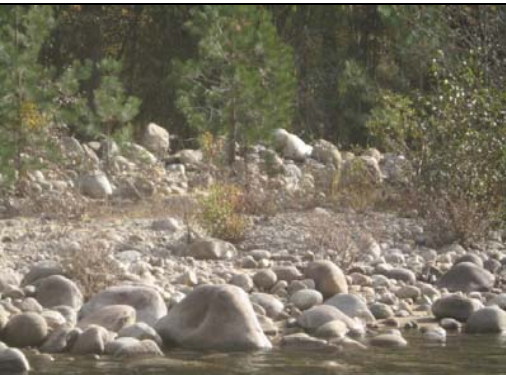
<p>View to the southeast in the downstream direction at a boulder push-up levee blocking a side-channel along river left near RM 7.95 (November 2009).</p>

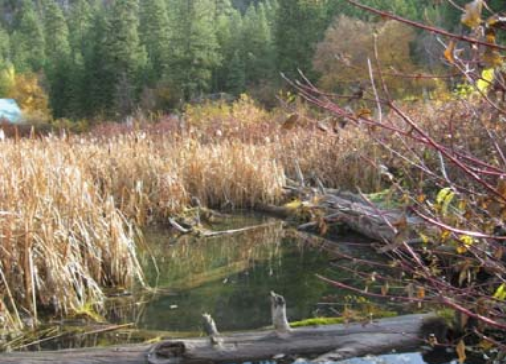
Reach	Project Number	Sub-Unit	Strategy Category	Project Name	Description	Photo
4b	Project CR_Prj-10.2 (USBR 2008b)	Outer Zone 1 (OZ-1)	Off-Channel Habitat Enhancement		This area has been identified by the USBR as a location for to restore a wetland or network through restoration of cleared areas and assessment of impacts to connectivity.	
4b	Project RM 10.35L	Inner Zone 1 (IZ-1)	Off-Channel Habitat Enhancement	Wetland habitat enhancement	There is a large floodplain wetland formed by old beaver dams at this site. There is a channel connecting this feature to inner-zone habitats, but it does not provide passability at all flow levels. Some excavation would be needed to provide fish passage into the off-channel habitat at lower flows. Wood could also be added to provide cover for rearing fish.

<p>View to the north at a wetland located near RM 10.35 (November 2009).</p>
4b	Project RM 10.37L	Inner Zone 1 (IZ-1)	Riparian Restoration	Riparian restoration and LWD enhancement	This bank is directly downstream of the riprap section referred to in Project RM 10.46L. The bank is slumping and appears to be eroding at an accelerated rate due to riparian clearing. There is some LWD recruitment taking place where a large cottonwood has fallen. The uniform, eroding bank could be enhanced with several jams along the bank to provide erosion control and habitat cover and complexity. There is also an opportunity to re-establish a forested riparian buffer along this section.

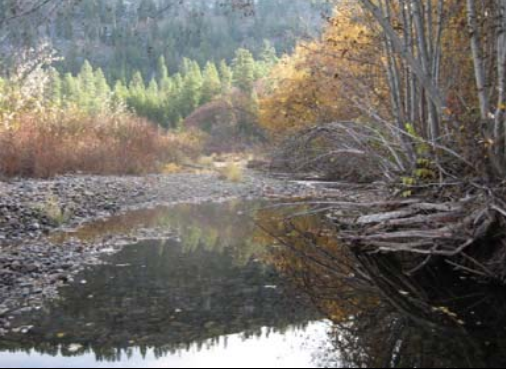
4b	Project RM 10.37R	Inner Zone 1 (IZ-1)	Off-Channel Habitat Enhancement	Side-channel habitat enhancement	This project would enhance the habitat conditions of an existing side-channel that extends around the river-right side of a gravel bar between RM 10.33 and RM 10.42. The side-channel is active, carrying flow at a wide range of discharges. There is a pool formed at the upstream end by scour against bedrock and the hydraulic control of the gravel bar. Large log jams at the up and downstream end would be used to increase pool scour, add cover, and re-establish natural geomorphic features of the system.

<p>View to the east in the downstream direction at a side-channel near RM 10.35 (November 2009).</p>
4b	Project CR_Prj-10.4R (USBR 2008b)	Disconnected Outer Zone 1 (DOZ-1)	Off-Channel Habitat Enhancement		This area has been identified by the USBR as a location for low surface reconnection through restoration of cleared areas.

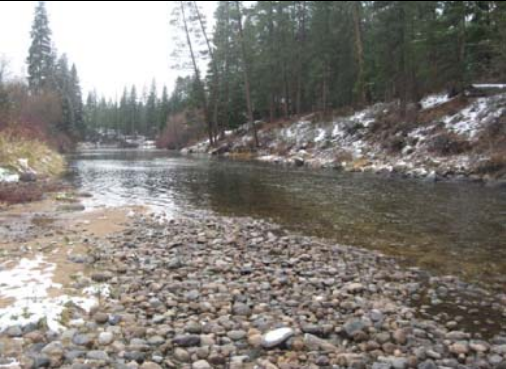
<p>View to the east at riprap and floodplain clearing along the river-left bank near RM 10.46 (November 2009).</p>
4c	Project RM 10.6R	Inner Zone 1 (IZ-1)	In-Stream Habitat Enhancement	LWD enhancement	This project involves LWD placement to increase local habitat quality and cover. This channel section is straight and currently lacks habitat complexity.

<p>View to the south in the downstream direction at a low complexity stretch of river near RM 10.6 (November 2009).</p>

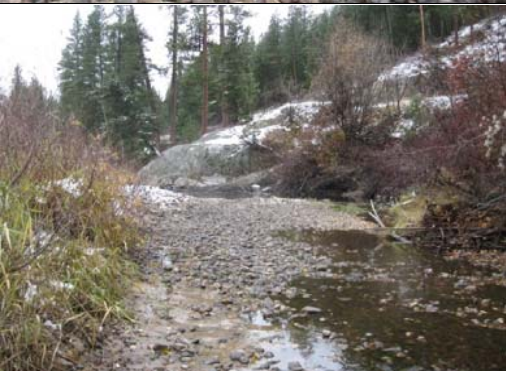
<p>View to the southwest in the downstream direction at a side-channel and bedrock outcrop near RM 11.75 (November 2009).</p>

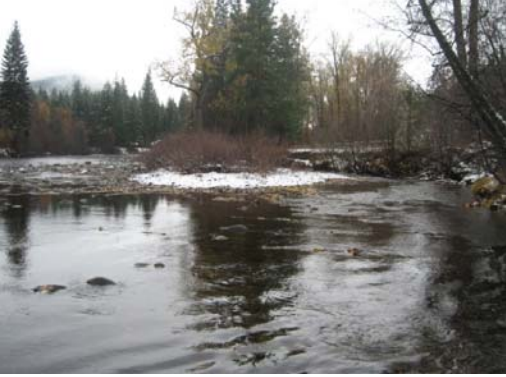
Reach	Project Number	Sub-Unit	Strategy Category	Project Name	Description	Photo
4c	Project RM 10.9C	Inner Zone 1 (IZ-1)	Reconnect Stream Channel Processes	Re-establish channel LWD dynamics	There are multiple opportunities between RM 10.93 and 10.87 to use LWD to reconnect channel processes. Near RM 10.93 there is a small section of split flow at this location where the river flows around a gravel bar and is actively eroding to the west into a relatively low terrace. The project would entail placing a log jam at the apex of the gravel bar to enhance split flow and encourage inner-zone processes such as scour and lateral migration. Near RM 10.87 is a location of active split flow where the channel flows around a short gravel bar and is eroding the terrace to the west of the channel. There is overhanging riparian vegetation, undercut banks, and root wads providing good habitat in the right side channel. Placement of an apex log jam would enhance the inner-zone processes creating the bar and the split flow and increase habitat complexity.

<p>View to the south in the downstream direction at an area of split flow near RM 10.93 (November 2009).</p>

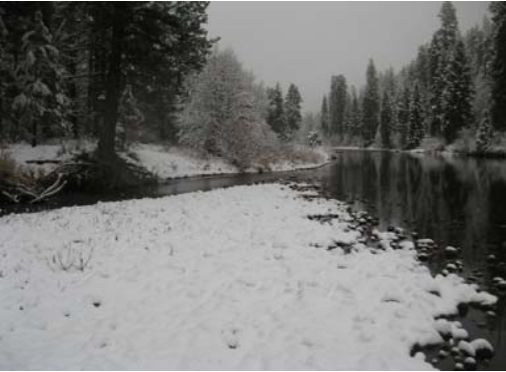
Reach	Project Number	Sub-Unit	Strategy Category	Project Name	Description	Photo
5a	Project RM 12.3C	Inner Zone 2 (IZ-2)	Reconnect Stream Channel Processes	LWD placement to enhance lateral connectivity	Between RM 12.25 and 12.4 there are multiple locations for log jam placements that would re-establish channel geomorphic processes such as lateral migration. In this area, the channel is more complex and wood placements can be used to increase the quality of existing habitat features. A series of bar apex jams near RM 12.4 could be used to enhance split flow conditions, increase scour for pool formation, and enhance habitat cover and complexity. The bank near RM 12.3 is fairly high and slightly undercut with overhanging vegetation. An LWD project here would increase the existing cover, and create scour thereby enhancing pool formation. Near RM 12.25 there are multiple split flows locations and side-channels. This is potentially rich habitat. LWD would be beneficial throughout IZ-2 to maintain channel dynamics and increase habitat complexity. This project is a bar apex jam that would maintain split flow, and increase scour to drive pool formation.

<p>View to the north in the upstream direction at the apex of a gravel bar and split flow location along river-right near RM 12.4 (November 2009).</p>

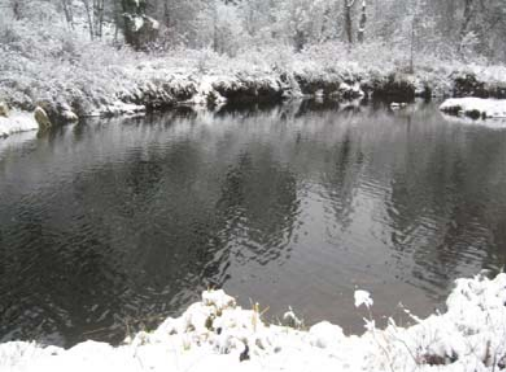
5a	Project RM 12.35L	Inner Zone 2 (IZ-2)	Off-Channel Habitat Enhancement	Alcove habitat enhancement	This project involves enhancement of habitat features in an existing side-channel and backwater. The side-channel, extending from RM 12.35 to 12.4 receives substantial scour during low main channel flows and empties into a large pool off the main channel that provides a backwater area for rearing and migrating fish. LWD would be placed to increase cover and complexity at this site.

<p>View to the southeast in the downstream direction at a large backwater located on river left near RM 12.3 (November 2009).</p>
5a	Project RM 12.45R	Outer Zone 2 (OZ-2)	Reconnect Floodplain Processes	Enhance floodplain connectivity	OZ-2 provides the largest open water wetland in the study area. This feature is an oxbow pond formed by past channel avulsion and maintained through beaver activity. There are multiple high-flow channels originating at the upstream end of the sub-unit that provide high-flow connection to the wetlands. Campsite access roads create barriers in some of these high-flow channels. The USBR (2008b) has identified this as a restoration project area with a focus on removing or installing culverts in these roads to increase connectivity. Other restoration options include enhancing the upstream surface connection to the floodplain by excavating appropriate channel inlets and constructing log jams to increase juvenile rearing fish cover in downstream wetlands.

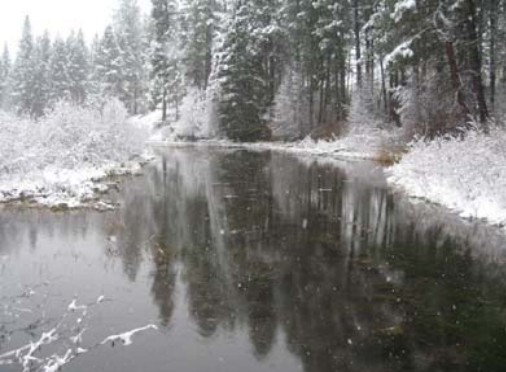
<p>View to the southeast at a large oxbow pond on the west side of the valley near RM 12.3 (November 2009).</p>

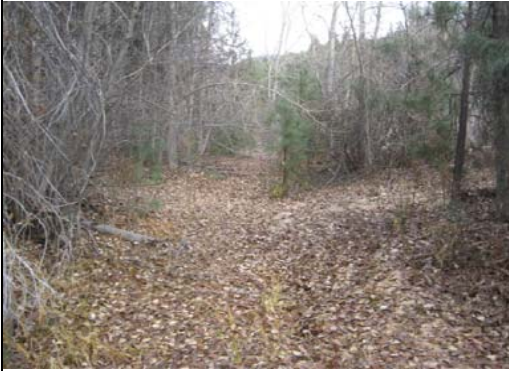
Reach	Project Number	Sub-Unit	Strategy Category	Project Name	Description	Photo
5b	Project RM 13.59R	Inner Zone 1 (IZ-1)	Side-Channel habitat enhancement	Side-Channel habitat enhancement	This side-channel runs along river-right between RM 13.53 and 13.63. This is a low energy side-channel with sand deposits. There are well established trees in the channel suggesting that flow rarely has the power to scour the bed. A large apex log jam at the upstream end would encourage flow into the side-channel, scouring the bed and coarsening sediment. With the addition of wood and other habitat features throughout the side-channel, habitat conditions would be improved for rearing, migrating, and spawning fish. Increased flow in the side-channel also has the potential to increase connectivity to a network of floodplain channels to the west.

<p>View to the south in the downstream direction at a river-right side-channel near RM 13.59 (November 2009).</p>

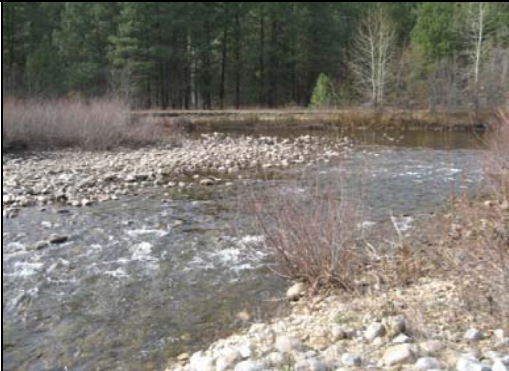
5b	Project RM 13.6C	Inner Zone 1 (IZ-1)	Reconnect Stream Channel Processes	LWD placement to enhance lateral connectivity	The area of the reach from RM 13.45 to RM 13.92 has multiple split flow locations with stable bars and islands. There are opportunities to load the entire stretch of river with wood and re-establish natural geomorphic elements and channel dynamics. Near RM 13.92 a large bank log jam would work with the natural sinuosity of the reach to move water laterally and encourage channel migration. The jam would also increase cover along the bank and create scour pool formation. AT RM 13.78 there is a bar apex log jam placement opportunity. This is a suitable location as wood naturally tends to accumulate on bar apexes, enhancing split flow, lateral channel migration, and habitat complexity. There is a split-flow location near RM 13.73 with opportunities for bank jams on both sides of the river. These jams would add complexity and enhance the split-flow condition. Near RM 13.62, a left-bank log jam would increase habitat quality and cover. There is bank erosion and modest LWD recruitment at this location that would be enhanced by the wood placement. A well-connected, active side-channel that extends from RM 12.4 to 12.54 could be enhanced with several log jams. The side-channel is an example of the effects of LWD on habitat complexity and abundance. There are scour pools around existing jams that provide good habitat when water is flowing through the channel. More wood could be added to increase the quality of habitat in the side-channel.

<p>View to the northwest in the upstream direction at split flow around a gravel bar near RM 13.78 (November 2009).</p>

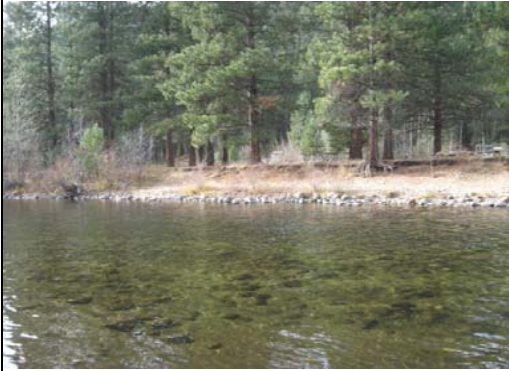
<p>View to the northeast in the upstream direction at the river left bank near RM 13.73 (November 2009).</p>

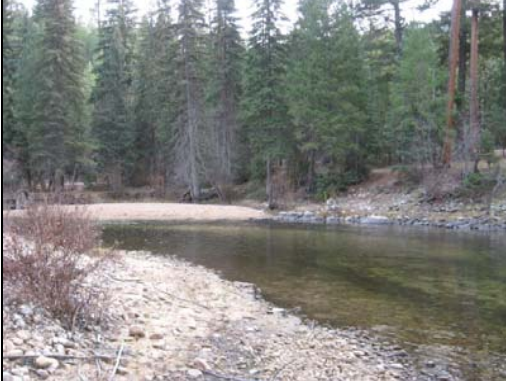
Reach	Project Number	Sub-Unit	Strategy Category	Project Name	Description	Photo
7	Project RM 14.76L	Inner Zone 2 (IZ-2)	In-Stream Habitat Enhancement	LWD enhancement	This is the only section of the reach with planform complexity. The river takes an abrupt turn to the west, eroding into the margin of the glacial terrace. There is a poorly developed riffle-pool sequence with a narrow bar on the inside of the bend and some scour occurring on the outside. LWD can be used at this site to enhance the scour and pool formation on the outside of the bend while providing cover and improved habitat.

<p>View to the northeast in the upstream direction at a bend in the river near RM 14.76 (November 2009).</p>
7	Project RM 15.15C	Inner Zone 2 (IZ-2)	In-Stream Habitat Enhancement	LWD enhancement	Between RM 15.34 and 14.93 there are opportunities to enhance instream habitat with bank log jams on both sides of the channel. Near RM 15.34 there is a long, straight section with little habitat availability. Several log jams could be placed along both banks in order to provide habitat cover and complexity. Near RM 15.21 is a right bank log jam opportunity meant to increase cover and habitat complexity. The bank is high and eroding, exposing several large root masses. There are pines that could be recruited as LWD. A log jam near RM 15.14 would alternate with the jam at RM 15.21, increasing overall density of cover and creating a location of potential pool scour on the opposite side of the channel. Bank conditions are similar with ongoing erosion of a terrace and potential for LWD recruitment. Near RM 14.93 there are several log jam opportunities in stream banks on both sides of the river. As with the inner zone upstream of this site, there is very little habitat complexity and there is an opportunity at this location to improve it.

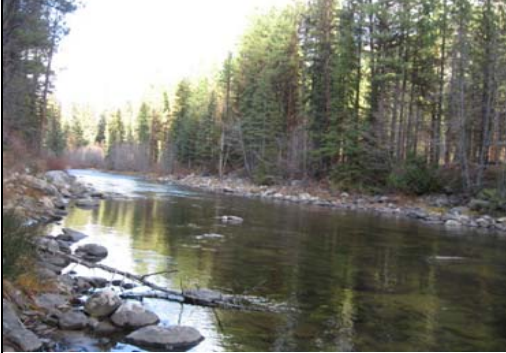
<p>View to the north in the upstream direction at a low complexity section of the reach near RM 15.34 (November 2009).</p>

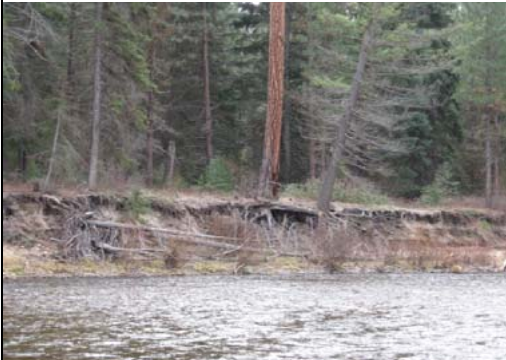
<p>View to the northwest in the upstream direction at the river right bank near RM 15.21 (November 2009).</p>

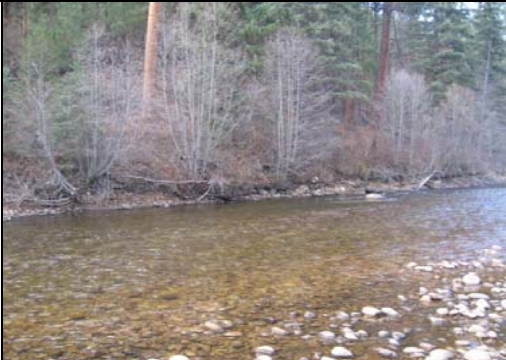
7	Project RM 15.54R	Inner Zone 1 (IZ-1)	In-Stream Habitat Enhancement	LWD enhancement.	This site is at the tail-out of an upstream riffle that orients flow to the west toward the river-right bank resulting in erosion and overhanging root wads. The addition of LWD along the bank would increase scour and pool formation as well as provide cover.

<p>View to the northwest in the upstream direction at the river-right bank near RM 15.54 (November 2009).</p>

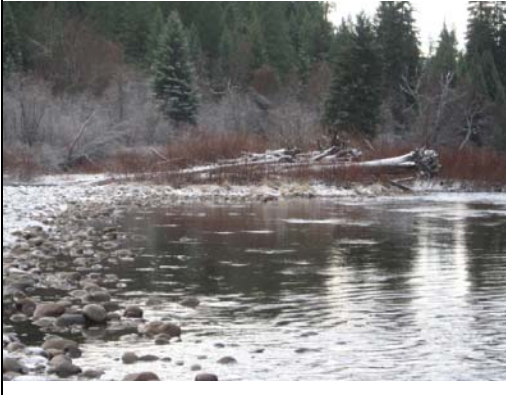
Reach	Project Number	Sub-Unit	Strategy Category	Project Name	Description	Photo
8	Project RM 16.65C	Inner Zone 2 (IZ-2)	Reconnect Stream Channel Processes	LWD placement to enhance lateral connectivity	Between RM 16.5 and 16.8 log jam placements are possible at several bar apexes and in multiple side-channels. A general goal with all the placements is to encourage the processes that are naturally taking place in this area and to enhance the habitat by providing cover and complexity. A bar apex jam has naturally accumulated a relatively significant log jam near RM 16.8 and there is active split flow around the bar at all flow levels. The river-left side-channel has some pool habitat but with little cover. LWD placements would include supplementing the bar apex jam and adding several smaller jams along the left side channel to increase cover and habitat complexity. There are several potential log jam placements around a gravel bar and the multiple active side channels near RM 16.62. A bar apex log jam has formed at the upstream end of the project area. This jam would be enhanced with several large logs to increase scour and enhance flow into the side-channels. Several other large log jams would be placed throughout the river-right and river-left side-channels where there are several small riffle-pool sequences and some undercut banks that would be improved with the addition of wood. Near RM 16.51 there is active gravel bar formation on river-left and active bank erosion on river-right. The bank erosion has resulted in LWD recruitment. This project would entail placing log jams on both sides of the river including a bar apex jam on the left and enhancement of existing bank wood on the right.

<p>View to the south in the downstream direction at a bar apex log jam near RM 16.8 (November 2009).</p>

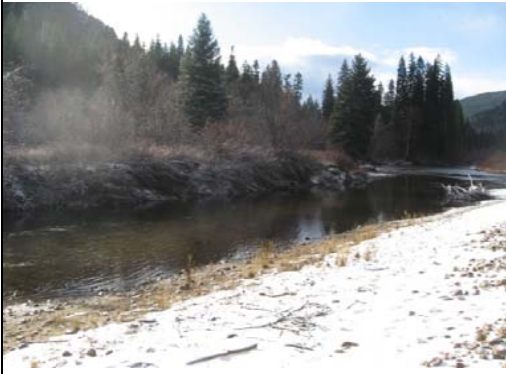
<p>View to the southeast in the downstream direction at a river-left side-channel near RM 16.78 (November 2009).</p>
8	Project RM 16.7R	Inner Zone 2 (IZ-2)	Off-Channel Habitat Enhancement	Side-channel habitat enhancement	There is a long narrow side-channel that runs along the river-right between RM 16.6 to 16.8. This channel is separated from the main channel by a narrow gravel bar. Near RM 16.7 the side-channel turns west and flows away from the main channel providing a greater connection to floodplain habitats. There is outflow at this point that reduces flow in the rest of the side-channel downstream during low flow periods. This project would include several log jams throughout the side-channel including at this outflow location with the intention of enhancing side-channel habitat and floodplain connectivity during high flow events. A wetland at the downstream end near RM 16.6 could be enhanced with wood for cover, and potentially excavated at its outlet to increase its connectivity with the main channel.

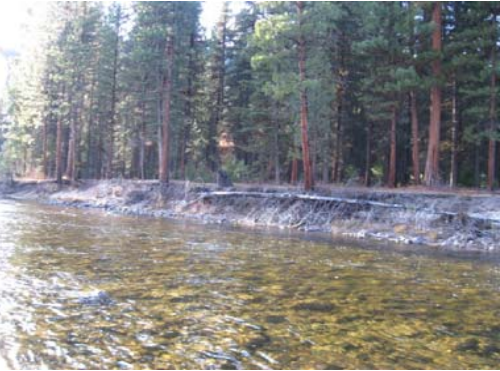
Reach	Project Number	Sub-Unit	Strategy Category	Project Name	Description	Photo
8	Project RM 17.56L	Inner Zone 2 (IZ-2)	Reconnect Stream Channel Processes	LWD placement to enhance side-channel connectivity	This project area involves using several log jams on both side of the river between RM 17.6 and 17.55 to enhance the flow conditions in a side-channel that extends along river-left between RM 17.5 and 17.6. Between RM 17.55 and 17.6 there are two river-right locations where streambank log jams would increase the amount of cover and available habitat in the vicinity while pushing flow to left with increasing discharge. At the upstream site, the log jam placement would enhance bank erosion that has the potential to recruit large pine trees. The inlet to the side channel is at about RM 17.6 on river left. Vegetation and geomorphic evidence suggest that the channel does not carry flows with sufficient energy to scour the bed. The bank at the upstream end is high, and there is not a well-defined inlet. However, farther downstream there are depressions that hold groundwater and a backwater pool with an open surface connection at the downstream end. A log jam at the upstream end would encourage scour and increase flow into the side channel. The backwater channel at the downstream end could be enhanced with wood for cover.

<p>View to the southwest in the downstream direction at potential LWD recruitment along the river right bank near RM 17.55 (November 2009).</p>

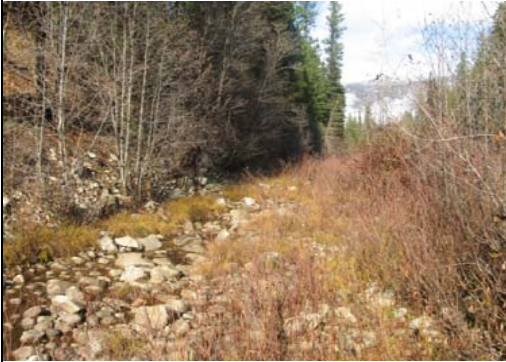
Reach	Project Number	Sub-Unit	Strategy Category	Project Name	Description	Photo
9	Project RM 18.5C	Inner Zone 2 (IZ-2)	Reconnect Stream Channel Processes	LWD placement to enhance lateral connectivity	This project area includes several log jams along both sides of the channel with the goal of increasing habitat complexity and lateral dynamics in the active channel. The stretch of river between RM 18.6 and 18.45 is relatively complex with large stable bars, active split flow, and moderate amounts of LWD. This area presents the opportunity to install multiple habitat features. At the upstream end of the project area near RM 18.6, there is an existing bar apex jam that could be enhanced to move more water into the seasonally dry river-right channel. Near RM 18.55, LWD could be added along the left bank to enhance existing root masses and overhanging trees to increase cover in a pool. Another bar apex jam opportunity exists at RM 18.5. There is a significant amount of wood that is naturally racking up on the bar and across the left channel of the split flow around the bar. The bar forms a riffle and a high quality pool in the right side-channel. LWD added along the bank would enhance cover. Downstream at RM 18.45 there is a location along river-left where LWD recruitment is taking place. Addition of some large wood jams across the channel could increase the rate of recruitment and add complexity to the channel.

<p>View to the north in the upstream direction at a river-right side-channel near RM 18.6 (November 2009).</p>

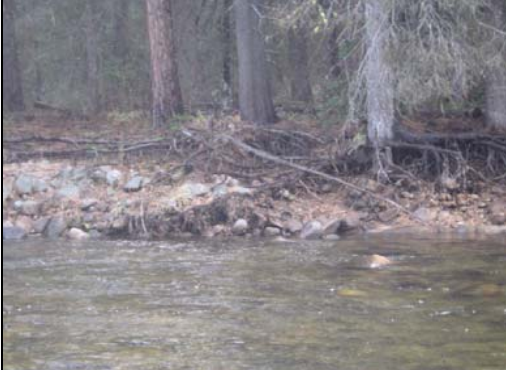
9	Project RM 18.65L	Inner Zone 2 (IZ-2)	In-Stream Habitat Enhancement	LWD enhancement	This location has some bank erosion and exposed root masses that could be enhanced to provide greater cover and available habitat along the bank. The channel morphology is currently a glide. Large wood jams along this bank would enhance cover and likely establish quality pool habitat.

<p>View to the east at the river-left bank near RM 18.65 (November 2009).</p>
9	Project RM 18.75R	Inner Zone 2 (IZ-2)	Reconnect Stream Channel Processes	Riprap removal or modification	Around the mid-channel bar described in Project RM 18.81, there are riffle-glide sequences on both sides of the split flow. The right side flows against riprap at the toe of the road embankment. LWD placed along the bank would provide cover and increase habitat complexity. There is also the potential for scour to form pools over time.

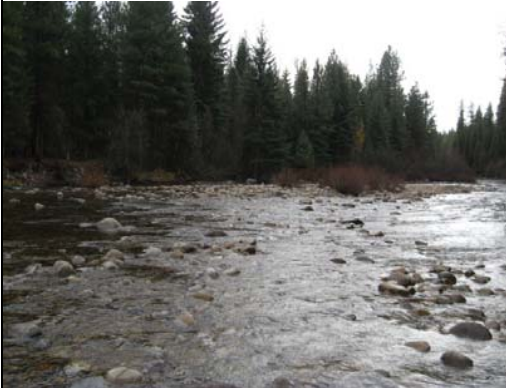
Reach	Project Number	Sub-Unit	Strategy Category	Project Name	Description	Photo
9	Project RM 18.81C	Inner Zone 2 (IZ-2)	Reconnect Stream Channel Processes	LWD placement to enhance lateral connectivity	This project involves constructing a bar apex log jam to maintain and enhance split flow and provide complexity and cover at higher flows. The location is on a small mid-channel bar.

View to the south in the downstream direction at a mid-channel bar near RM 18.81 (November 2009).
9	Project RM 18.9L	Inner Zone 2 (IZ-2)	In-Stream Habitat Enhancement	LWD enhancement	The left bank is the toe of a large alluvial fan that has delivered boulders to the Chewuch valley during high energy debris torrent events. Boulder substrate is not easily moved by the Chewuch once it enters the river, resulting in coarse uniform bed morphology with relatively little habitat complexity. To enhance habitat complexity, several large log jams could be placed in the left bank glide.

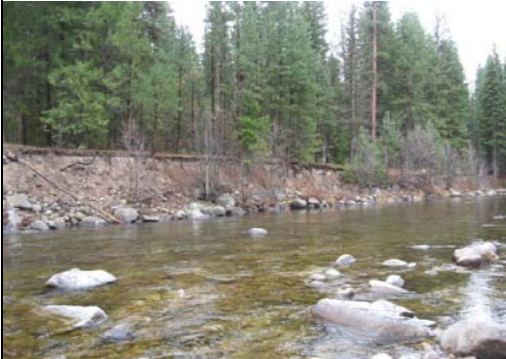
View to the southeast in the downstream direction at the river-left bank near RM 18.9 (November 2009).

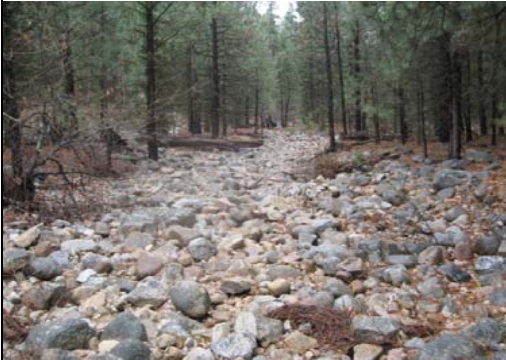
9	Project RM 18.9R	Outer Zone 3 (OZ-3)	Off-Channel Habitat Enhancement	Off-channel/side-channel habitat enhancement	At this project site, there is a high-flow channel along the hillslope margin the entire length of the sub-unit. This channel has clean cobble substrate that suggests relatively frequent conveyance of high-flow. Farther downstream, flood flow becomes dispersed on the floodplain and the channel loses definition. Connectivity between the active channel and this floodplain channel could be increased through excavation and log jam construction at the inflow. A backwater pool could be created at the downstream end, which would also require excavation.

View to the south in the downstream direction at a high-flow channel on river-right near RM 18.9 (November 2009).
9	Project RM 19C	Inner Zone 2 (IZ-2)	Reconnect Stream Channel Processes	Abandoned bridge abutment removal and LWD enhancement	This project involves using LWD to enhance several areas on both sides of the channel between RM 18.96 and 19.1. Near the upstream end of this stretch at RM 19.1, there is a pool on river-left with overhanging vegetation that provides a moderate amount of cover. A log jam along the bank would improve habitat quality. A glide near RM 19.05 provides an opportunity for log jams on both sides of the river to instigate pool formation. At the downstream end of this project area near RM 18.96, there is an old bridge pier in the channel and an abutment on the bank. The old bridge concrete could be removed or kept in place to form the foundation of a large log jam that would increase cover and extend the size and depth of the existing pool feature.

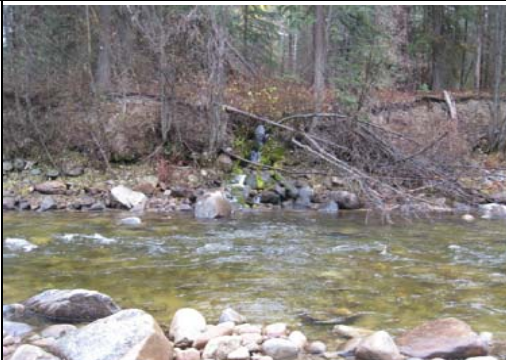
View to the east at the river-left bank near RM 19.1 (November 2009).

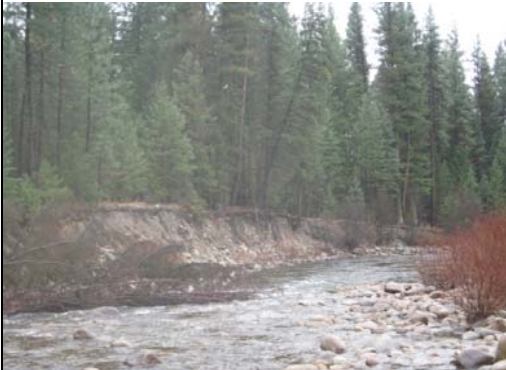
9	Project RM 19.25R	Inner Zone 2 (IZ-2)	Reconnect Stream Channel Processes	Enhance side-channel habitat connectivity	This area of the inner zone is very active with mid-channel bar formation, split-flow, and LWD recruitment along river-left where the channel is eroding the toe of an alluvial fan. A bar apex jam has naturally formed on the mid-channel bar. This feature could be enhanced to maintain split flow and habitat complexity. The apex jam could be designed to encourage LWD recruitment along the river-left bank downstream. To the far river-right there is a high flow channel that extends between RM 19.1 and 19.35, with a well-connected off-channel backwater at its downstream end. The apex jam would maintain flow through this feature, and several smaller log jams could be placed to add habitat and cover to the backwater. Upstream of the apex jam near RM 19.2 is a bank log jam opportunity on the outside of a slight bend in the river where there is slow water that could be enhanced to provide better habitat. There is very little habitat in the main channel upstream of the side-channel. Large logs could be placed to provide cover and potentially drive scour-and-fill to form a pool and provide substrate smaller than the cobbles and boulders that dominate now.

<p>View to the southeast in the downstream direction at erosion of the river-left bank near RM 19.25 (November 2009).</p>
