LOWER LIBBY CREEK REACH ASSESSMENT

Prepared for **YAKAMA NATION FISHERIES** | PO BOX 15, FORT ROAD | TOPPENISH, WA 98948

Prepared by
INTER-FLUVE, INC.
1020 WASCO STREET, SUITE I | HOOD RIVER, OR 97031
541.386.9003 | www.interfluve.com

July 2012

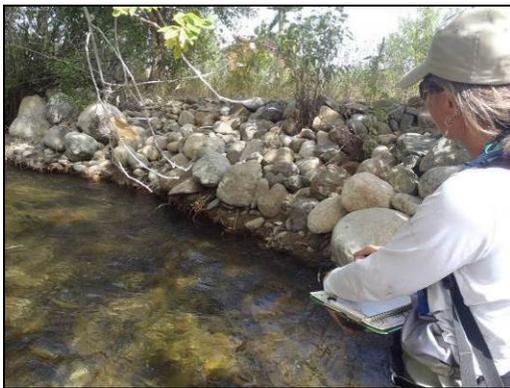
There are multiple instream alterations present throughout Reach 1. Two of the most significant alterations within Reach 1 are a 42-ft long riprap wall that has been installed along the river left bank at RM 0.11 (Figure 6) and the Highway 153 bridge (Figure 7).

Figure 6. Riprap wall near RM 0.11. The top elevation is approximately 5.5 ft above OWH.

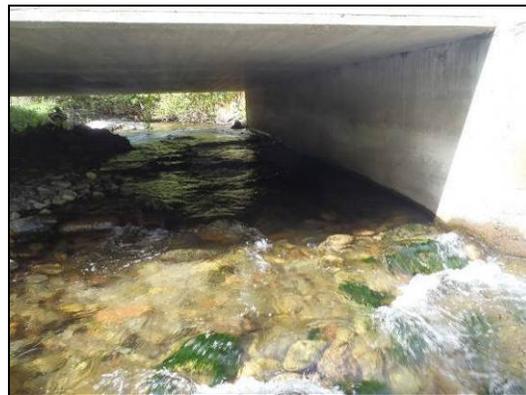
Figure 7. Highway 153 bridge facing upstream.

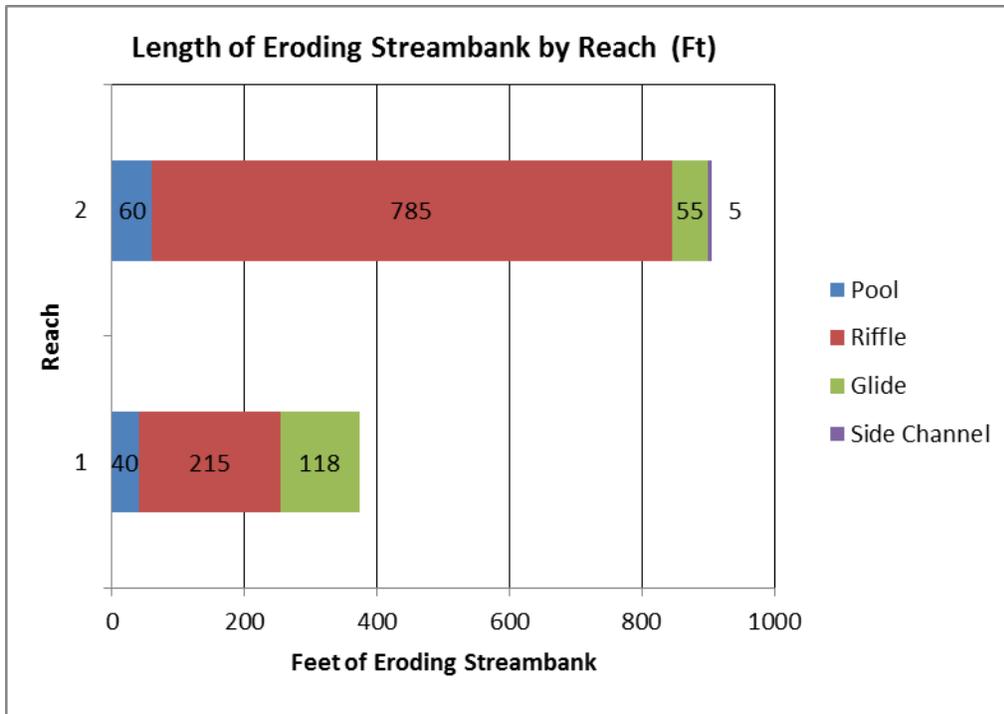
Reach 2 bank erosion was higher with a total of 11% of the mainstem streambanks (905 feet) showing signs of active erosion (Figure 7). Erosion in this reach can be attributed to natural conditions as well as land uses including livestock grazing. Eroded areas were characterized by loam soils with fewer instances of cobble banks than was observed in Reach 1.

Figure 7. Length of bank erosion by habitat type and reach along lower Libby Creek.

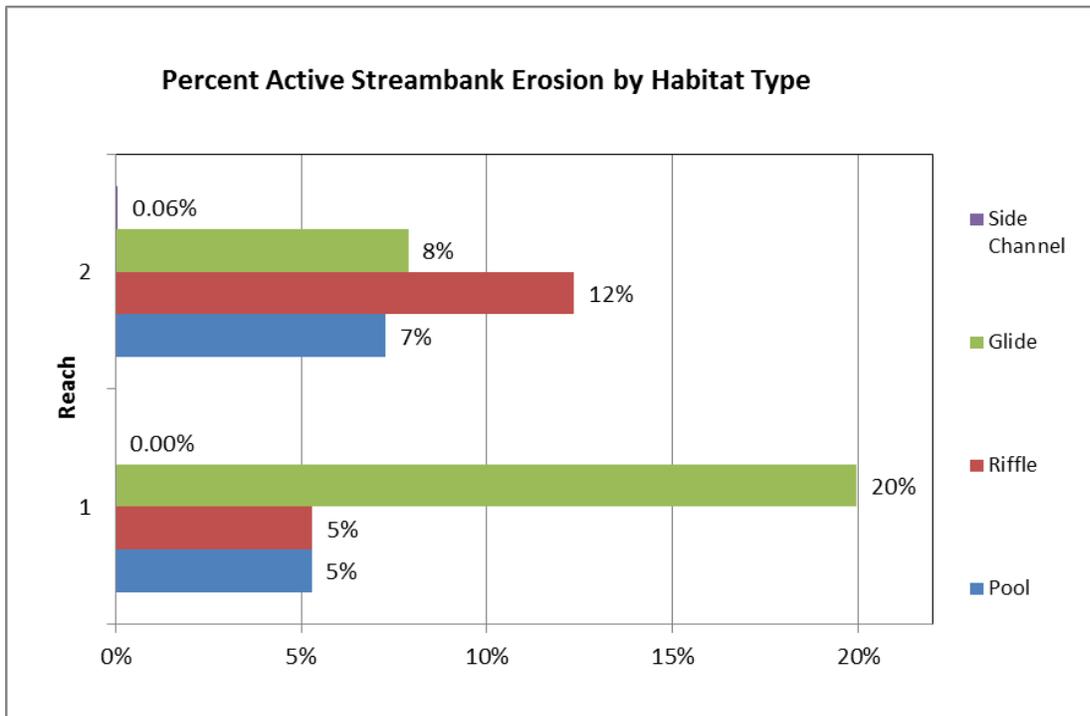
Bank erosion occurred in all habitat types; however, it was most frequently observed in riffle and glide habitats (Figure 8). In portions of Reach 1, streambank erosion is limited by the presence of riprap armoring near residential development. Plywood riprap lines a small (10 feet) section in Reach 2 near an abandoned irrigation diversion along river-right.

Figure 8. Percent active erosion of each habitat type along lower Libby Creek.

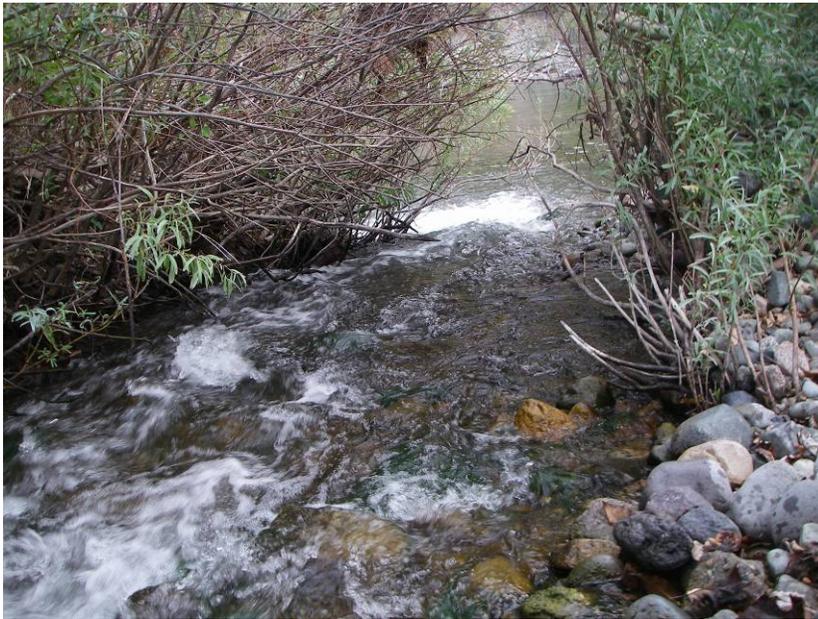
Figure 13. Confluence of Libby Creek looking downstream towards the Methow River. Young willows are growing along the alluvial deposits (September 2011).

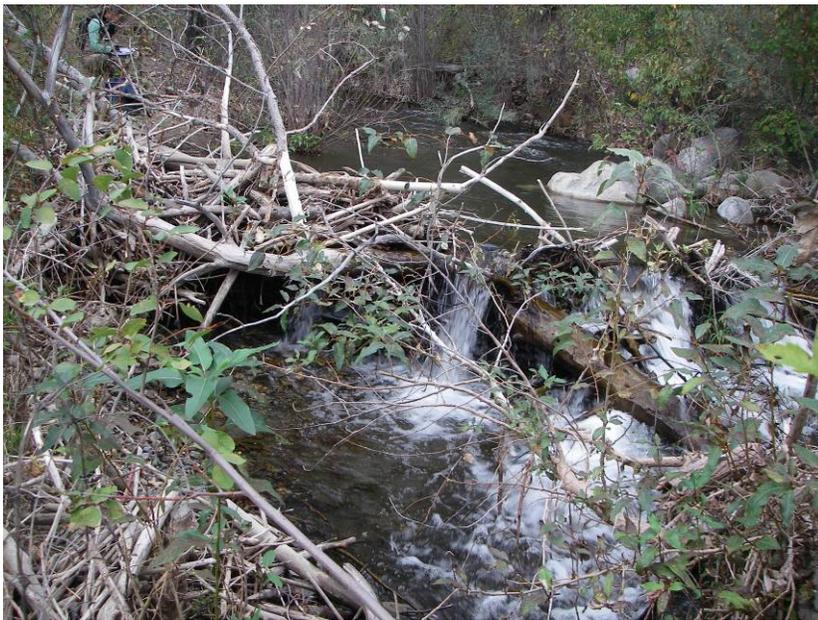
Figure 14. Looking upstream from the mouth of Libby Creek at a beaver-dammed pool (September 2011).

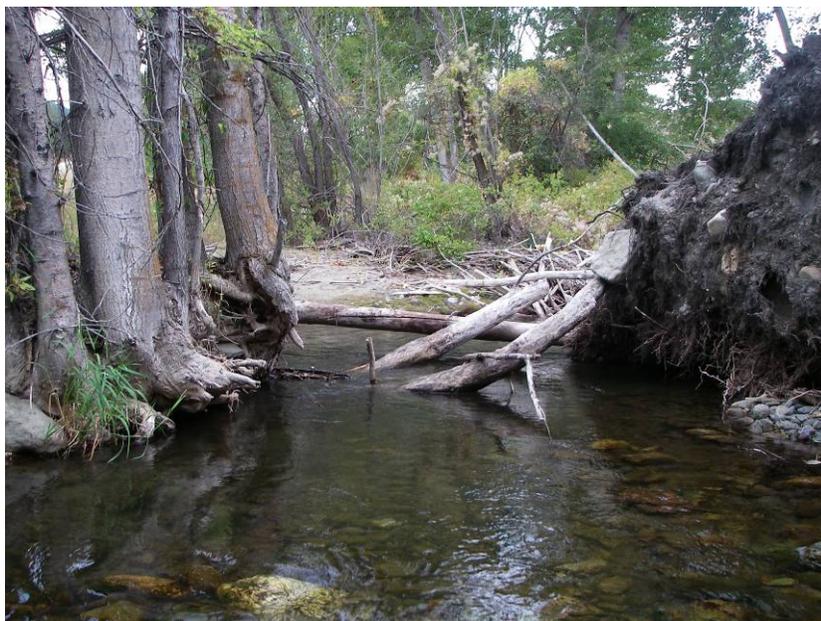
Figure 17. Scour pool near the mouth of Libby Creek. This is a representative slow water unit (pool) observed in Reach 1 (September 2011).

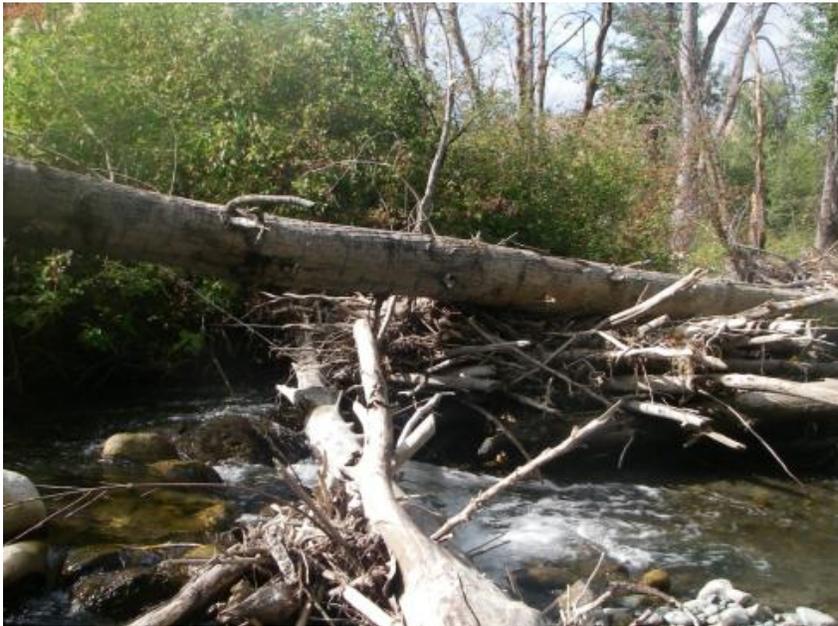
Wood plays a moderate role in Reach 1, including sediment sorting, habitat cover, and channel complexity (Table 1 and Figure 18). The number of LWD pieces in Reach 1 was higher than in Reach 2. LWD frequency was 104 pieces/mile, with “large” pieces comprising 20% of all LWD in the reach. “Medium” wood pieces accounted for 27% of all LWD in the reach, and “small” pieces accounted for 53%. Black cottonwood is the most abundant species of LWD. Wood quantities averaged 204 pieces per mile in Reach 1, less than the recommended quantities of 274 pieces/mile for median wood loading in unmanaged stream systems of comparable size and type (Fox and Bolton 2007). When making these comparisons, it should be noted that the size criteria for large wood used by Fox and Bolton (2007) is based on the WA State Timber Fish & Wildlife criteria, which is smaller (4 inches diameter and 6.6 feet long) than the size criteria used for the USFS Level II surveys (6 inches diameter and 20 feet long).

Figure 18. Large woody debris jam in Reach 1 (September 2011).

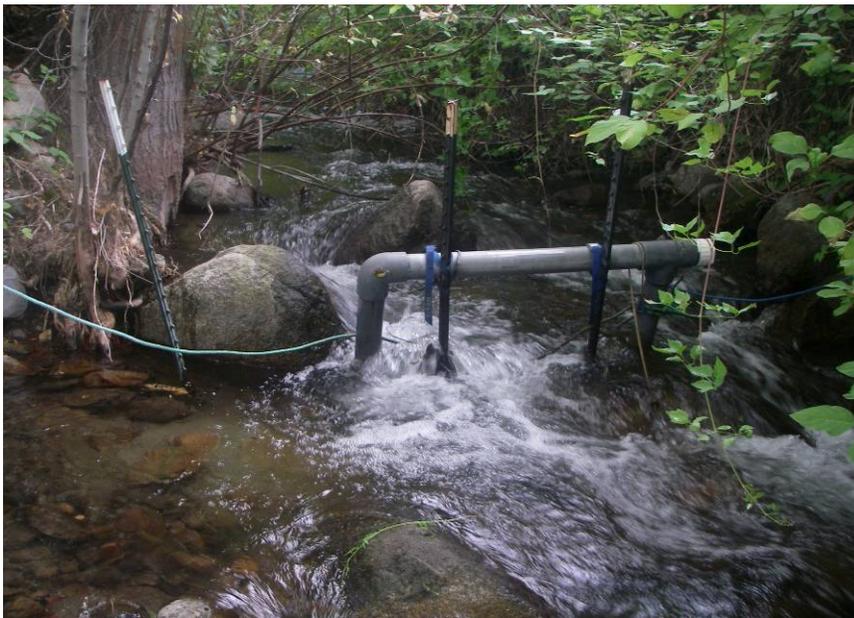
Steelhead and trout primarily use this reach as a migration corridor to access upstream habitat closer to the Okanogan National Forest boundary. WDFW collects PIT (Passive Integrated Transponder) tag data from steelhead and other salmonids migrating through Reach 1 (Bob Jateff, WDFW, personal communication, Oct. 19, 2011). An instream PIT tag detection antenna is located at RM 0.3, just upstream from the Hwy 153 Bridge (Figure 26).

Figure 26. Instream PIT tag detection antenna in Lower Libby Creek at RM 0.3 (September 2011).

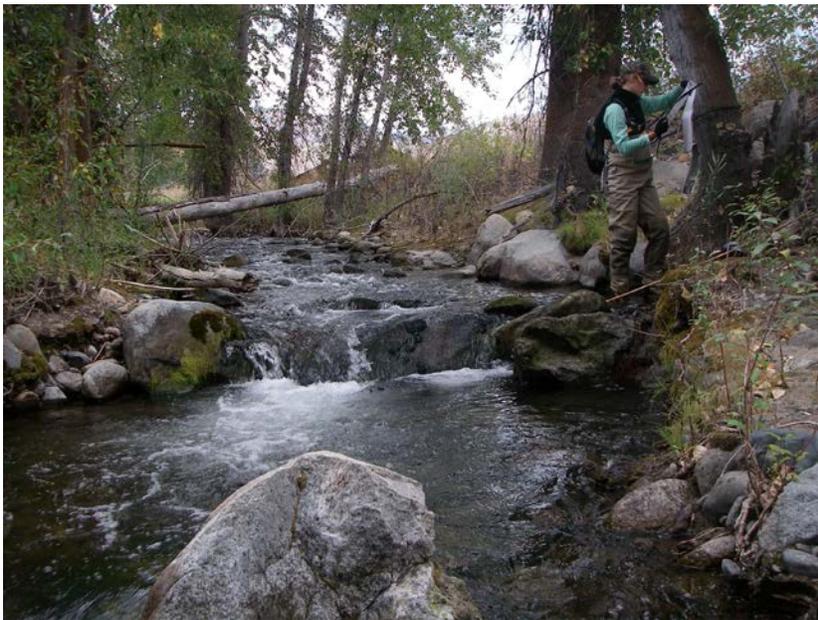
Near the mouth of Libby Creek, mature cottonwoods dominate the riparian zone and understory vegetation was sparse (Figure 29). The riparian overstory in the upper portion of Reach 1 was dominated by small trees (including alder, birch, and cottonwood), yet some areas lack substantial overstory vegetation aside from dense thickets of red-osier dogwood (12-20 ft tall). In other sections, small alders were dominant, providing valuable stream shade and future woody

Figure 29. Dominant vegetation observed in Reach 1 near RM 0.2 (September 2011).

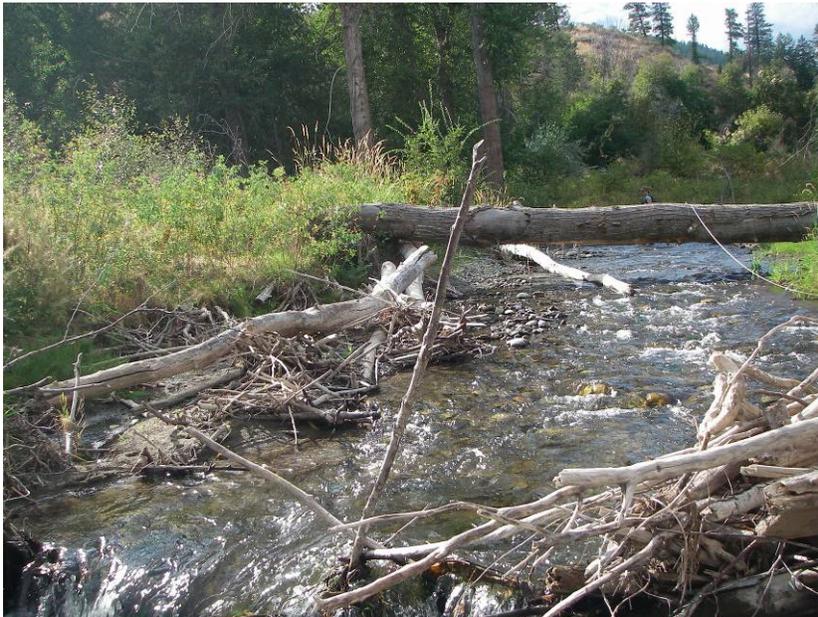
Figure 30. Reach 2 flows through a narrow floodplain and has a greater wood supply than Reach 1. The channel is moderately confined between the right bank hillside (observed in the photo) and a left bank road (September 2011).

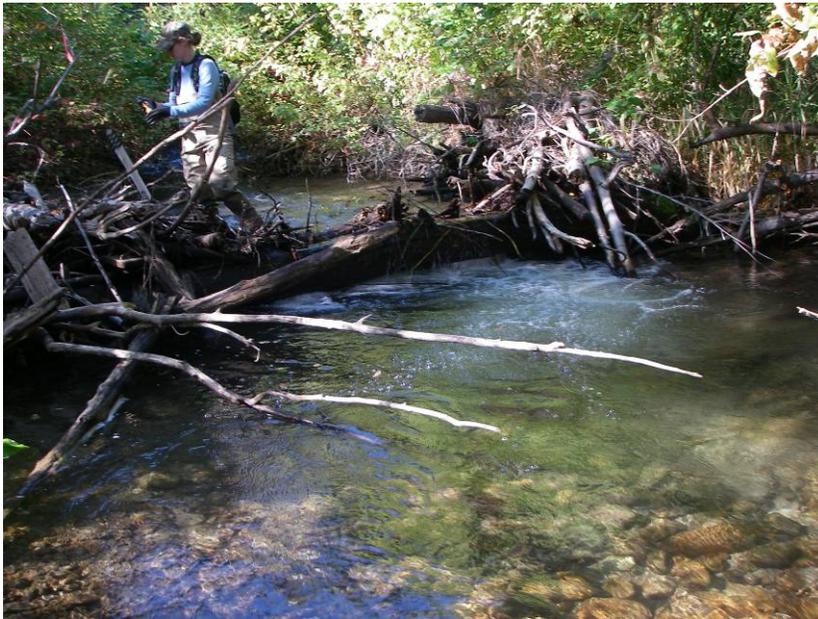
Figure 33. Representative plunge pool in Reach 2 (September 2011).

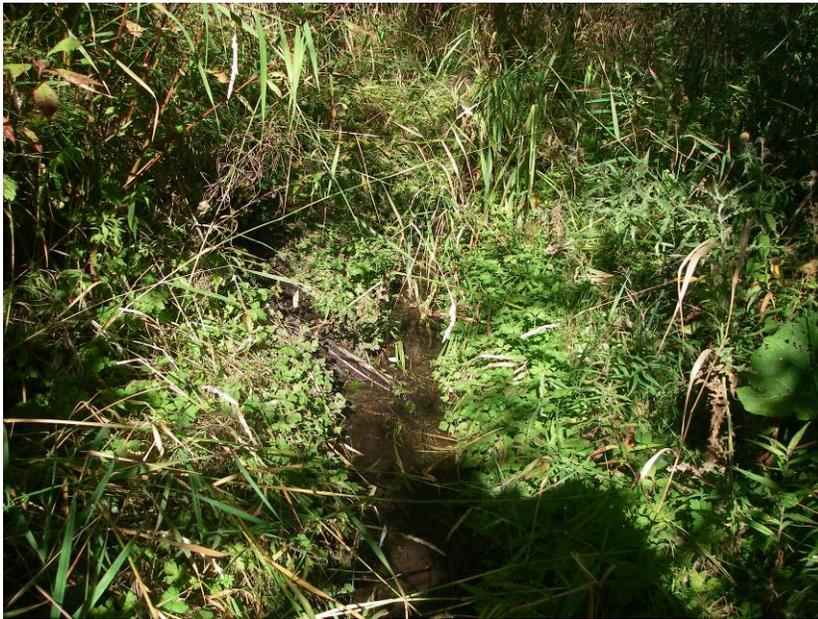
Opposite the abandoned irrigation diversion, and confined between the left bank and Libby Creek Road, was a wetland complex perched on a bench above the main channel. The wetland was currently isolated from the main channel. Further upstream, at RM 0.8 and 1.2, were two separate tributaries that originate from groundwater springs along the river-right hillside (Figure 36). The wetland and one of the tributaries had evidence of beaver activity.

Figure 36. Spring-origin tributary entering the channel from river-right (September 2011).

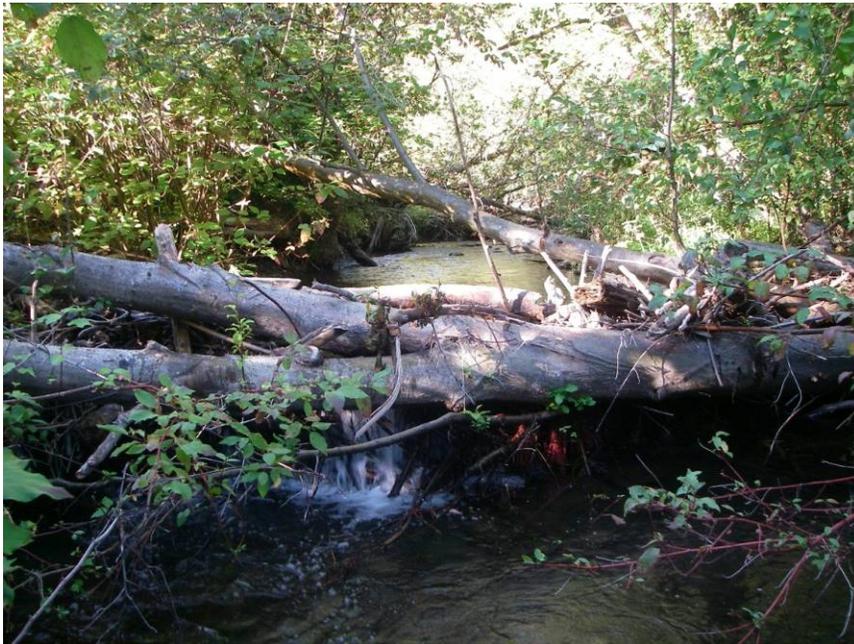
Instream wood plays a moderate role in Reach 2, including sediment sorting, habitat cover, flood refuge habitat, and channel complexity (Table 2). Wood was an important component of plunge pool formation observed in Reach 2 (Figure 37). Most wood jams were comprised principally of small material that had accumulated behind larger stable pieces. The jams had captured fallen leaves, needles, and other stream detritus, improving habitat cover and providing food for macroinvertebrates and fish.

Figure 37. Characteristic plunge pool formed by channel-spanning LWD, Reach 2 (September 2011).

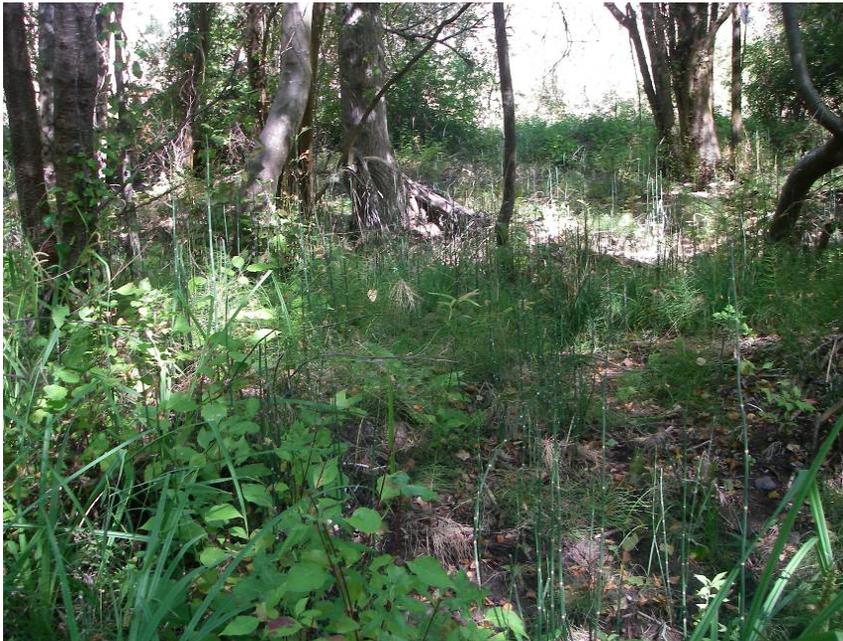
LWD frequency totaled 164 pieces with 216 pieces/mile and “small” pieces comprising 70% of all LWD counted in the reach. “Large” pieces accounted for only 5% of the LWD. Reach 2 appeared to have adequate LWD recruitment potential due to numerous mature riparian trees within the narrow floodplain (Figure 38).

Figure 38. Narrow floodplain with large cottonwoods and high flow channel along river-left (September 2011).

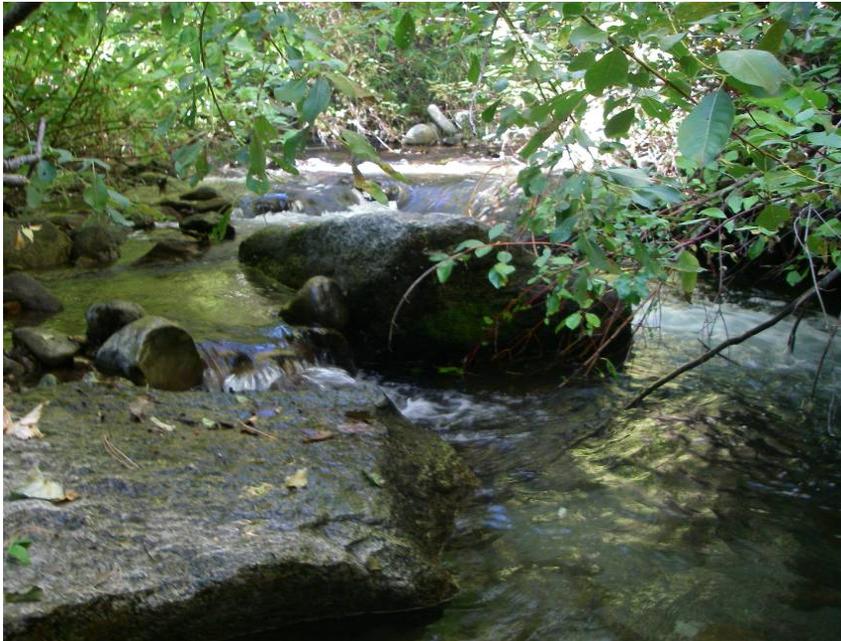
Figure 39. Boulders were observed towards the upstream end of Reach 2 (September 2011).

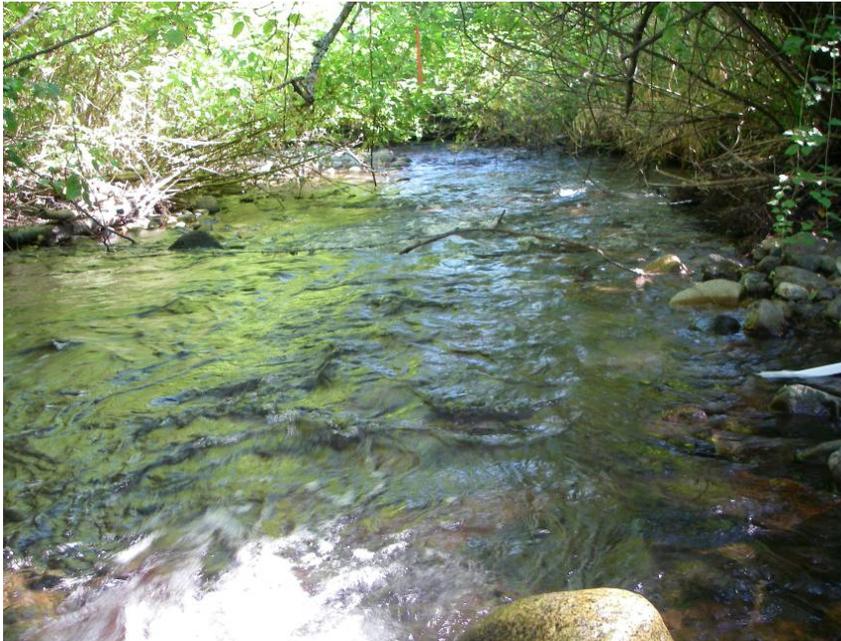
Figure 47. Riffle where steelhead spawning has been observed during past spawning surveys (September 2011).

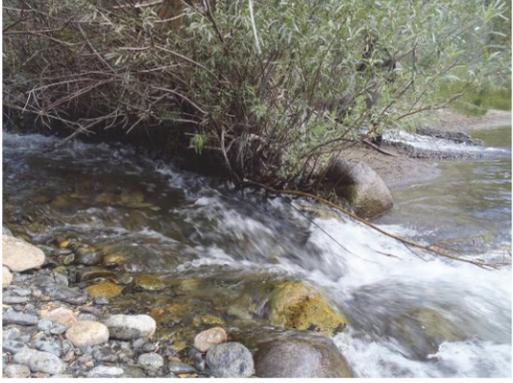
Reach	Sub-Unit	Project Number	Strategy Category	Project Name	Description	Photo
1	IZ-16	Project RM 0.0	Instream Habitat Enhancement	Confluence Maintenance	A Low flow passage problem currently exists at the confluence of Libby Creek and the Methow River. There is currently a short, steep riffle to connect the base flow elevation of Libby Creek to the base flow water surface elevation of the Methow River. This may present a passage problem for juveniles at low flow. This location should be monitored, and if necessary, grade control should be installed to ensure fish passage at all flows.

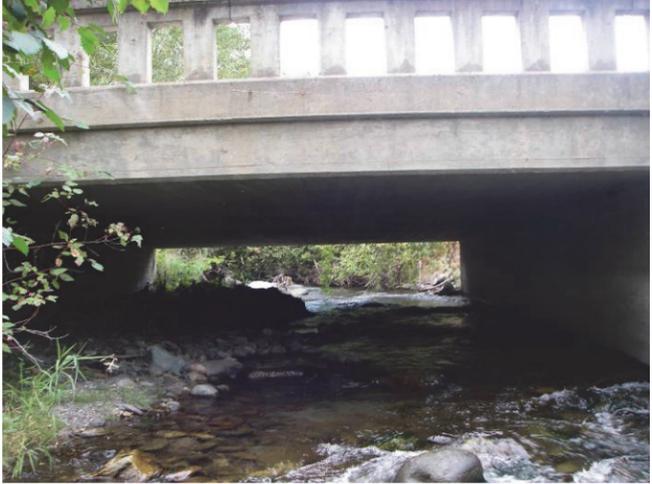
1	IZ-08	Project RM 0.29	Reconnect Stream Channel Processes	Replace Highway 153 Bridge	The existing Highway 153 bridge is undersized – it is currently only equivalent to 1.25 channel widths at low flow. The bridge is acting as a hydraulic constriction and limiting lateral migration of the channel. Additionally, it is causing scour downstream of the bridge. The bridge should be replaced with a wider and higher structure to allow for the lateral and vertical expansion of Libby Creek.

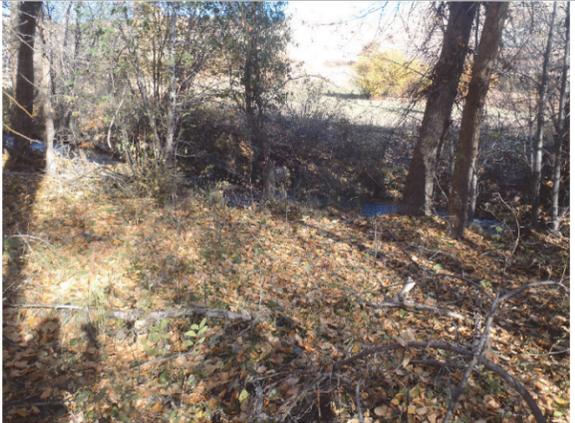
1	OZ-03	Project RM 0.38	Reconnect Floodplain Processes	Floodplain Reconnection	The incision of Libby Creek has resulted in extremely limited connected floodplain throughout the survey reach. This location presents adequate space to lower floodplain surfaces on either side and install alternating large wood jams. This would promote increased hydraulic and hydrologic connectivity with floodplain surfaces on either side, as well as provide habitat diversity throughout the reach.

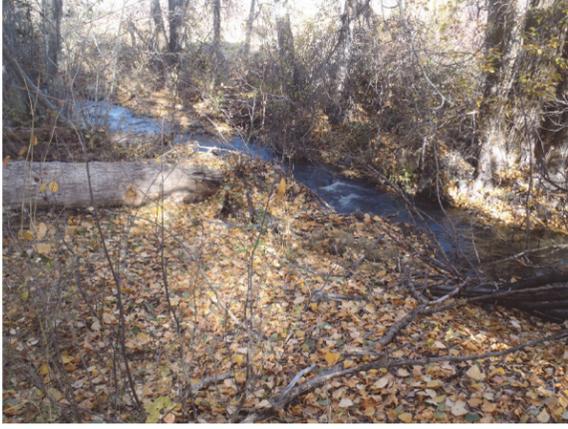
Reach	Sub-Unit	Project Number	Strategy Category	Project Name	Description	Photo
1	DOZ-03 and DOZ-01	Project RM 0.41	Reconnect Floodplain Processes	Floodplain Reconnection	The left and right bank throughout this area provide space to lower floodplain elevations to create an active floodplain. Floodplains would be treated with large wood to increase complexity and provide roughness throughout the reach. Large wood would promote gravel recruitment and pool scour over time.

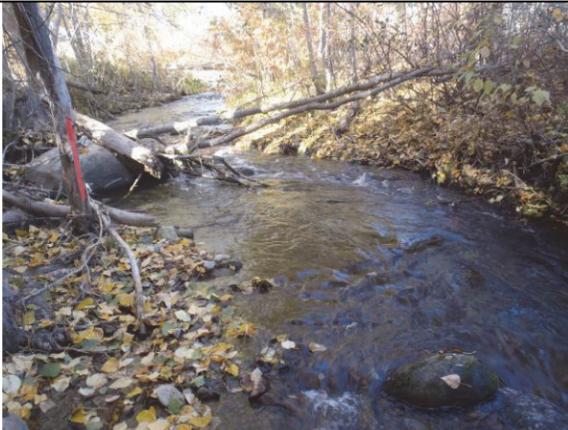
1	DOZ-03 and DOZ-01	Project RM 0.42	Reconnect Stream Channel Processes	LW Enhancement	This project would be paired with RM 0.41 if possible. This project would include creating alternating channel margin log jams to reintroduce lateral migration into Libby Creek and slow its rate of incision.

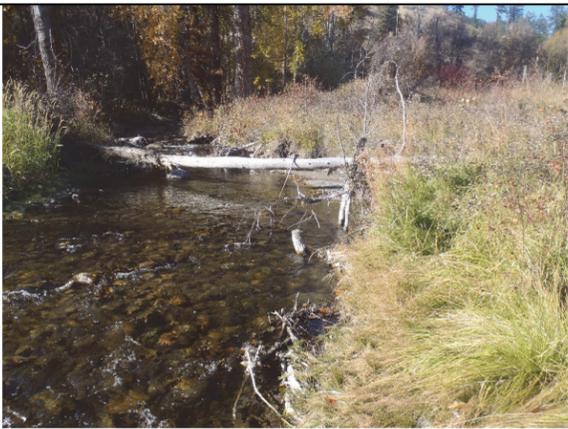
1	IZ-03	Project RM 0.5	Instream Habitat Enhancement	LW Enhancement	This project would involve the placement of two large log jams (one along the right bank at the downstream end, and one along the right bank at the upstream end) that extend out into the channel. This would promote lateral channel dynamics, pool scour, gravel recruitment, and cover enhancement. These actions would be paired with dense plantings of riparian vegetation along both banks.

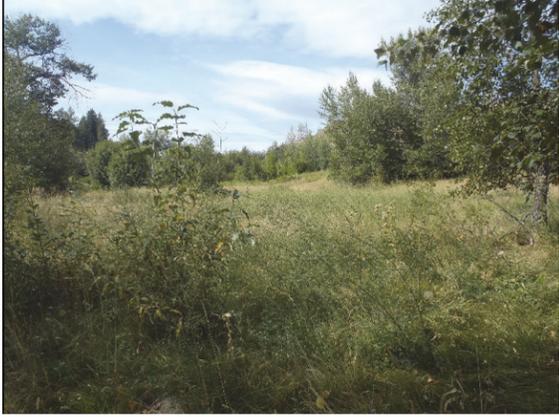
Reach	Sub-Unit	Project Number	Strategy Category	Project Name	Description	Photo
2	DOZ-09	Project RM 0.62	Riparian Restoration	Riparian Restoration (right bank)	Approximately 150 feet of the right bank is unvegetated along this reach. Native replanting would improve shade, natural stability, and provide future sources of large wood.

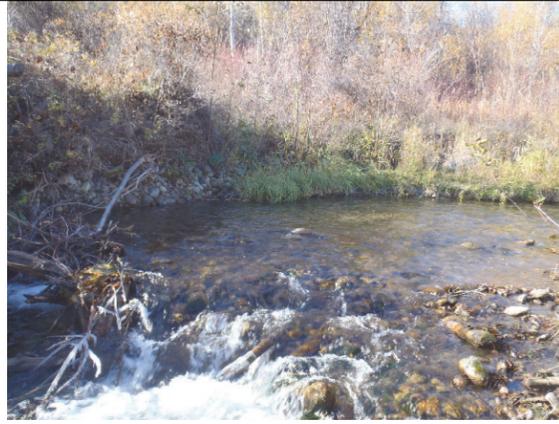
2	IZ 17	Project RM 0.7	Instream Habitat Enhancement and Riparian Restoration	LW Enhancement, Riparian Restoration, and Diversion Monitoring	Large wood could be keyed into the right bank to provide overhanging cover, recruit gravels, and promote pool scour. This would be paired with riparian restoration along the right bank to provide shade, natural stability, and future sources of large wood material.

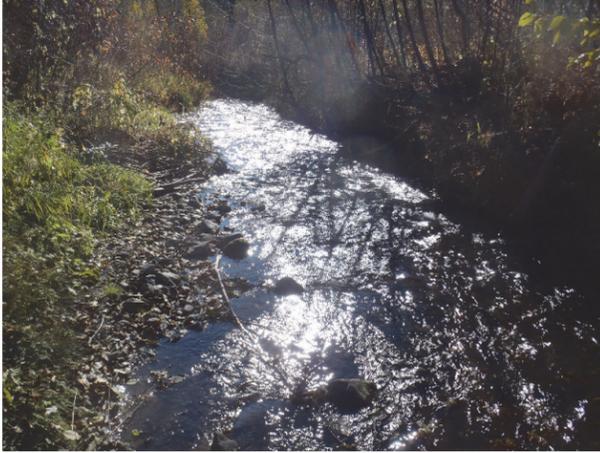
2	IZ-16	Project RM 0.71	Reconnect Stream Channel Processes	LW Enhancement	Alternating jams would be placed along the left and right banks throughout this long riffle. This would promote lateral migration of the channel as well as initiate gravel recruitment and pool scour. This would provide habitat complexity in this long, uniform riffle.

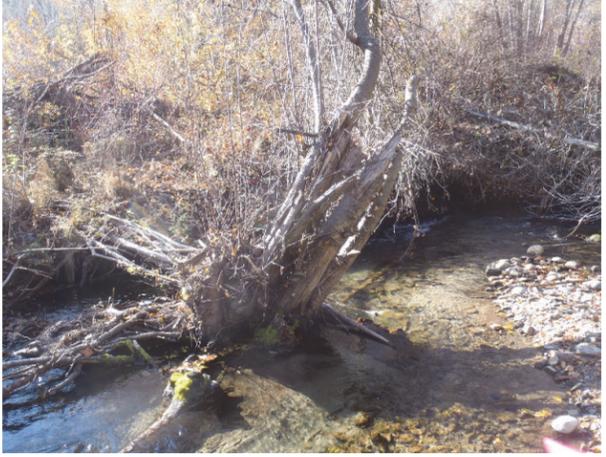
Reach	Sub-Unit	Project Number	Strategy Category	Project Name	Description	Photo
2	IZ-15	Project RM 0.75	Instream Habitat Enhancement	LW Enhancement	A small jam could be built into the right bank along this reach. The goal of the jam would be to add complexity and cover.

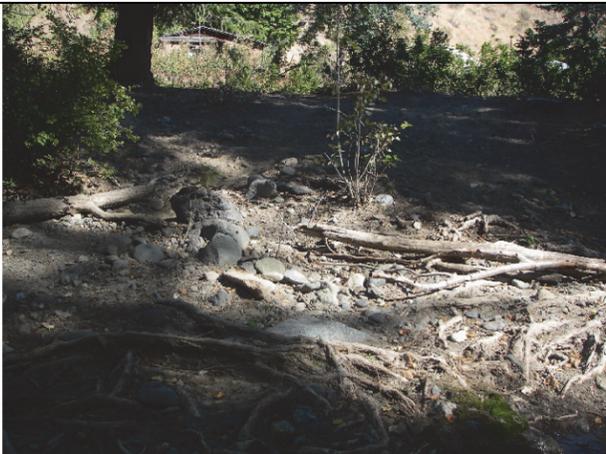
2	DOZ -04	Project RM 1.07	Riparian Restoration	Riparian Restoration	The right bank is sparsely vegetated from RM 1.07 to RM 1.14. The shoreline has been altered, regraded, and cleared for residential development along the banks. This project would replant banks with native riparian seedlings and regrade where necessary.

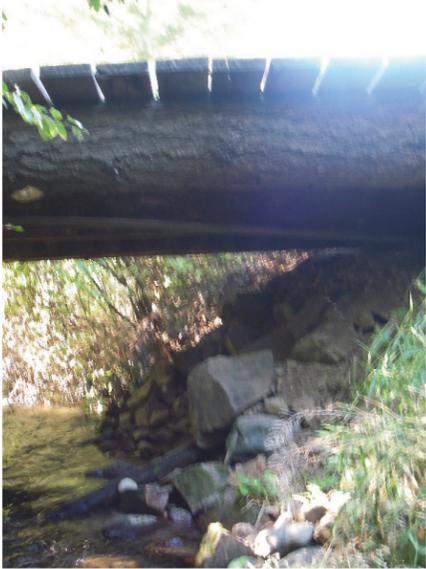
2	IZ-02 and IZ-03	Project RM 1.35	Reconnect Stream Channel Processes	Bridge Replacement	The left and right abutments of this bridge are limiting Libby Creek's lateral channel dynamics and are acting as a hydraulic constriction. Replacing the bridge with a larger bridge would restore channel processes.
