Lower Twisp River Reach Assessment

Provided for:

Yakama Nation Fisheries Program

JUNE 2010

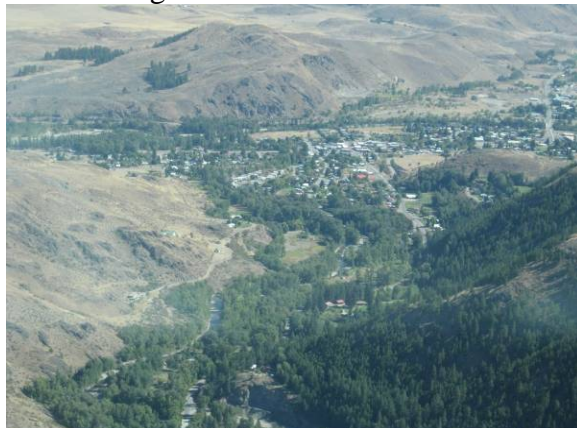
This reach is located at the confluence of the Twisp and Methow Rivers. Reach geomorphology is a function of mainstem/tributary interactions over the last 15,000 years. Valley confinement decreases abruptly as the Twisp River enters the Methow River Valley (Figure 3). The reduction in valley confinement creates a sediment deposition zone that has created a broad alluvial fan over time. Lacustrine deposits between the towns of Twisp and Carlton along the Methow River suggest that the Twisp River may have flowed into the upstream end of a lake at some point during the Pleistocene epoch (Konrad et al. 2005). Since the last glacial retreat about 15,000 years ago, the river has incised the deposits near its mouth, leaving paired-terraces down to river mile 0.45 (USBR 2008a App G). Between these glacial terraces, the river is naturally limited in floodplain width of just over 200 ft, and limited meander migration. Additional limits to planform adjustment have been imposed by levees and riprap. LiDAR data reveals that downstream of river mile 0.45, lateral channel dynamics have created several terraces along river

Figure 3. Low elevation oblique aerial photo looking downstream to the confluence of the Twisp and Methow Rivers (September 2009).

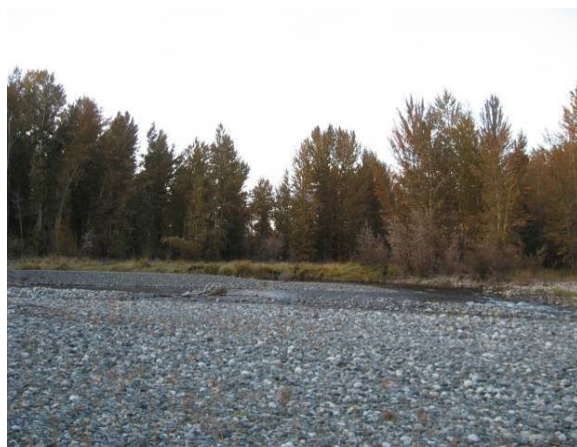
left. These terraces are now developed with residential and commercial development. The mouth of the river downstream of river mile 0.2 is a wide, active, and braided channel with un-vegetated gravel bars that have shifted position during the last 45 years. There has been a recent trend of northward meander migration between river mile 0.0 and 0.2 (Figure 4). The position of the confluence also changes depending on the position of the Methow River, sometimes becoming shorter, and sometimes longer as the Methow meanders across its floodplain.

Figure 4. View looking north across the braided channel at the mouth of the Twisp River (November 2009).

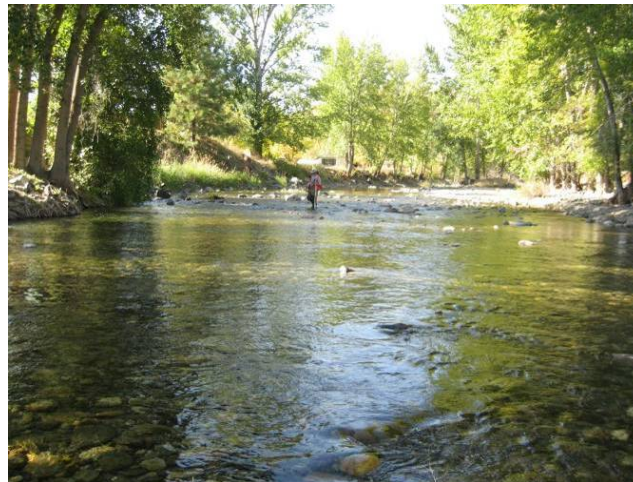
Bed morphology consists primarily of long shallow pools alternating with short riffles (Figure 6). Pools comprise about 56% of the channel area. Natural stream banks through this reach are composed mainly of unconsolidated alluvial deposits and glacial outwash ranging in size from boulders to sand. Bed and bank erosion is limited through much of the reach as a result of bank armoring and hydromodifications. Pebble counts suggest that large gravel and cobbles comprise the majority of bed material (See Habitat Assessment, Appendix A). PWI (2003) found that material smaller than 2mm comprised 12% of the bed, and that 71% of pool features have embedded gravel and cobble.

Figure 6. View looking east in the upstream direction at a riffle-pool section of reach T1 (October 2009).

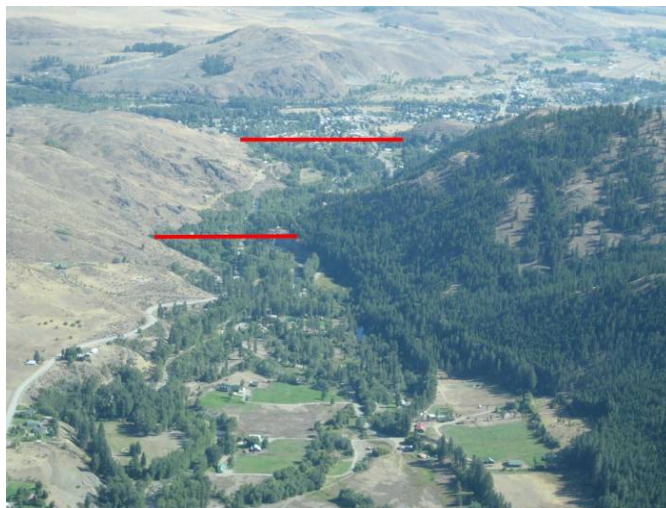
Reach T2a forms a constriction between the unconfined reach upstream and the Methow River Valley downstream (Figure 10). Hill slopes on both sides of the valley are composed of volcanic breccias inter-bedded with sandstone that can be seen in outcrops in several locations including

Figure 10. Low elevation oblique aerial photo looking downstream to the east at the transition between reaches T2b (foreground), T2a (mid-ground), and T1a (background) (September 2009).

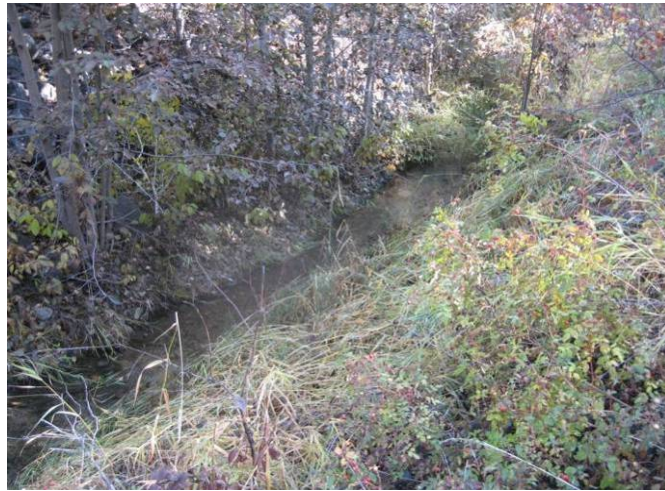
Figure 11. Diversion canal near RM 1.58 that occupies a historical split flow channel that was active prior to 1964 (October 2009).

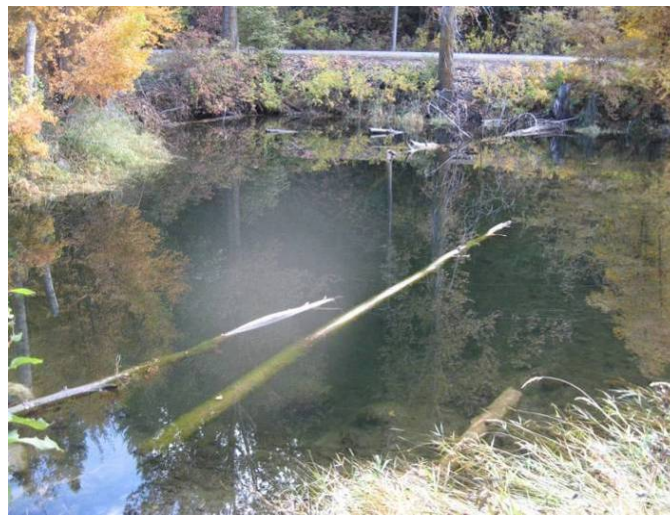
Figure 12. One of several off-channel rearing ponds developed in the historical secondary channel that was active prior to 1964 (October 2009).

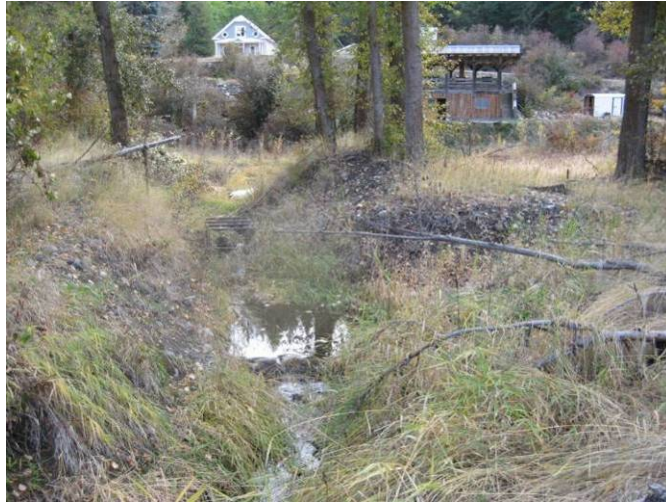
Figure 13. Outflow of “Pond 5” which is a seasonal acclimation pond near RM 1.05 (October 2009).

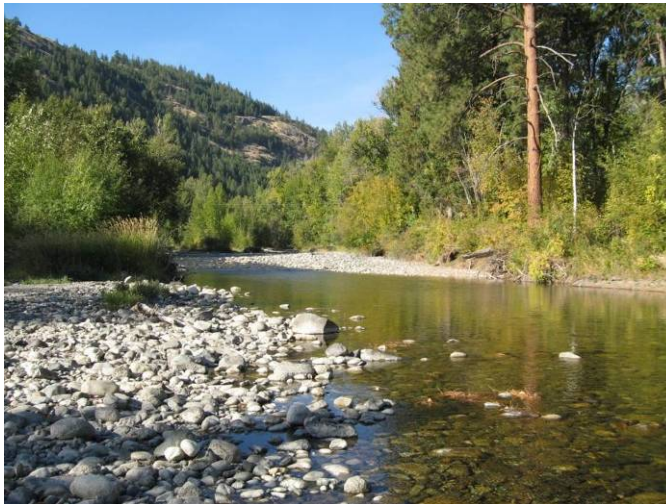
The channel has a moderate 1% grade. Bed morphology throughout the reach consists primarily of long shallow pools alternating with short riffles (Figure 14). Pools comprise about 47% of the channel area, riffles about 36%, and glides 6%. Natural streambanks through this reach are composed mainly of unconsolidated alluvial deposits and glacial outwash ranging in size from boulders to sand. Reach T2a has the highest percent length of total bank erosion in the study area at 7%. Pebble counts suggest that bed material is comprised primarily of large gravel and cobble size material (See Appendix A: Habitat Assessment).

Figure 14. View looking east in the upstream direction at a riffle-pool transition in reach T2a (October 2009).

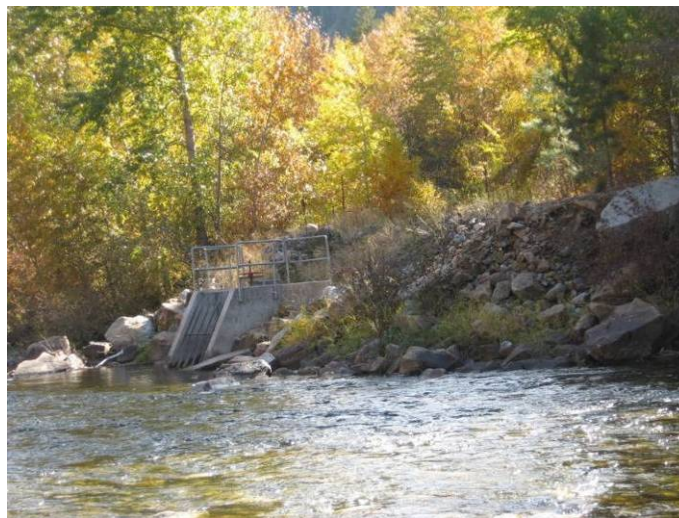
area is disconnected in this reach. Scattered residences and managed fisheries facilities are the primary human features occupying the floodplain. Bank armoring protects private lands and residential development on both sides of the channel, including about 1,869 ft of the upstream right bank (Figure 16). A diversion through the levee near RM 1.55 provides water to off-channel ponds (Figure 17). This area also includes trails, an observation area, pump houses, a pit tag station, and a screw trap in the channel. The ponds and diversion canal occupy a historical side-channel that was abandoned sometime after 1964. The restoration of the floodplain ponds in this area helps to alleviate some of the floodplain disconnection in this reach and restore off-channel habitat. An additional 630 ft of levee and riprap modifies the banks and disconnects the floodplain along the river left of the channel near the downstream end of the reach. An irrigation diversion near RM 1.3 appears to have been abandoned (Figure 18). A push-up levee on the river-left bank just downstream of the structure disconnects the floodplain from the channel.

Figure 17. Diversion structure supplying surface water to restored off-channel ponds along the river-right floodplain (October 2009).

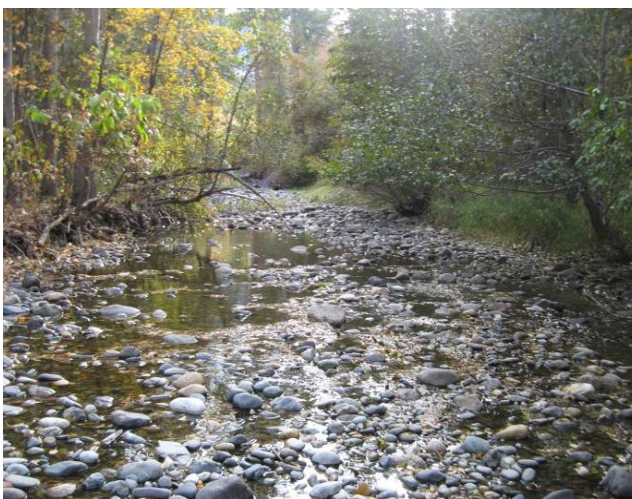
Figure 22. Side-channel habitat formed in a laterally dynamic area of the reach near RM 3.15 (October 2009).

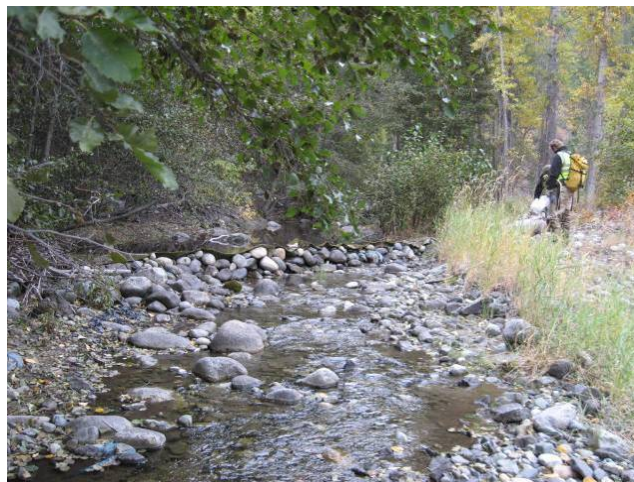
Figure 35. View to the southwest in the upstream direction at an irrigation diversion in a side-channel near RM 6.5 (October 2009).

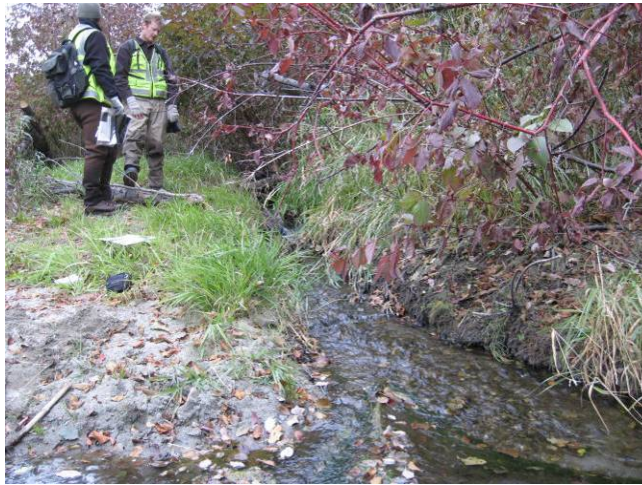
Figure 40. View to the north at the outflow of a floodplain wetland near RM 7.08 (October 2009).

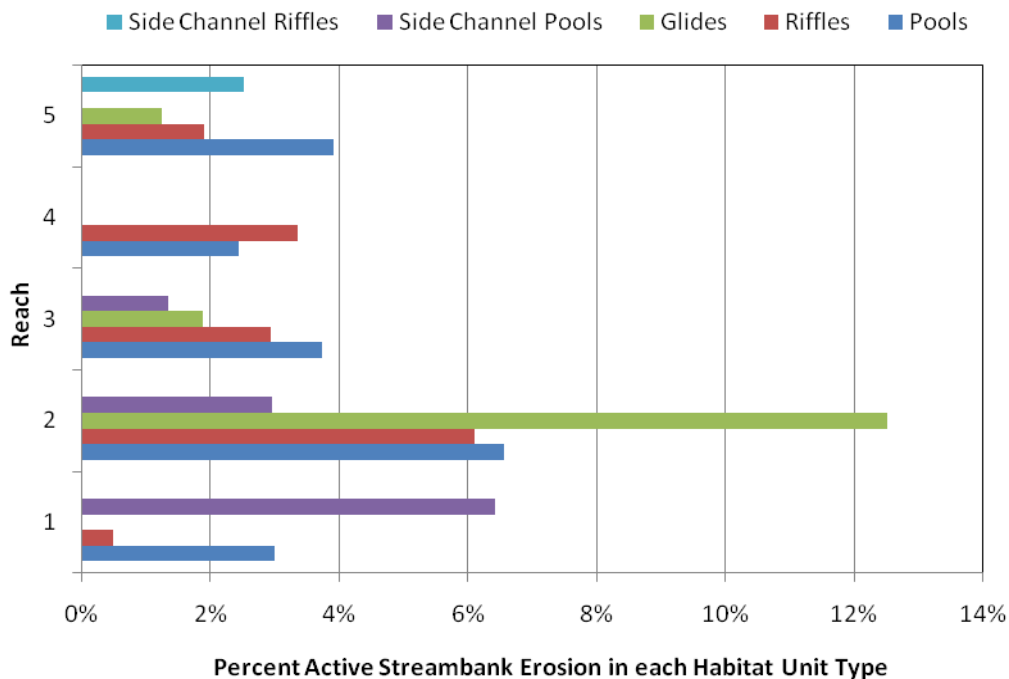
On average, only 3% of the streambanks along the lower 7.8 miles of the Twisp River are actively eroding. The greatest amount of bank erosion was observed in Reach 2, where an average of 7% of the mainstem streambanks displayed active erosion. The other four reaches contained only 2% to 3% bank erosion overall.

Bank erosion occurs in all habitat unit types (Figure 10). Ninety percent of the river-left bank along Reach 2 was eroding, but overall, the lower Twisp does not exhibit excessive erosion. In some areas, streambank erosion is prevented by riprap and boulder weirs.

Figure 10. Percent active streambank erosion in each habitat unit type.

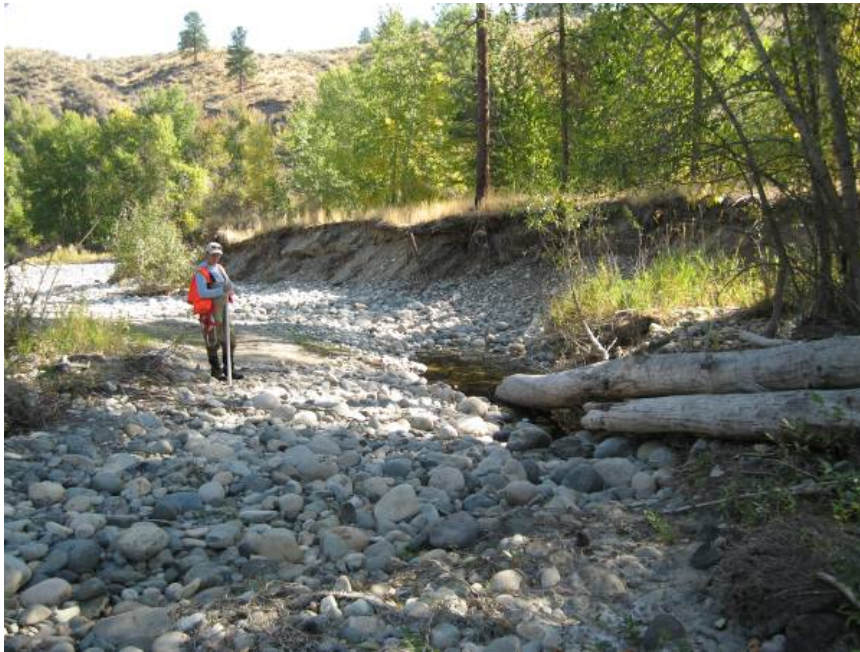
Four side channels were observed in Reach 1. Two of the side-channels were distributary channels that flowed directly into the Methow River (Figure 8). The downstream 0.2 miles of the reach is a dynamic section of channel and has experienced shifting channel locations of the mainstem Twisp River, Twisp distributary channels, and Methow River channels in the past. Off-channel complexity is high in this section of the river. Off-channel availability in the upstream portion of the reach through the town of Twisp is limited due to artificial confinement, bank armoring, and fill. This area likely had high historical off-channel complexity that has been severely reduced as a result of development and river management.

Figure 8. High-flow distributary side-channel that flows directly into the Methow River at the confluence (October 2009).

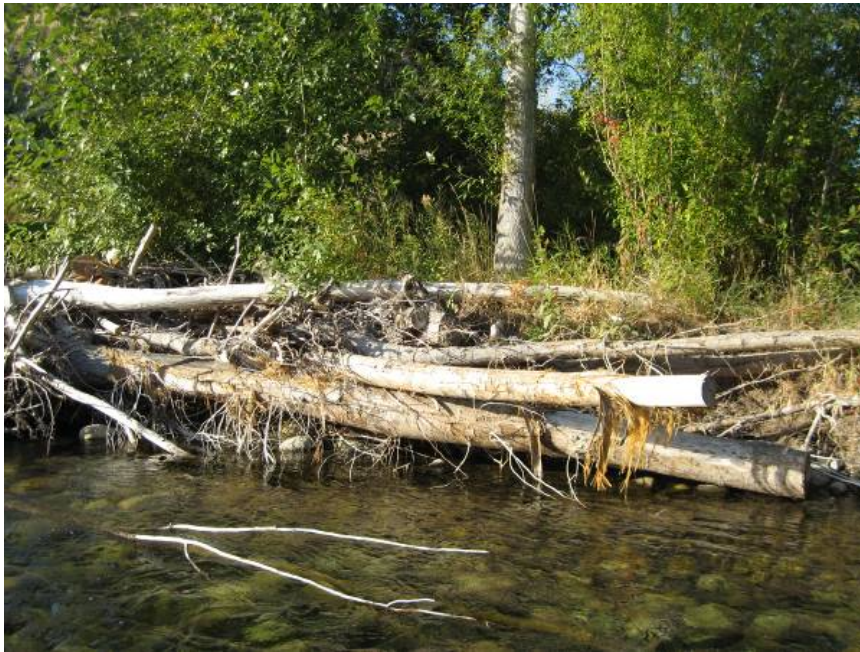
LWD plays a moderate role in Reach 1, including sediment sorting, habitat cover, and channel complexity (Table 1 and Figure 9). Wood is an important component of pool formation. Large wood frequency is 73 pieces/mile, with “small” pieces comprising 80% of all large woody debris counted in the reach. “Large” wood pieces only accounted for 5% of all large woody debris counted in the reach.

Figure 9. Large woody debris jam in Reach 1 (October 2009).

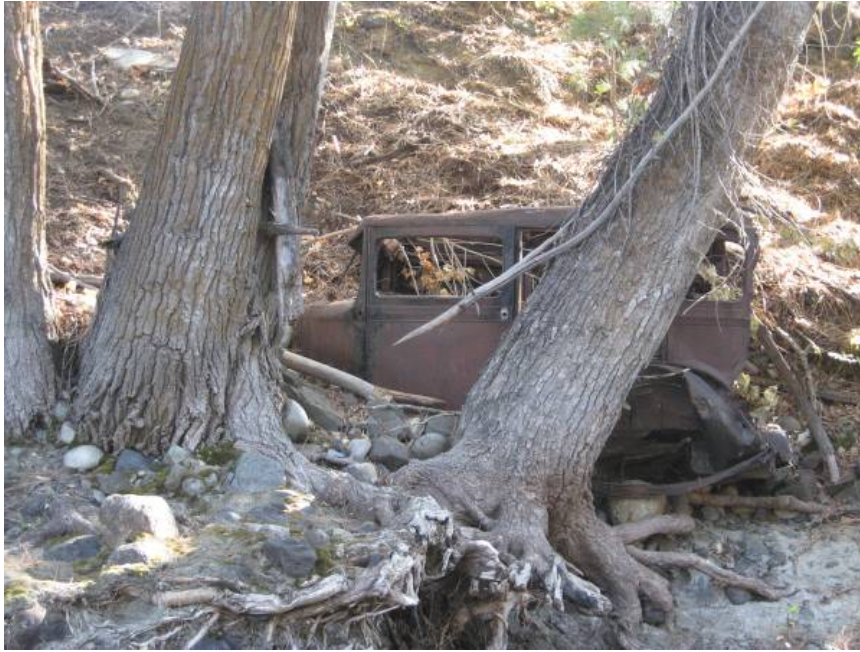
There has been considerable human alteration to the channel and floodplain throughout Reach 1. Channel straightening, bank armoring, artificial confinement (levees), and incision have reduced dynamic channel adjustments that would have existed historically. The Highway 20 Bridge crosses the reach at RM 0.35. Riprap lines almost the entire river-right (southern) bank of the reach and portions of the river-left bank. Car bodies have also been used in places to provide bank stabilization (Figure 13). Residential development is protected by a levee on the river-right bank from RM 0.4 to 0.8. Houses with lawns and recreational access points occur frequently from RM 0.3 to RM 0.6 (Figure 14).

Figure 13. Old car bodies (“detroit riprap”) have been incorporated into streambanks in several locations (October 2009).

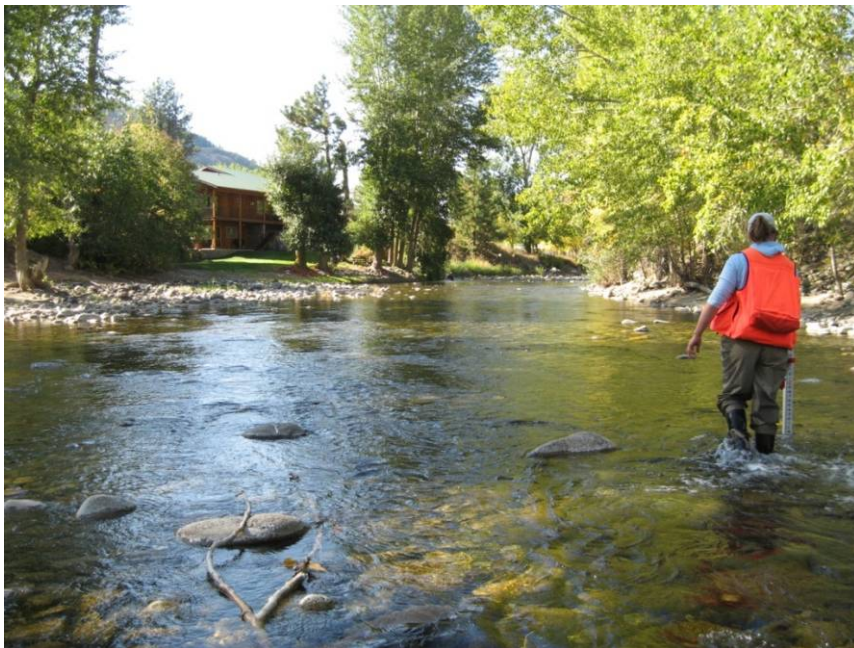
Figure 14. Residential development within the riparian corridor in Reach 1 (October 2009).

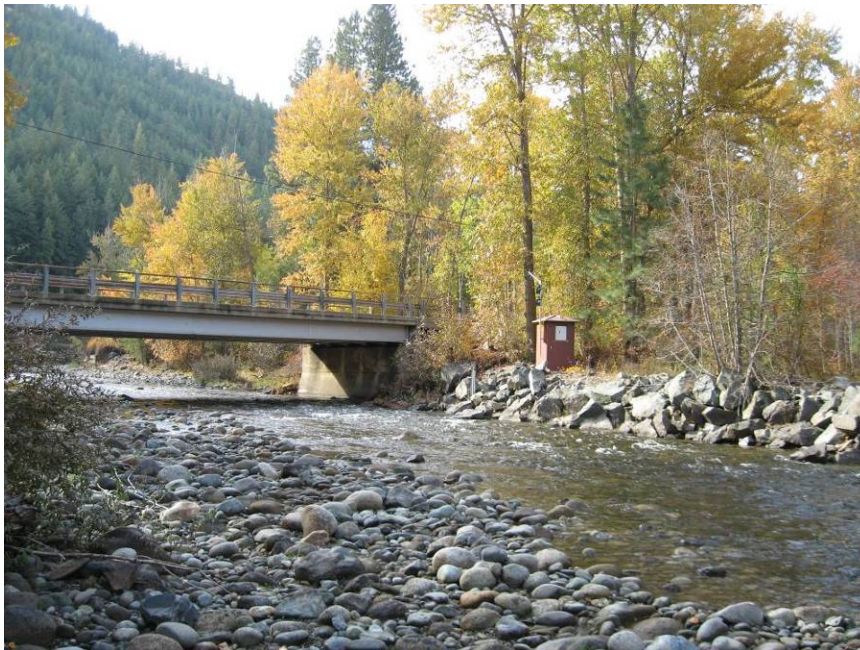
Figure 16. Looking upstream at the Twisp River Road bridge (October 2009). The stream gage is visible on the right.

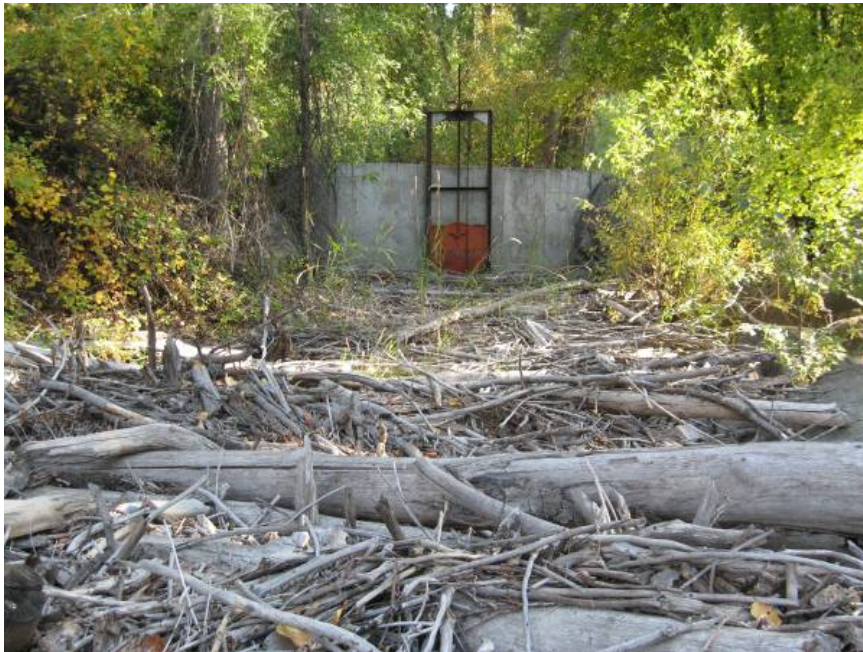
There are five side-channels in Reach 2. One of the side-channels is a diversion ditch controlled with a headgate at RM 1.3 (Figure 20). This headgate is currently closed and abandoned. In addition to the five side-channels, there is a diversion at RM 1.5 that waters the Methow Salmon Recovery Foundation and Yakama Tribe's coho acclimation ponds located to the south of the main channel. The diversion is a large concrete headgate with a hand-built rock dam used to help divert water (Figure 21). The acclimation ponds are former gravel pits that have been connected to allow for juvenile fish passage through the ponds and out into the mainstem Twisp River. Flow from the ponds enters a side channel at RM 1.0.

Figure 20. Headgate on river-left at RM 1.3 (October 2009).

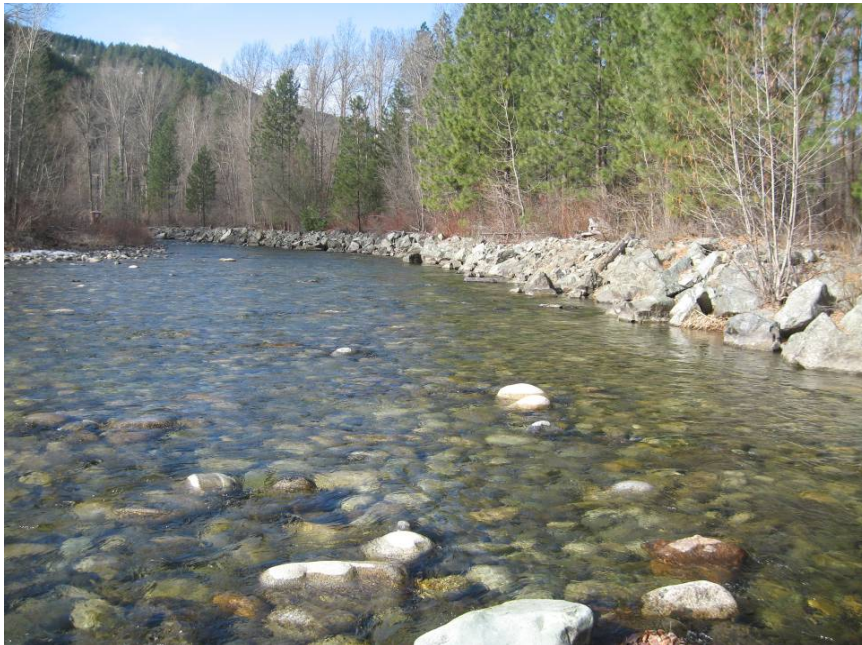
along river-left for 700 feet (Figure 26). A boulder vein extends out from the river-right bank near RM 1.37 (see Figure 25). A right-bank levee affects side-channel connectivity near RM 1.0. There are other short sections of riprap and push-up levees that affect channel and floodplain processes throughout the reach.

Figure 26. View looking upstream near RM 1.75 at riprap on river-left bank (March 2010).

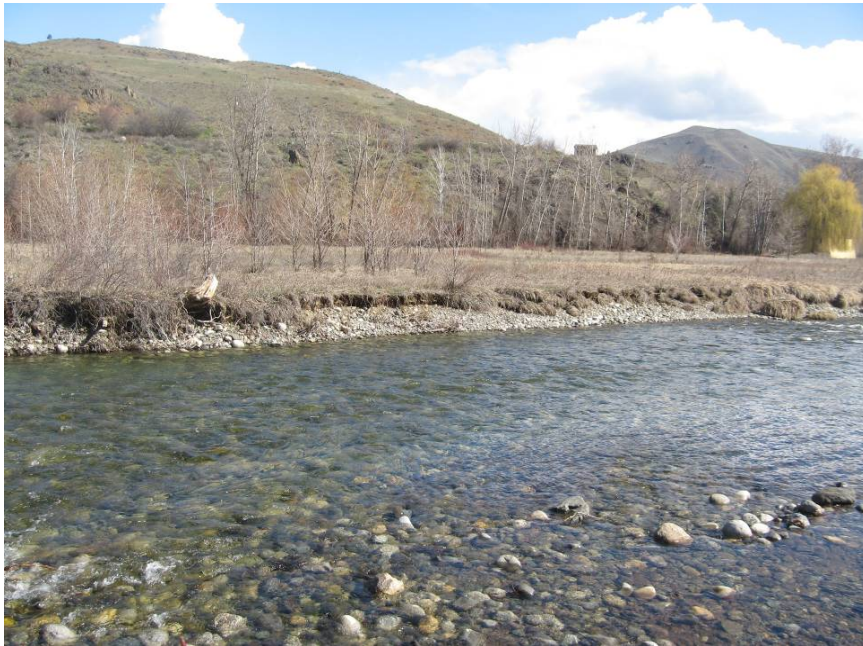
There is active bank erosion in several locations. In some areas, erosion is associated with a lack of a mature streambank vegetation. This is particularly evident on both banks between RM 1.1 and 1.3 (Figure 27).

Figure 27, View looking downstream at eroding river-left bank and cleared riparian zone near RM 1.15 (March 2010).

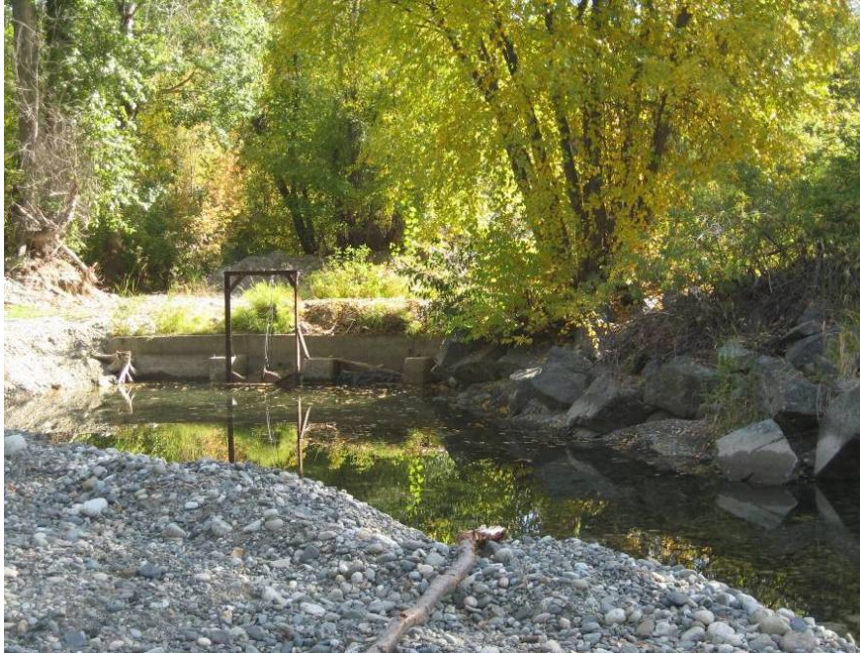
Eight side channels were observed in Reach 3. One of the side-channels is a diversion ditch controlled with a headgate at RM 4.4 (Figure 36). Approximately half of the side channels were dry or partially dry at the time of the survey.

Figure 36. Irrigation diversion and headgate near RM 4.4 (October 2009).

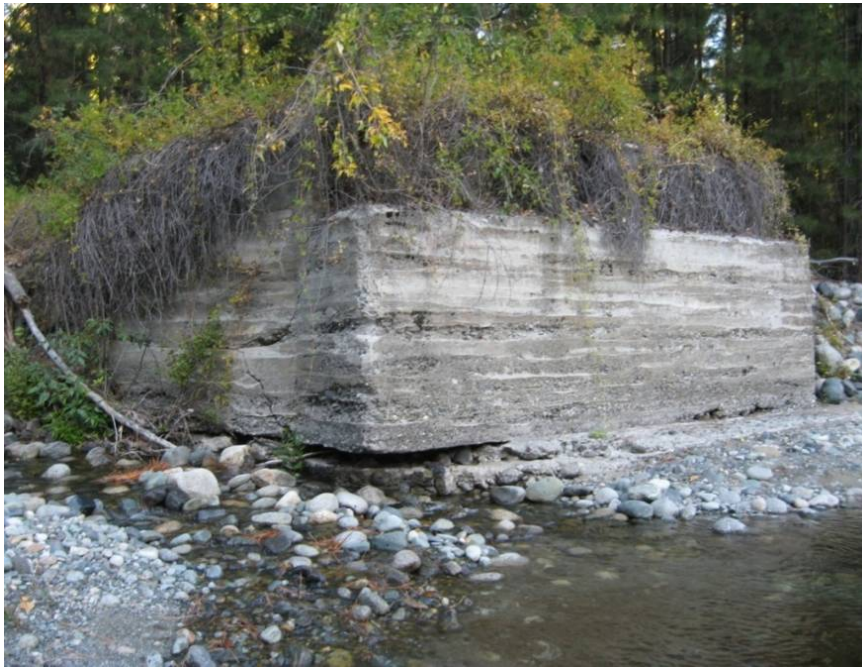
Levees, riprap, and boulder weirs are used to stabilize banks and control flooding in several locations. Long sections of riprap (>1,000 ft) are located along both banks near RM 2.6. Smaller sections of riprap and levees are located intermittently between RM 4.0 and 4.5. There is 600 feet of riprap along the river-right bank just upstream of the bridge at RM 1.9 where Poorman Creek Road abuts the channel. An old concrete abutment is located just upstream of the Twisp River Road bridge at RM 1.9 (Figure 40).

Figure 40. Old concrete footing/abutment near RM 1.9 (October 2009).

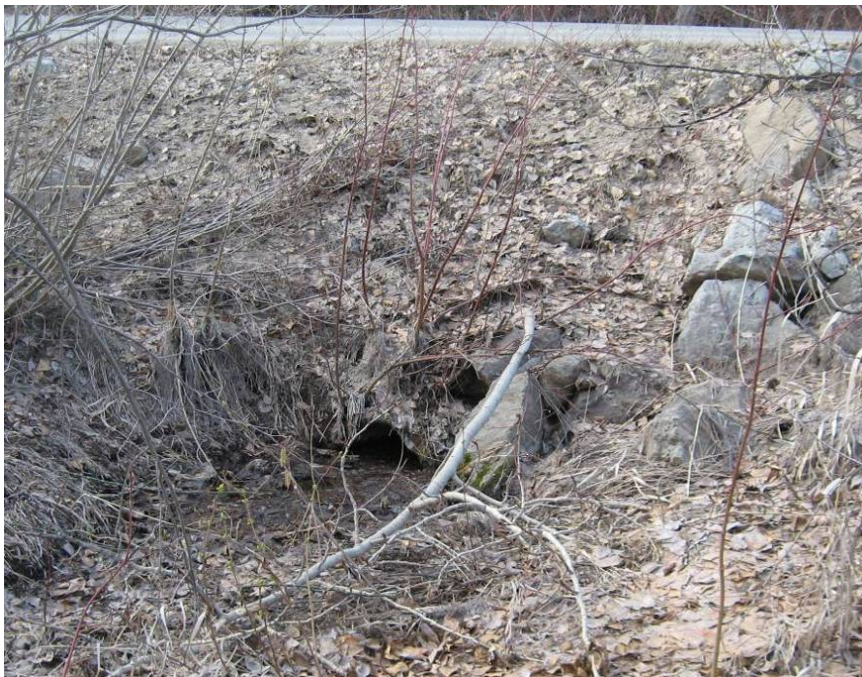
Culverts discharge into the channel at RM 1.95, RM 2.3, and RM 3.8. The culvert at RM 1.95 discharges flow from the series of abandoned gravel pits (aka “chain of lakes”) located along the southern floodplain terrace. This culvert is mostly plugged and was not flowing during surveys in March 2010 (Figure 41). Neither of the other culverts were flowing at the time of the October 2009 survey. Two irrigation pumps are located at RM 2.7, one on the right bank and one on the left bank. Both pumps are screened.

Figure 41. Culvert (mostly plugged) draining floodplain ponds at RM 1.95 (river-right bank) (March 2010).

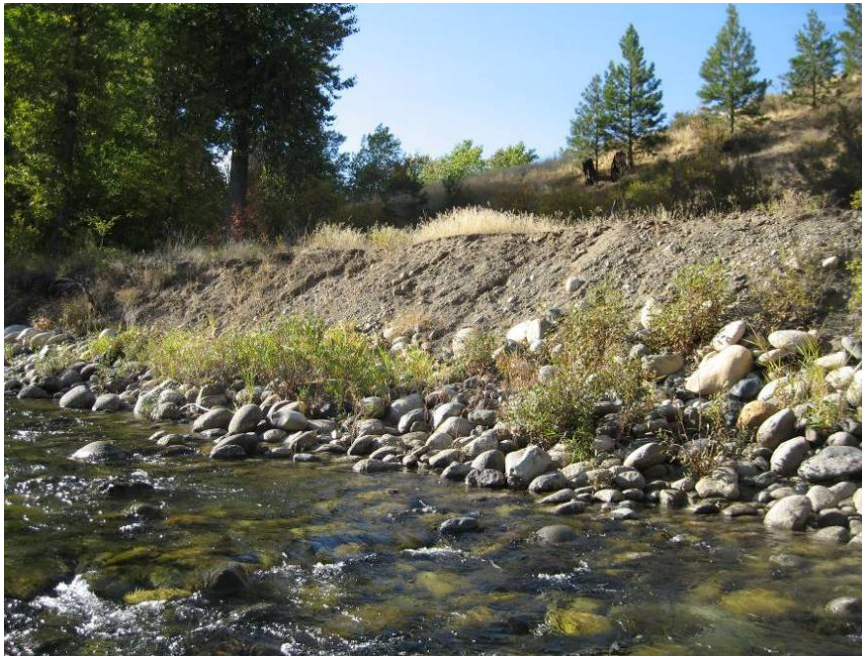
Active bank erosion was also evident in several locations. Bank erosion was associated with clearing of riparian vegetation at several locations between RM 3.2 and 3.5 (Figure 42). There is also considerable erosion of the high glacial terrace near RM 4.6.

Figure 42. Erosion on river-left (north) bank near RM 3.2 (October 2009).

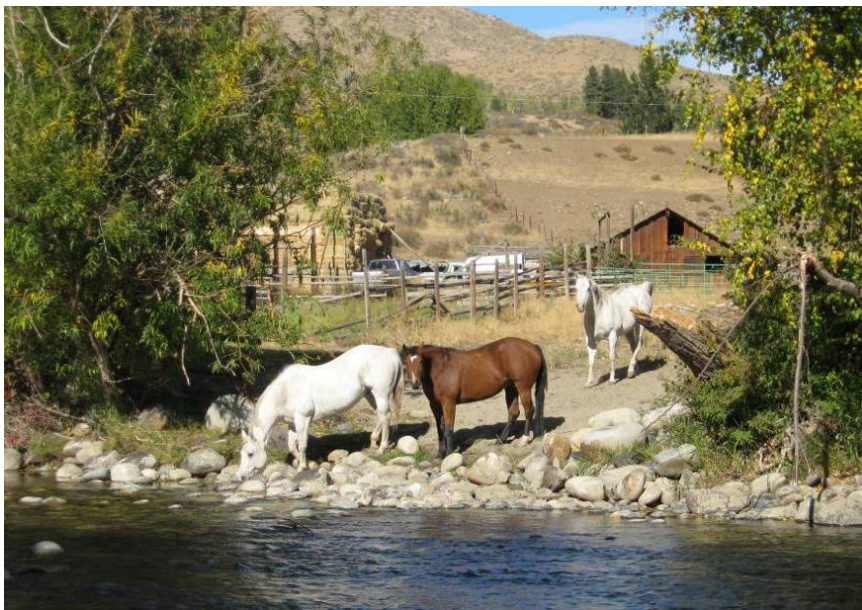
There are numerous residences within the floodplain; some with lawns extending to the top of bank and recreational access to the river. Grazing and watering of livestock is also evident along sections of the reach (Figure 43).

Figure 43. Livestock access to the stream near RM 4.9 (October 2009).

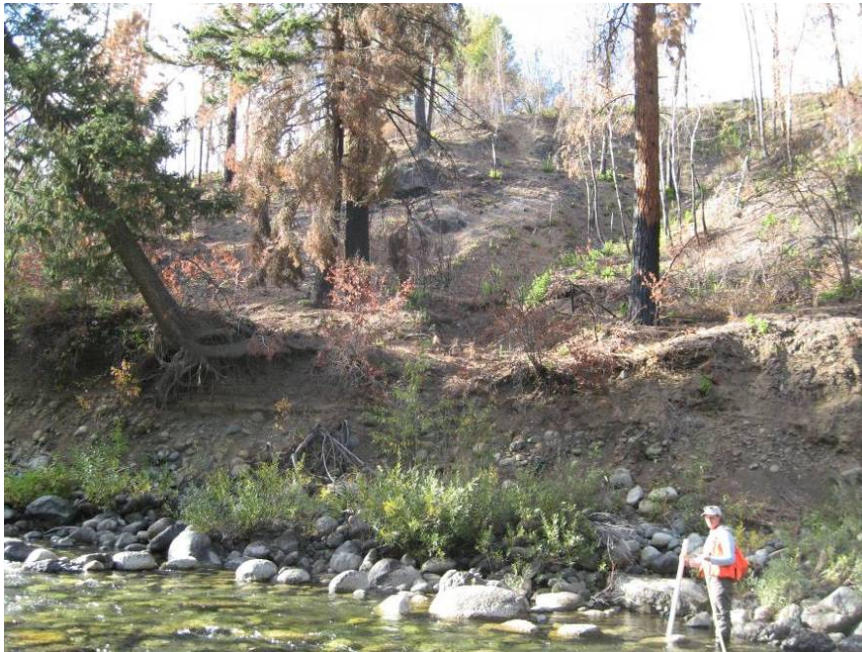
Mature riparian timber, the prevalence of large confers in the riparian zone, and steep hillslope topography provides stream shade and LWD recruitment potential. A burned area on the river-left bank near RM 5.2 has the potential to contribute LWD to the channel in the short-term (Figure 51).

Figure 51. Burned area near RM 5.2 has the potential to provide short-term LWD recruitment (October 2009).

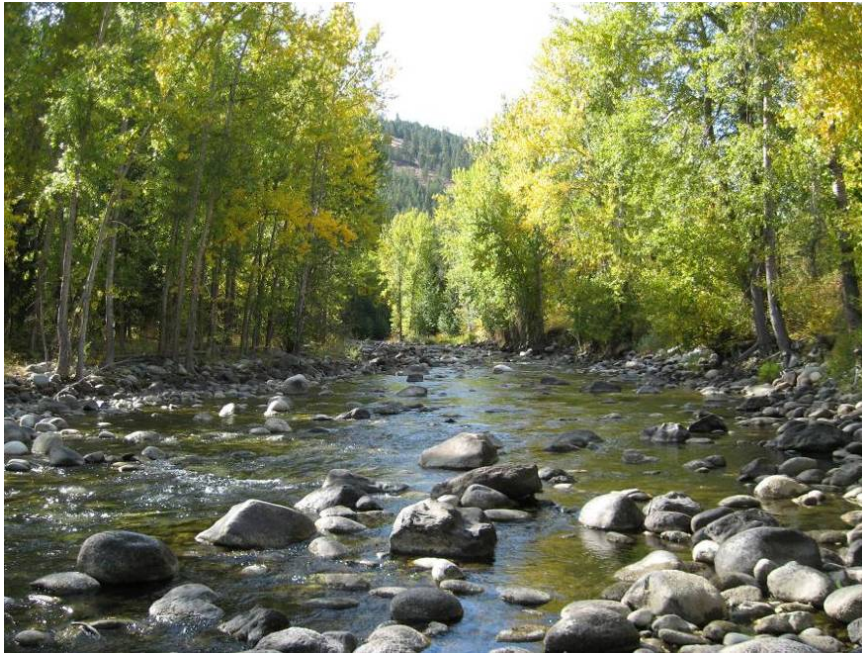
Figure 59. View looking upstream at a long plane-bed section near RM 6.3 (October 2009).

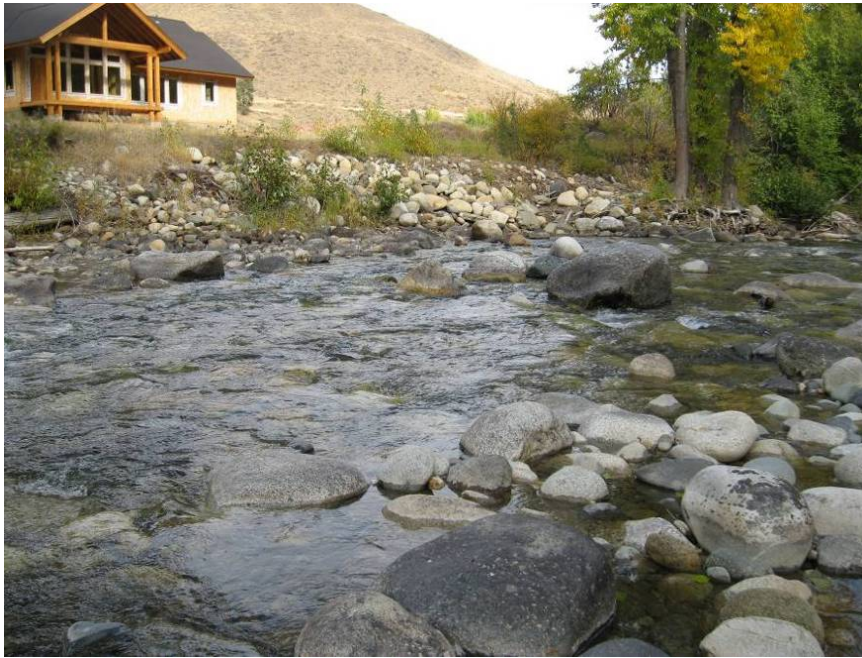
Land use is rural residential and agriculture. There are several private residences located within the floodplain or on adjacent terraces (Figure 65); many of these areas have streambanks protected with riprap. There is cleared pasture land at several locations, including a long section along the south bank from RM 5.8 to 6.3, where there is only a narrow forested riparian buffer (less than 50 feet in most locations) (Figure 66).

Figure 65. House adjacent to main channel near RM 6.75 (October 2009).

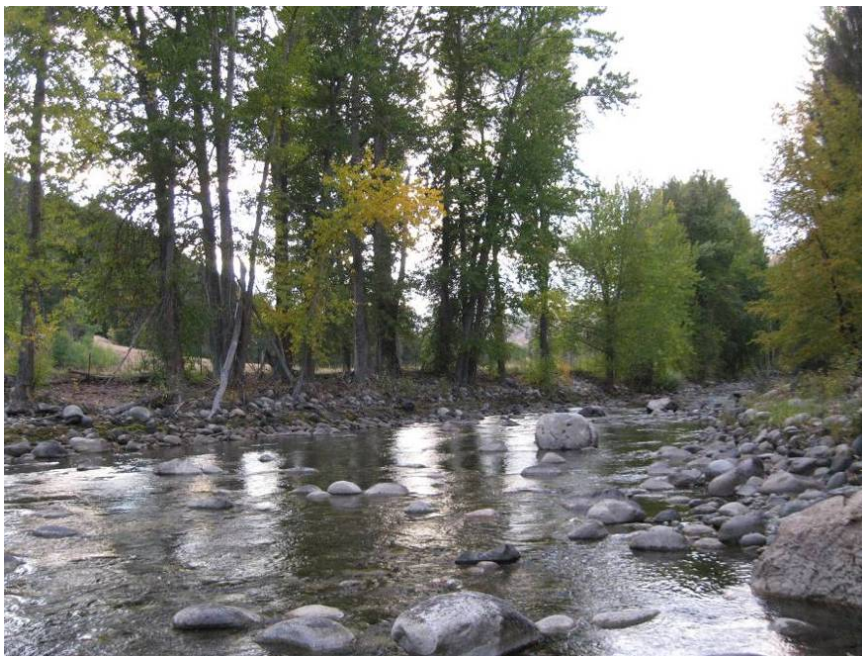
Figure 66. View looking upstream at the narrow forested buffer separating the main channel from pasture land near RM 5.9 (October 2009).

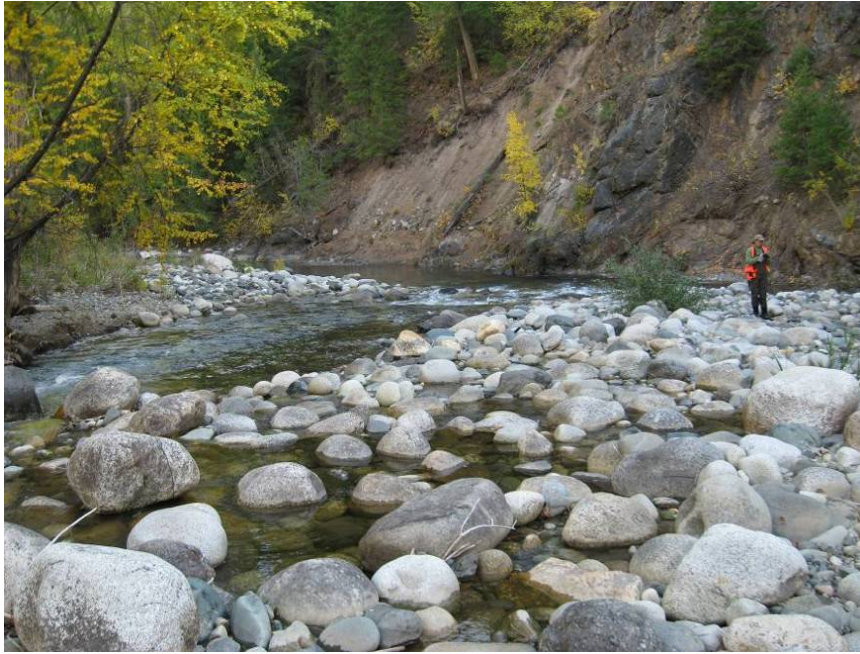
Active bank erosion is evident along the reach, often associated with land clearing for agriculture, residential uses, or roadways. Active erosion of the glacial terrace also occurs in several places, including at RM 6.9 and RM 6.55 (Figure 67).

Figure 67. Exposure of bedrock and erosion of glacial material near RM 6.55 (October 2009).

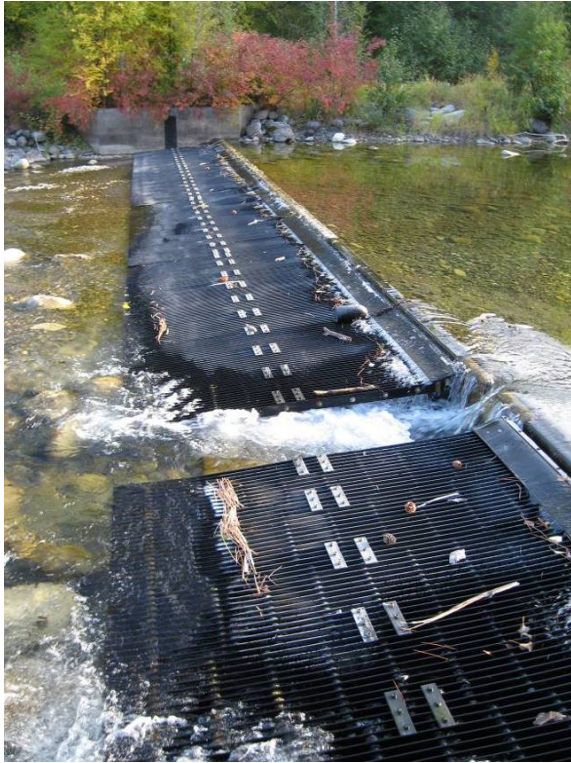
The fish weir at RM 7.25 likely presents a passage barrier for upstream migration juveniles during low flows (Figure 68). A 2.5-ft tall concrete dam located just downstream of the irrigation diversion on a side-channel at RM 7.6 may limit fish passage, especially during summer low flow periods (Figure 69).

Figure 68. Adult fish weir at RM 7.25 (October 2009).

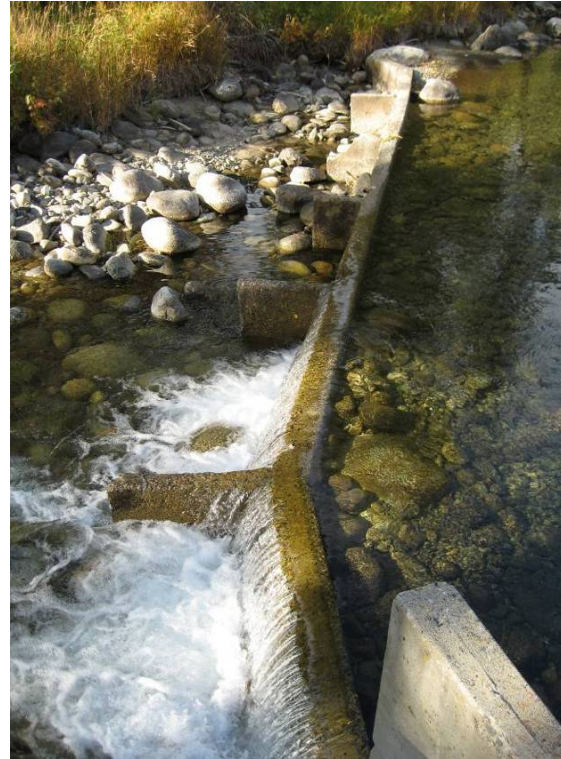
Figure 69. Concrete diversion weir at RM 7.6 used to divert flow into an irrigation canal (October 2009).

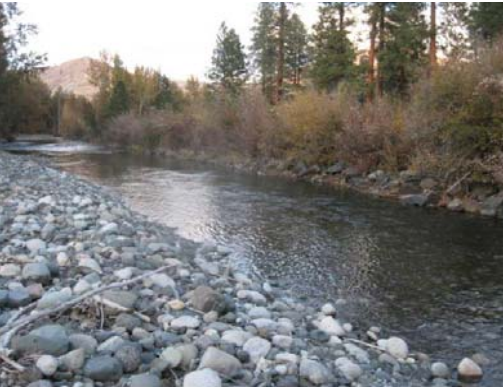
Reach	Project Number	Sub-Unit	Strategy Category	Project Name	Description	Photo
1	Project RM 0.3R	Inner Zone 1 (IZ-1)	In-stream Habitat Enhancement	LWD habitat enhancement	The bank in this area has been protected with riprap beginning at the bridge and extending down to RM 0.25. The riprap is currently protecting residences built in DOZ-3. Riprap limits geomorphic connectivity (e.g. channel migration), riparian function, and habitat complexity. Bank protection should be maintained for safety, but could be enhanced with LWD to enhance in-stream habitat cover/complexity.

<p>Looking downstream to the northeast at the river-right bank near RM 0.3 where LWD could enhance a riprap protected bank (October 2009).</p>
1	Project RM 0.53L	Inner Zone 1 (IZ-1)	Reconnect Stream Channel Processes	Side-channel habitat reconnection	In 1985, this side-channel was mapped as active split flow. Currently, the channel is scoured and contains un-vegetated alluvial material indicating a frequent high-flow connection; however, there is no active flow when water levels are low. A low-flow connection could be enhanced to provide a perennial split flow channel. Protection of adjacent residences would be a primary consideration. A small portion of riprap near the downstream outlet could be moved to the margin of the floodplain surface.

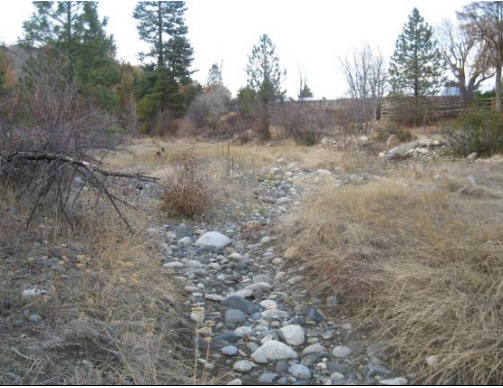
<p>View looking upstream toward the northwest at a small high-flow channel that could be enhanced to provide side-channel habitat at all flow levels (October 2009).</p>

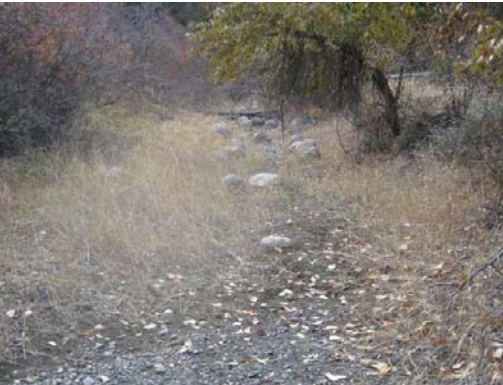
2a	Project RM 0.87R	Disconnected Outer Zone 1 (DOZ-1)	Off-Channel Habitat Enhancement	Wetland habitat enhancement	The downstream outlet of the acclimation ponds is near RM 1.05. Downstream of that point, there is topographic and vegetative evidence of a more active hydrologic connection between the channel and DOZ-1. This area is also managed by MSRF. MSRF breached the levee in several places, allowing for semi-annual flooding. Groundwater investigation by MSRF does not support a flow augmentation here. This channel could be developed with a surface connection to an active side-channel near RM 0.9, enhancing connectivity between channel and floodplain processes and habitats. There is also potential to create an active low-flow side-channel through this area in combination with Project RM 1.0R.

<p>Floodplain channel near RM 0.9. This channel is continuous across the surface but is currently not well-connected (October 2009).</p>

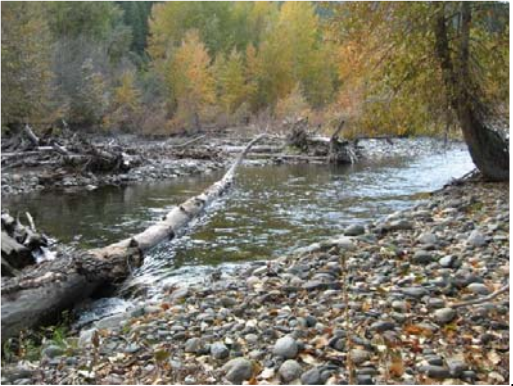
Reach	Project Number	Sub-Unit	Strategy Category	Project Name	Description	Photo
2a	Project RM 0.88L	Inner Zone 2 (IZ-2)	Reconnect Stream Channel Processes	LWD enhancement and side-channel reconnection	LWD jams at this location would enhance LWD that is naturally being deposited in this area and could enhance flows into adjacent high-flow channels. Downstream near RM 0.86, a bar apex log jam would be used to enhance a gravel bar high-flow cut-off. The cut-off channel is scoured and appears active. The purpose of the jam would be to increase scour, increase low flow discharge in the channel, and provide improve habitat.

<p>View looking upstream toward the west at LWD near RM 0.9 (October 2009).</p>
2a	Project RM 0.95R	Inner Zone 2 (IZ-2)	Off-Channel Habitat Enhancement	Alcove habitat enhancement	This wood structure would enhance an existing backwater pool that has above average residual depth, providing cover and habitat complexity.

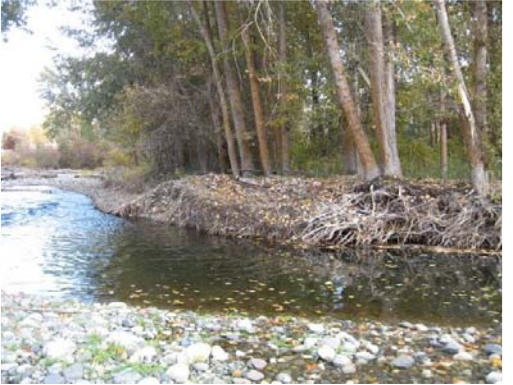
<p>View looking downstream toward the east at an alcove near RM 0.95 (October 2009).</p>

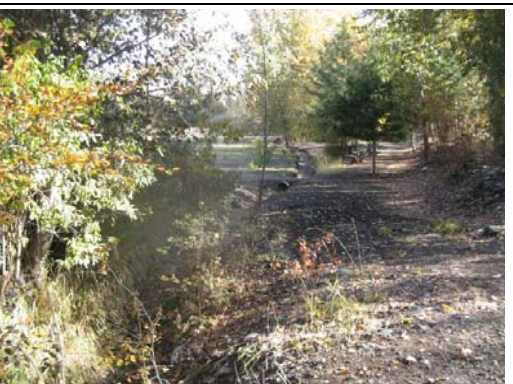
2a	Project RM 1.0R	Disconnected Outer Zone 1 (DOZ-1)	Reconnect Floodplain Processes	Levee removal	There is a 560 ft long push-up levee that creates a barrier to downstream connection to high-flow across the floodplain, and to the connectivity of off-channel and floodplain side-channel habitat. The levee does not appear to provide protection to vital infrastructure and could be removed to re-establish floodplain connectivity.

<p>View looking east in the downstream direction at an old irrigation ditch in the center of the photo protected by a levee on the right (October 2009).</p>

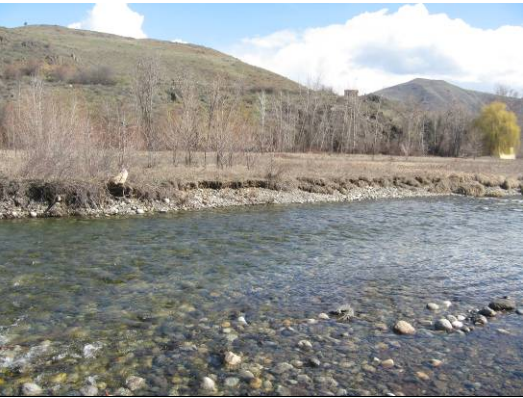
<p>View looking towards the left bank at eroding bank near RM 1.15 (October 2009).</p>

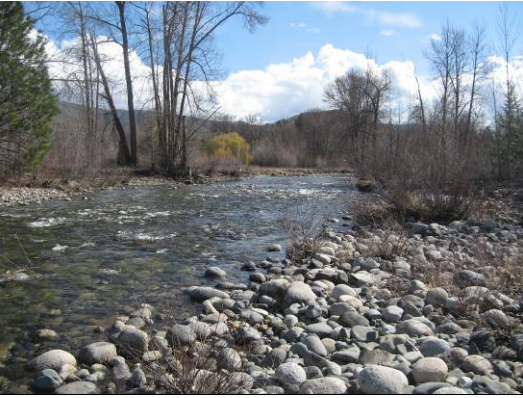
2a	Project RM 1.19R	Inner Zone 2 (IZ-2)	Reconnect Stream Channel Processes	Side-channel reconnection	An existing side-channel would be enhanced with placement of an apex wood jam. There is an existing jam at this location that would be enhanced.

<p>View looking downstream at point bar with potential for apex jam placement near RM 1.19 (October 2009).</p>

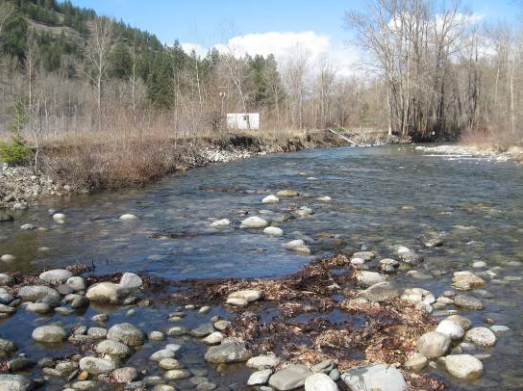
Reach	Project Number	Sub-Unit	Strategy Category	Project Name	Description	Photo
2a	Project RM 1.21R	Inner Zone 2 (IZ-2)	In-Stream Habitat Enhancement	LWD enhancement	This project includes placement of several log jams along the river right bank to control erosion and increase cover for habitat enhancement.

<p>View looking upstream at eroding bank on river-right near RM 1.21. Smolt trap in background (October 2009).</p>
2a	Project RM 1.25R	Disconnected Outer Zone 1 (DOZ-1)	Riparian Habitat Enhancement	Riparian re-vegetation	Several acres of riparian forest have been cleared on the south side of the valley for residential and agricultural development. There is no active agricultural or residential use for this cleared area, and the potential exists to re-plant native riparian vegetation to enhance habitat quality. The land is currently under protection and slated for riparian restoration.
