Lower Twisp River Reach Assessment

Provided for:

Yakama Nation Fisheries Program

JUNE 2010

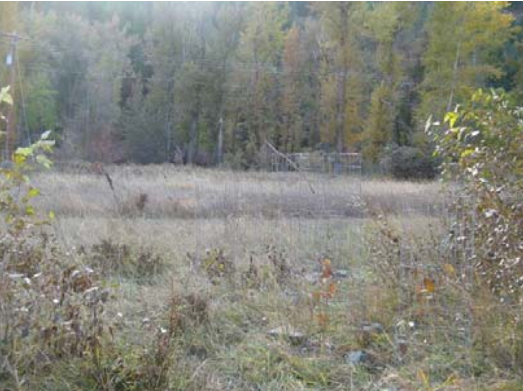
<p>View to the south at a cleared floodplain area near RM 1.25 (October 2009).</p>

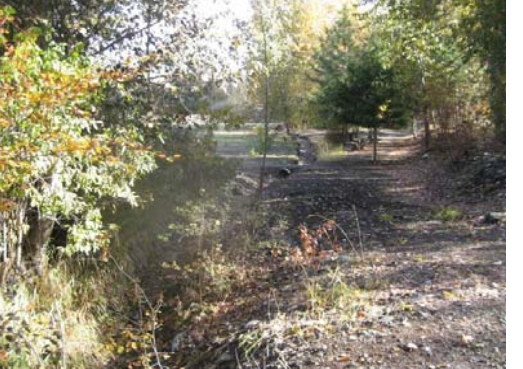
2a	Project RM 1.2L	Disconnected Outer Zone 2 (DOZ-2)	Riparian Restoration	Riparian re-vegetation	Several acres of riparian forest have been cleared north of the channel between RM 1.0 and 1.3. This clearing was originally agricultural, but now appears to be fallow. The land is under protection and is slated for riparian restoration. Re-planting native riparian vegetation would enhance habitat quality and stream processes by increasing solar shading of the channel, and eventually providing a source for large woody debris.	
2a	Project RM 1.28L	Disconnected Outer Zone 2 (DOZ-2)	Reconnect Floodplain Processes	Levee removal	Along the channel margin at the upstream end of DOZ-2, a levee protects an abandoned irrigation canal. Without the need to protect the canal, the levee could be removed to re-establish channel/floodplain connection between processes and habitat.

<p>View looking east in the downstream direction at an old irrigation ditch in the center of the photo protected by a levee on the right (October 2009).</p>

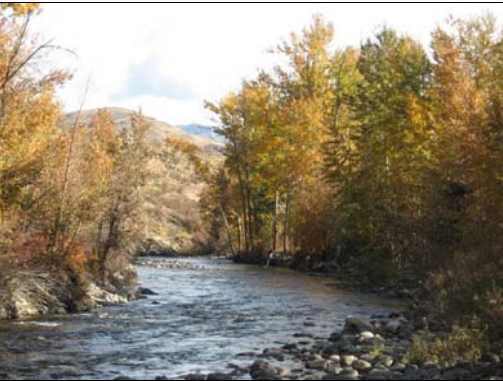
Reach	Project Number	Sub-Unit	Strategy Category	Project Name	Description	Photo
2a	Project RM 1.45C	Inner Zone 1 (IZ-1)	In-Stream Habitat Enhancement	LWD enhancement	Between RM 1.4 and 1.5 there are several opportunities for placement of LWD on both sides of the channel. These structures would increase habitat cover and complexity.

<p>View looking east in the downstream direction near RM 1.45 where both sides of the channel provide opportunities for LWD enhancement (October 2009).</p>
2a	Project RM 1.7R	Disconnected Outer Zone 1 (DOZ-1)	Reconnect Floodplain Processes	Levee removal or set-back	At the upstream end of the reach, a levee runs along the right bank of the channel for approximately 1,869 feet. Residential development does not begin for several hundred feet downstream. The levee could be set back farther on the floodplain to provide more direct protection for residential development, and re-establish a connection between channel/floodplain processes and habitats.

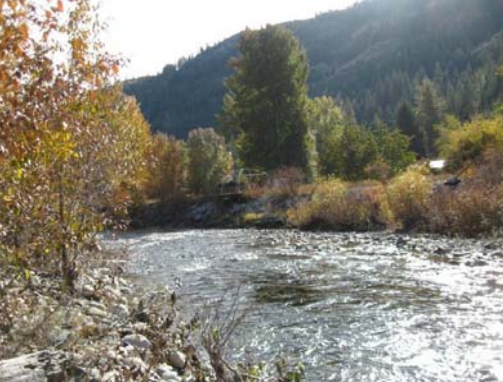
<p>View looking downstream towards the east at a levee along river-right (October 2009).</p>

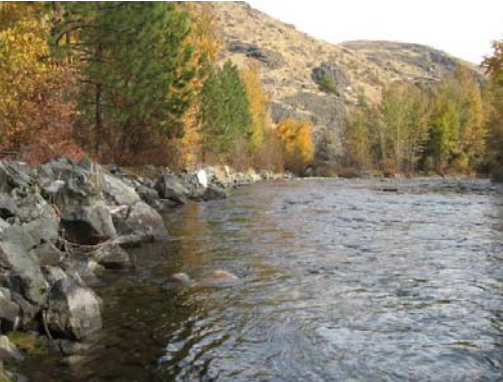
2b	Project RM 1.72L	Disconnected Outer Zone 5 (DOZ-5)	Off-Channel/Side-Channel Habitat Enhancement	Alcove habitat enhancement	This project would create an off-channel backwater/alcove at the upstream end of the north channel of the split-flow area between RM 1.68 and 1.73. The backwater would provide high-flow refugia for fish in the active channel and provide connectivity between channel and floodplain habitat.	
2b	Project RM 1.75L	Inner Zone 5 (IZ-5)	Reconnect Stream Channel Processes	Riprap removal	Downstream of the bridge at RM 1.85, the river-left channel is protected by riprap for over 700 feet. There is no residential development or other infrastructure in the adjacent floodplain. The riprap could be removed and replaced with LWD in order to reconnect stream channel and floodplain processes and to increase habitat cover and complexity. Alternatively, the riprap could remain in place and be enhanced with LWD additions.

<p>Northeast view in the downstream direction of riprap bank along river-left downstream of the bridge at RM 1.87 extending to RM 1.71 (October 2009).</p>

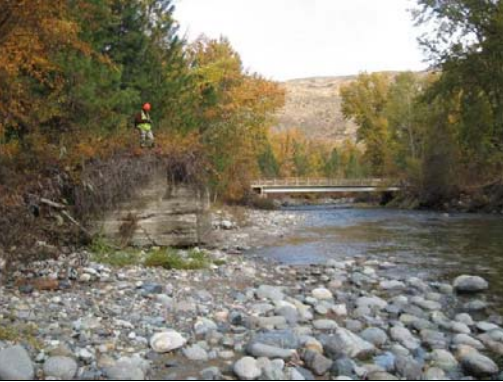
Reach	Project Number	Sub-Unit	Strategy Category	Project Name	Description	Photo
2b	Project RM 1.87L	Inner Zone 5 (IZ-5)	Reconnect Stream Channel Processes	Abutment removal	An old bridge abutment is located along the river-left channel margin. The abutment currently serves no purpose, but creates a process barrier. Removal would enhance inner zone processes.

<p>Northeast view in the downstream direction at an old bridge abutment along river-left near RM 1.87 (October 2009).</p>
2b	Project RM 2.0R	Disconnected Outer Zone 4 (DOZ-4)	Reconnect Floodplain Processes	Wetland habitat reconnection	A larger effort to reconnect habitat and process throughout DOZ-4 would require several culverts on Poorman road, multiple private roads, and multiple landowner approval. This approach is mentioned by the BOR as the “Spokane Grade” project (BOR 2008). The effort faces too many constraints to be considered here. A scaled-back approach with one culvert to connect floodplain wetlands at the downstream end is described here. This project involves replacing a culvert at RM 2.0 in order to re-connect off-channel habitat south of Poorman Road between RM 2.0 and 2.4.

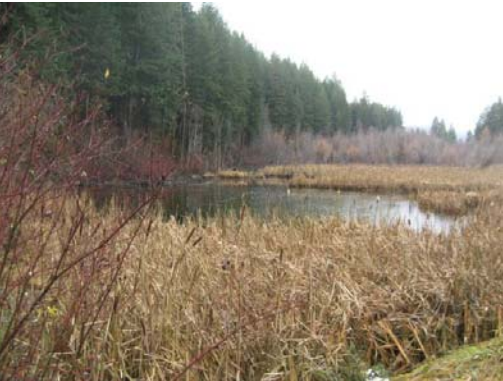
<p>View to the west in the upstream direction at wetlands south of Poorman Road in DOZ-4 (November 2009).</p>

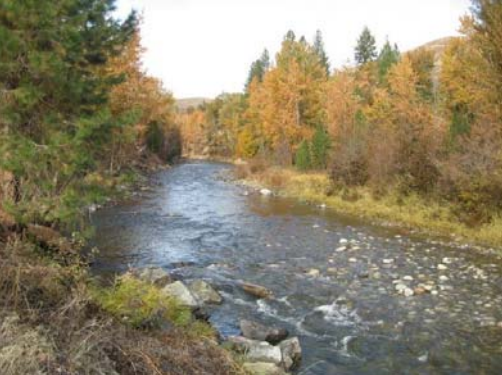
Reach	Project Number	Sub-Unit	Strategy Category	Project Name	Description	Photo
2b	Project RM 2.25R	Inner Zone 5 (IZ-5)	Reconnect Stream Channel Processes	Riprap modification or removal	This project involves incorporation of LWD along the riprap bank with the goal of increasing habitat complexity and quality. There is a backwater created by the crest of a riffle. A LWD structure could provide enhanced pool habitat in this area.

<p>Northwest view in the upstream direction at a potential LWD location along river-right near RM 2.25 (October 2009).</p>
2b	Project RM 2.3L	Outer Zone 7 (OZ-7)	Off-Channel Habitat Enhancement	Side-channel habitat enhancement	An existing meander scar could be excavated and opened up to create a floodplain channel. There is no evidence that the feature is frequently inundated. The downstream end of the channel could be widened to create a backwater/alcove connected to the active channel.

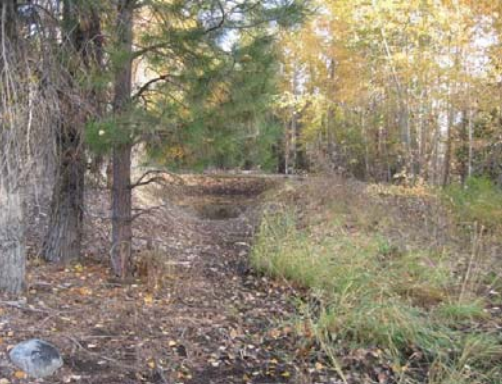
<p>Southeast view in the downstream direction at a portion of the riprap that extends along river right between RM 2.58-2.75 (October 2009).</p>
2b	Project RM 2.7L	Disconnected Inner Zone 3 (DIZ-3)	Reconnect Stream Channel Processes	Levee removal and side-channel reconnection	This project involves removing anthropogenic features to reconnect inner zone processes. A portion of the high flow channel is currently ditched, lined, and routed into a catch basin near RM 2.7. There are also two push-up levees in this area that limit connectivity of channel and floodplain processes. These features could be removed to enhance floodplain and side-channel connectivity.

<p>View to the east in the downstream direction at a catch basin that has been built to capture high-flow from a side-channel near RM 2.7 (October 2009).</p>

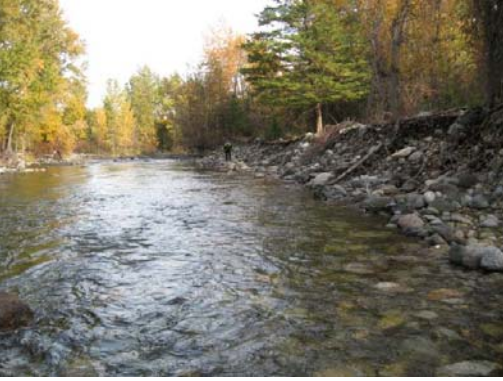
Reach	Project Number	Sub-Unit	Strategy Category	Project Name	Description	Photo
2b	Project RM 2.9C	Inner Zone 4 (IZ-4)	In-Stream Habitat Enhancement	LWD enhancement.	LWD structures on both sides of the channel would increase habitat cover, pool scour, and complexity

<p>Northeast view in the downstream direction at a potential LWD location along river-right near RM 2.9. The left side of the channel provides a similar opportunity (October 2009).</p>
2b	Project RM 2.93L	Inner Zone 4 (IZ-4)	In-Stream Habitat Enhancement	LWD enhancement	This is a location where LWD could be added to the channel along river-left near RM 2. This project is located in an active side-channel. The log jam would provide habitat complexity in the side channel.

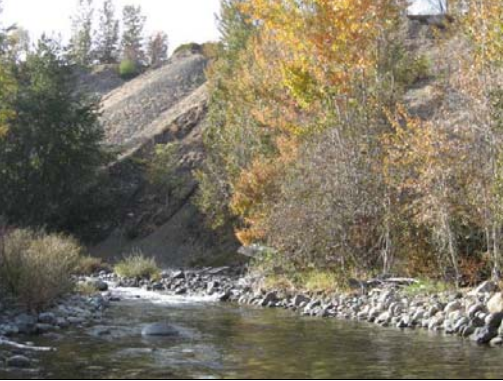
<p>View to the northwest in the upstream direction at a side channel near RM 2.93 (October 2009).</p>
2b	Project RM 3.0R	Disconnected Outer Zone 4 (DOZ-4)	Reconnect Floodplain Processes	Levee removal, side-channel reconnection	Habitat actions proposed for this project would re-connect several floodplain sub-units and the active channel. Currently a large levee extends 550 ft between RM 3.1 and 3.2. The levee creates a process and habitat barrier between DOZ-3, DOZ-4, and OZ-4. High-flow channels and wetlands occupying older channel scars intersect the levee and terminate, with the water entering the levee prism and going sub-surface. LiDAR data suggests that these high flow channels historically extended beyond the levee connecting with wetland features in DOZ-4. The levee does not appear to serve a protection purpose; there is no residential development or transportation corridor nearby. In addition to removing the levee, high flow channels and off-channel habitat would be enhanced to re-establish historical floodplain connections and functions in the system.

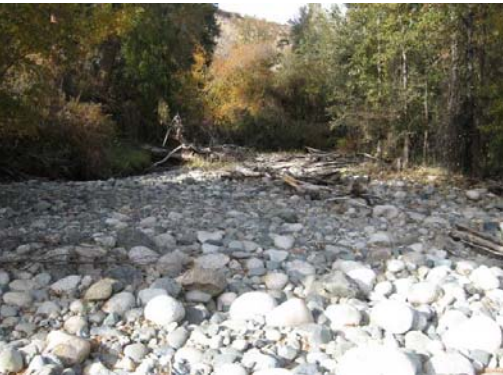
Reach	Project Number	Sub-Unit	Strategy Category	Project Name	Description	Photo
2b	Project RM 3.13C	Inner Zone 4 (IZ-4)	Reconnect Stream Channel Processes	Re-establish channel LWD dynamics	This project entails enhancing an existing apex jam in order to increase channel complexity, and enhance an existing side-channel by encouraging split-flow at all flow levels. The side-channel currently sees active flow during annual high-flow events. Creating a split-flow condition would increase habitat complexity. Habitat features could be installed throughout the side-channel as well.

<p>View to the northeast in the downstream direction at a side-channel near RM 3.13 (October 2009).</p>
2b	Project RM 3.25R	Inner Zone 4 (IZ-4)	In-Stream Habitat Enhancement	LWD enhancement	A LWD meander bend jam would improve local habitat and cover. Existing riparian vegetation is in good condition along the bank and enhancing lateral channel adjustment processes could drive future LWD recruitment

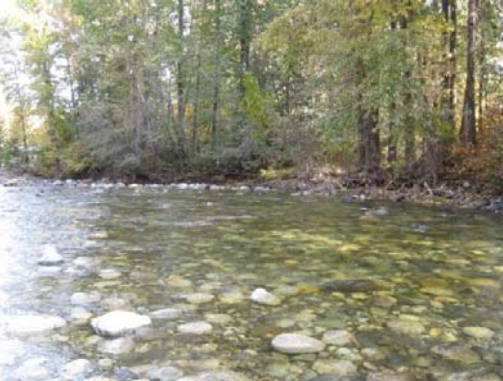
<p>Northeast view in the downstream direction at a potential LWD jam location on river-right near RM 3.25 (October 2009).</p>

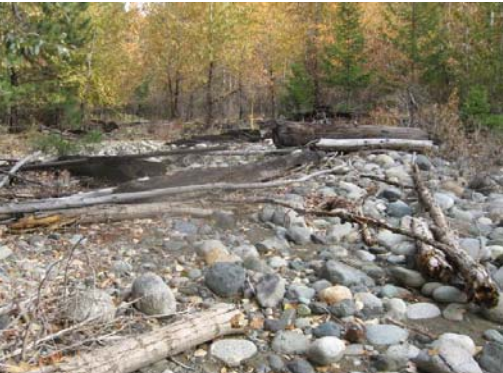
2b	Project RM 3.35L	Inner Zone 4 (IZ-4)	Reconnect Stream Channel Processes	Levee removal and side-channel reconnection	This project involves enhancement of a river-left side-channel that runs between RM 3.22 and 3.38. This side-channel was the active channel location in 1954 and 1964 aerial photos. Geomorphic and vegetative evidence suggests an active connection to inner zone processes that could be enhanced through a combination of actions. Enhancement of an existing bar apex jam would encourage flow into the side-channel. The existing jam is limited by current wood recruitment levels. A 200 ft long push-up levee currently creates a flow barrier between the main channel and the side-channel at the downstream end. Removing this levee would allow inner zone processes to proceed unimpeded.

<p>Northeast view in the downstream direction at a small LWD jam at a bar apex near RM 3.38 (October 2009).</p>

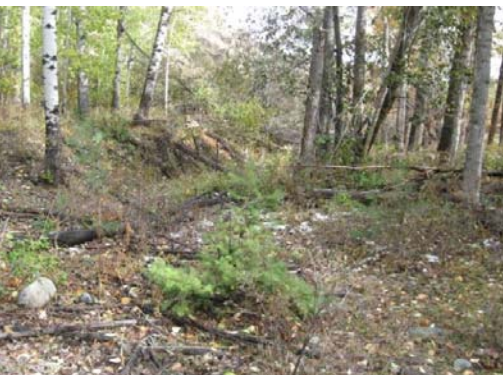
2b	Project RM 3.5L	Outer Zone 3 (OZ-3)	Off-Channel Habitat Enhancement	Side-channel habitat enhancement	This project involves re-activating a high-flow channel between RM 3.3 and 3.6. Currently, the channel does not appear to be regularly inundated, but cross-section geometry suggests that moderate flows were historically accommodated in this channel. Excavation would be required to lower the upstream end of the channel and activate flow at a 1.5-2 yr frequency. The channel is well defined in its upstream half and would require minimal mechanical enhancement to accommodate flow. Excavation is needed to construct a channel and outlet at the downstream end of the project. Dry ground and upland vegetation suggest that groundwater would not be a significant contributor to flow in this channel.

<p>Northeast view in the downstream direction at the historical high-flow channel found between RM 3.3 and 3.6 in OZ-3 (October 2009).</p>

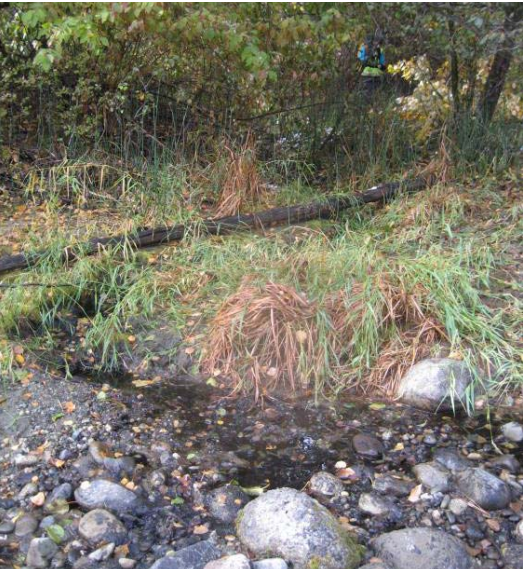
2b	Project RM 3.9R	Disconnected Outer Zone 3 (DOZ-3)	Off-Channel Habitat Enhancement	Alcove habitat enhancement	At RM 3.9, there is a low area on the channel margin that forms the drainage point for the upstream end of the “Chain of Lakes” (Figure 20). Despite the berms that surround the wetlands, and the lack of natural drainage, there is a small surface discharge into the channel. This topographic low point could be excavated into the floodplain to create an off-channel alcove that connects channel and floodplain habitats.

<p>View to the southwest toward the outlet of the upstream end of the "Chain of Lakes" near RM 3.9 (October 2009).</p>

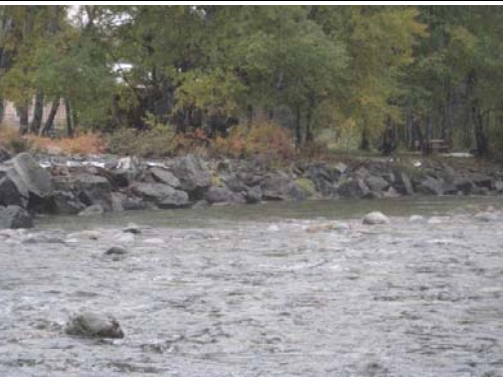
2b	Project RM 4.2R	Disconnected Outer Zone 2 (DOZ-2)	Off-Channel Habitat Enhancement	Off-Channel Habitat Enhancement at fish return channel	The fish return channel from the fish screen near RM 4.2 could be developed to provide access to off-channel habitat. The channel currently provides some off-channel habitat, but placement of habitat features would increase the quality of habitat components in the channel.	
2b	Project RM 4.25L	Inner Zone 2 (IZ-2)	Reconnect Stream Channel Processes	Riprap modification or removal	This project involves the removal or modification of large riprap and installation of LWD structures to maintain bank stability while allowing for greater connection of process and enhanced in-stream habitat.

<p>Looking east in the downstream direction at riprap along river-left near RM 4.25 (October 2009).</p>
2b	Project RM 4.3L	Disconnected Outer Zone 1 (DOZ-1)	Reconnect Floodplain Processes	Wetland Habitat Reconnection	This project involves reconnecting wetland habitats to inner zone habitats, and re-establishing channel/floodplain connection. Groundwater fed wetlands provide potentially valuable off-channel habitat, but lack passable fish access. The outflow channel is blocked by fill, garbage, and riprap at the channel margin creating a steep fall into the channel that is impassible except at very high flows. The outflow channel could be opened up to allow fish passage into off-channel habitat. The wetlands themselves could be enhanced to provide increased quality of fish habitat

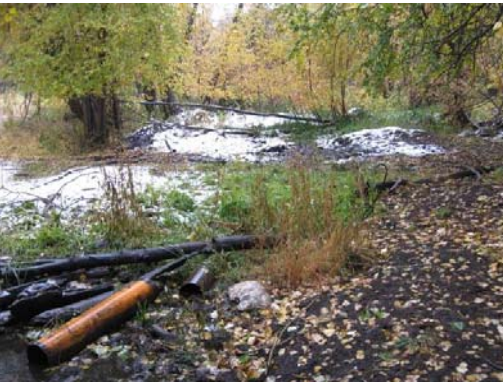
<p>Wetland outflow channel that has been altered with floodplain fill behind riprap. The channel does not currently provide habitat connection at any flow level except high flows (October 2009).</p>

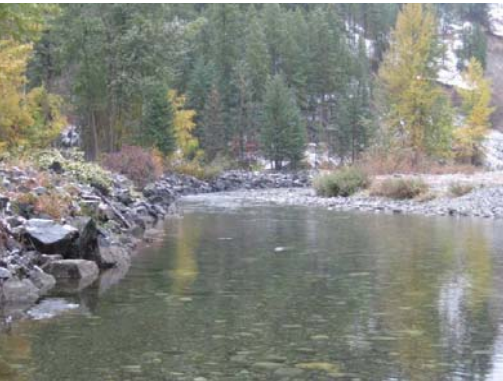
Reach	Project Number	Sub-Unit	Strategy Category	Project Name	Description	Photo
2b	Project RM 4.5R	Disconnected Outer Zone 2 (DOZ-2)	Reconnect Floodplain Processes	Levee removal and floodplain reconnection	The goal of this project is to re-connect the floodplain and the channel. Explore opportunities to re-locate the irrigation diversion and dam upstream to near RM 4.5 adjacent to the hillslope toe and remove or set-back the levee that forms the upstream boundary of DOZ-2. Given the amount of alteration to the sub-unit, the constraints are considerable (Figure 19). The irrigation canal and fish screen depend on protection from this levee.

<p>Looking southwest in the upstream direction at a levee that is a process and habitat barrier for DOZ-2 (October 2009).</p>
2b	Project RM 4.55L	Disconnected Inner Zone 1 (DIZ-1)	Reconnect Stream Channel Processes	Levee removal, side-channel reconnection	This project involves removing or modifying the push-up levee between RM 4.75 and 4.85. LWD enhancement near inlet locations of disconnected side-channels could direct high-flow into high flow channels, re-establishing process and enhancing habitat connection. Downstream outlets of the high flow channels are unimpeded, and would not require and mechanical enhancement.

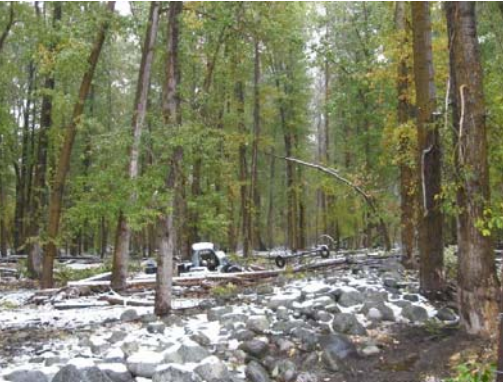
<p>Southeast view of DIZ-1 looking across a push-up levee into the thinned riparian forest (October 2009).</p>

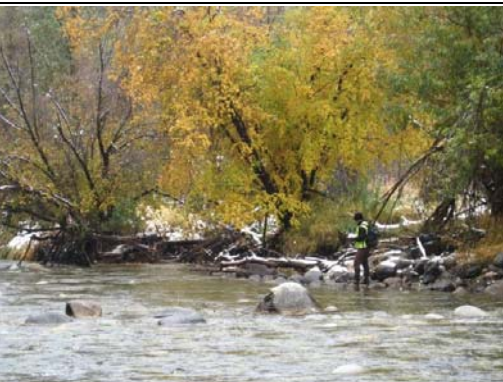
2b	Project RM 4.6C	Inner Zone 2 (IZ-2)	Reconnect Stream Channel Processes	Re-establish channel LWD dynamics	This portion of the inner zone is geomorphically active. The channel is eroding into a glacial terrace to the south and forming a gravel bar with the eroded material. Large wood is being deposited at the apex of this gravel bar. There are large boulders in the channel creating a scour pool. A large, channel spanning wood jam here would increase pool scour, provide cover, and re-establish large wood and lateral channel dynamics.	
2b	Project RM 4.75R	Inner Zone 1 (IZ-1)	In-Stream Habitat Enhancement	LWD enhancement	Existing root wads and small wood could be enhanced with a LWD bank structure to increase the quality of pool habitat

<p>Potential LWD location along river right near RM 4.75. Existing woody bank structure could be enhanced to provide increased habitat quality (October 2009).</p>

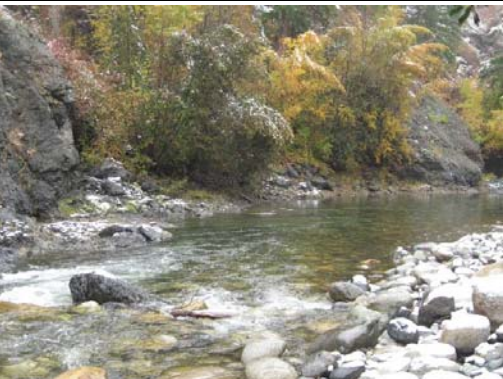
<p>Looking toward the southeast in the downstream direction where LWD placements on both sides of the channel could increase habitat quality and diversity (October 2009).</p>
3a	Project RM 5.23L	Inner Zone 1 (IZ-1)	In-Stream Habitat Enhancement	LWD enhancement	There is an existing boulder step-pool and bedrock outcrop in the channel. The pool has good residual depth but lacks cover. This project entails placing a meander-bend LWD jam to increase the amount of cover and quality of habitat provided in this deep pool.

<p>View to the northeast in the downstream direction at a deep bedrock pool near RM 5.23 (October 2009).</p>

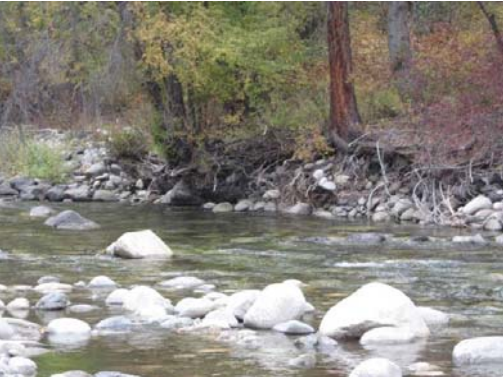
Reach	Project Number	Sub-Unit	Strategy Category	Project Name	Description	Photo
3b	Project RM 5.45L	Inner Zone 3 (IZ-3)	In-Stream Habitat Enhancement	LWD enhancement	Similar to Project RM 5.7L, this is a location where an existing root mass and pool could be enhanced with a LWD meander-bend jam.

<p>View to the west in the upstream direction at an overhanging root mass on the left bank near RM 5.45 (October 2009).</p>
3b	Project RM 5.5R	Inner Zone 3 (IZ-3)	Reconnect Stream Channel Processes	Side-channel reconnection	A high-flow channel between RM 5.4 and 5.6 appears to be inundated and scoured on an annual recurrence. This channel could be enhanced to provide side-channel habitat at a wider range of flows. LWD structures and select excavation would be used to provide low-flow access to the side-channel and to increased habitat complexity and quality.

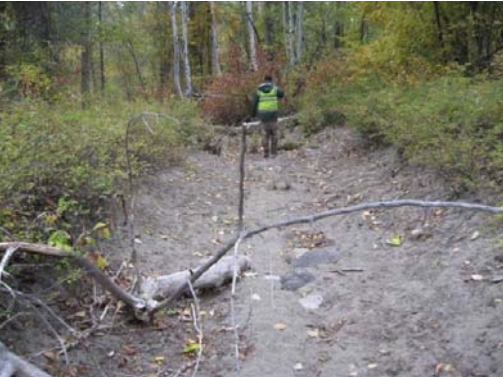
<p>View to the east in the downstream direction at an active high-flow channel near RM 5.5 (October 2009).</p>

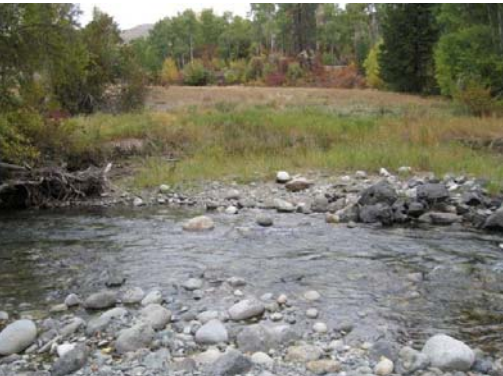
3b	Project RM 5.55L	Outer Zone 2 (OZ-2)	Off-Channel Habitat Enhancement	Off-channel habitat enhancement	This project involves increasing the availability and connectivity of off-channel habitat. A low-flow channel could be created to connect floodplain wetlands to the main channel.	
3b	Project RM 5.7L	Inner Zone 3 (IZ-3)	In-Stream Habitat Enhancement	LWD enhancement	There is an existing overhanging root mass and scour pool at an outside bend. Placement of a LWD meander-bend log jam would increase cover, pool scour, and complexity. Planting of the riparian area should be a part of project work at this location.

<p>View to the north at the river-left bank near RM 5.7 (October 2009).</p>

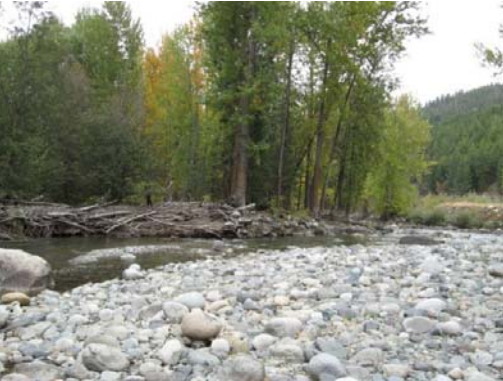
Reach	Project Number	Sub-Unit	Strategy Category	Project Name	Description	Photo
3b	Project RM 5.8L	Inner Zone 3 (IZ-3)	Reconnect Stream Channel Processes	Side-channel reconnection	This project involves enhancing the active side-channel and high-flow channels that have developed in the re-worked deposits of an alluvial fan between RM 5.7 and 5.9. LWD apex jams near the upstream end at RM 5.9 would enhance inundation of high-flow channels. Select excavation could be used to create a low flow side-channel. High-flow channel outlets could be enhanced to allow for habitat connection throughout the project area.

<p>View to the southeast in the downstream direction at the upstream inlet to a network of high flow channels located along river-left between RM 5.7 and 5.9 (October 2009).</p>
3b	Project RM 5.9R	Disconnected Outer Zone 2 (DOZ-2)	Riparian Restoration	Riparian re-vegetation	There is only a narrow forested riparian buffer (10 – 50 ft wide) on river-right between RM 5.8 and RM 6.2. This project would involve reforestation of the riparian zone up to 100 feet (or greater if possible) from the channel. Address livestock access if it is an issue on this parcel.

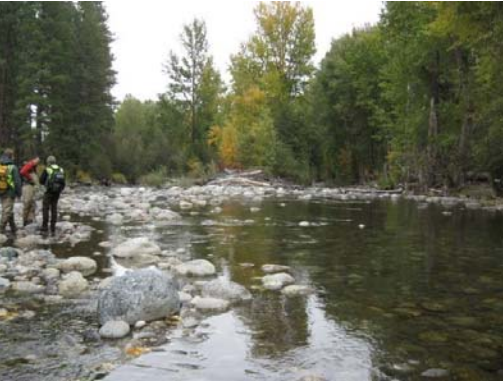
3b	Project RM 6.0C	Inner Zone 2 (IZ-2)	Reconnect Stream Channel Processes	LWD placement to enhance lateral dynamics	This location is just upstream of the transition from IZ-2 to IZ-3 where the channel width begins to expand and flow splits around a mid-channel bar. This project would involve placing LWD jams on point bars and mid-channel bar apexes to enhance split flow conditions.

<p>Downstream view to the east at an apex log jam on a mid-channel bar. LWD jams in this area would enhance lateral channel dynamics and improve habitat cover and complexity (October 2009).</p>
3b	Project RM 6.08C	Inner Zone 2 (IZ-2)	Reconnect Stream Channel Processes	Bridge modification	The bridge at RM 6.08 creates a hydraulic constriction at high flows. An improvement of the bridge with a wider span could alleviate hydraulic effects of increased energy in the channel during high flows.

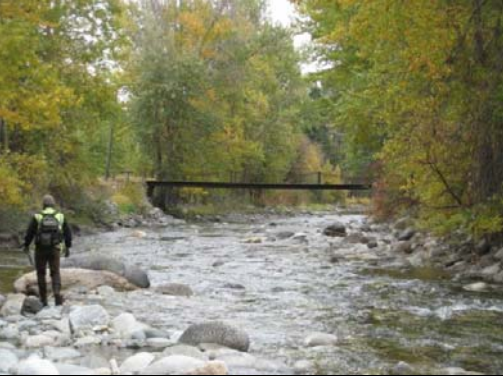
<p>View to the east in the downstream direction at a bridge crossing near RM 6.08. As stage increases, the bridge becomes a hydraulic constriction (October 2009).</p>

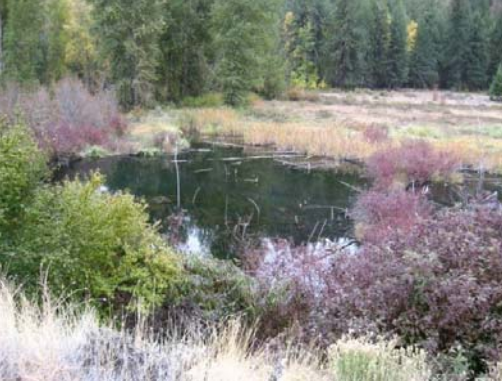
<p>Floodplain wetlands located in DOZ-1 that could be re-connected to inner-zone processes and habitat (October 2009).</p>

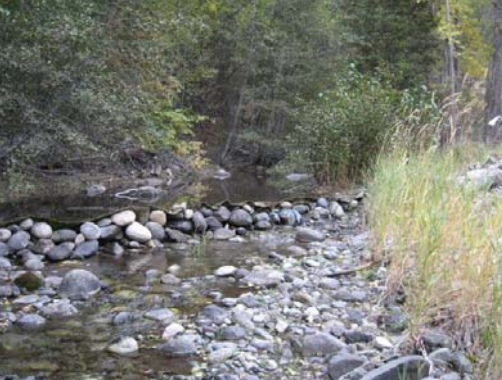
3b	Project RM 6.35R	Inner Zone 1 (IZ-1)	Reconnect Stream Channel Processes	Levee removal and side-channel reconnection	This project involves reconnecting the two main areas of side-channel habitat in this sub-unit. Both side-channels are located on river-right. The upstream side-channel is centered on RM 6.5; the downstream side-channel is centered on RM 6.25. A narrow high flow channel runs along the toe of the hillslope and connects the two side-channels. This connecting channel is being as an irrigation diversion. As part of the project, the diversion would be re-engineered to re-connect the upstream side-channel to inner-zone processes and habitat. A levee blocks the downstream side-channel. This levee would be removed to promote reconnection of inner-zone processes

<p>View to the southwest in the upstream direction at the diversion dam near RM 6.51. Removal of the dam would enhance side-channel habitat (October 2009).</p>

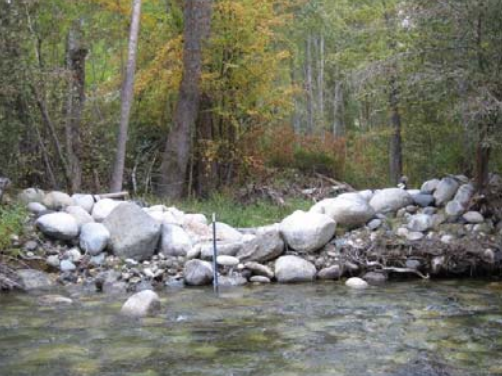
<p>View to the southeast in the downstream direction at a push-up levee near RM 6.4. The levee has been breached / lowered as part of an enhancement project (October 2009).</p>

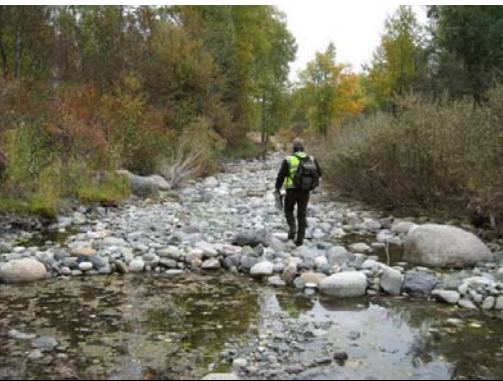
<p>View to the east in the downstream direction at a high-flow side-channel near RM 6.8 (October 2009).</p>

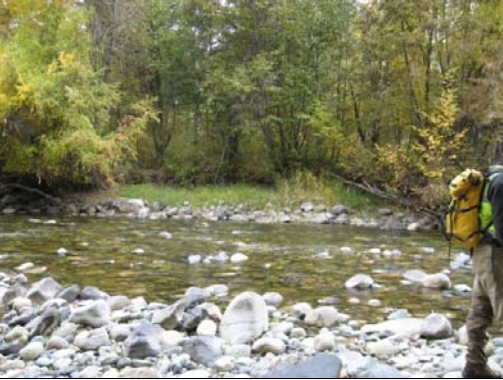
3c	Project RM 6.89R	Inner Zone 2 (IZ-2)	In-Stream Habitat Enhancement	LWD enhancement	There is another good location for LWD enhancement on river-left at RM 6.89. Construction of a meander-bend log jam would increase pool scour, cover, and habitat complexity.

<p>View to the north at river-left near RM 6.89 where LWD would enhance in-channel habitat (October 2009).</p>
3c	Project RM 6.95R	Inner Zone 2 (IZ-2)	In-Stream Habitat Enhancement	LWD enhancement	This project opportunity involves placement of LWD along the margins of an existing bedrock pool to increase habitat cover and complexity.

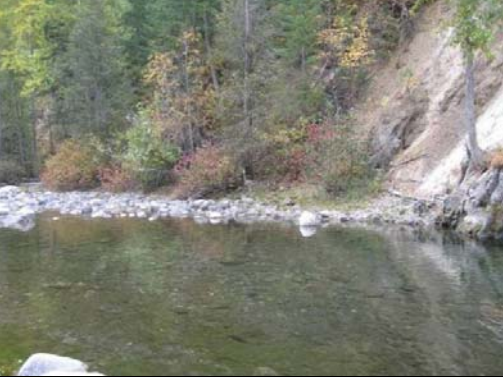
<p>View to the southeast in the downstream direction at a potential LWD placement location along river-right near RM 6.95 (October 2009).</p>

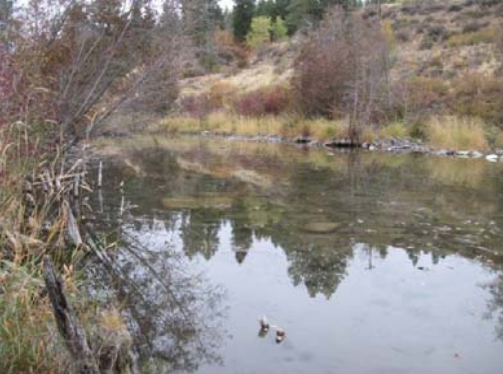
<p>Oxbow pond located near RM 7.15 that provides valuable, although largely disconnected, off-channel habitat (October 2009).</p>

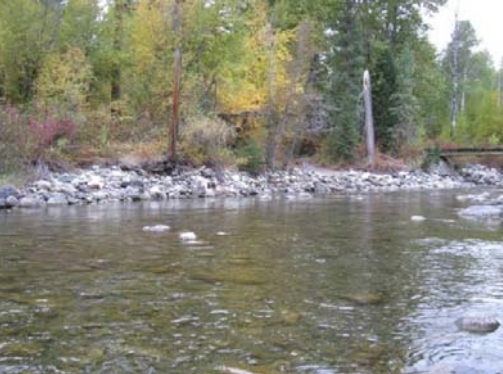
3c	Project RM 7.15R	Inner Zone 2 (IZ-2)	In-Stream Habitat Enhancement	LWD enhancement	This location is just downstream of the bridge crossing at RM 7.15. Installation of LWD would enhance cover and habitat along the right bank. Currently, the bank is protected with riprap and large alluvial material. LWD would increase pool scour, cover, and habitat complexity.

<p>View to the west in the upstream direction at a potential LWD jam location along river-right near RM 7.15 (October 2009).</p>
3c	Project RM 7.3L	Disconnected Inner Zone 1 (DIZ-1)	Reconnect Stream Channel Processes	Levee removal	This project involves removing 150 ft of push-up levee that has been constructed out of local alluvium. The levee may provide some protection for the TVIP canal. The levee could be set-back to provide more direct protection to the canal while re-connecting inner zone processes.

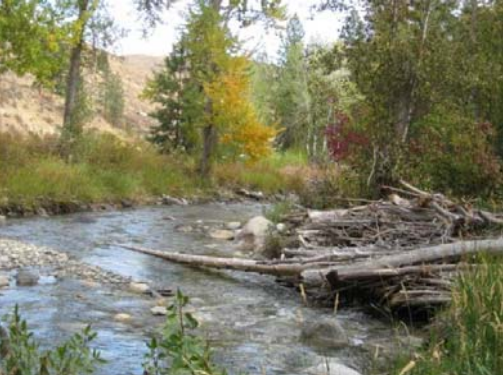
Reach	Project Number	Sub-Unit	Strategy Category	Project Name	Description	Photo
3c	Project RM 7.5L	Inner Zone 1 (IZ-1)	Reconnect Stream Channel Processes	Re-establish channel LWD dynamics	There are several LWD jams along the banks and at island apexes near RM 7.5 in the north split-channel. This project would enhance existing and create new jams to enhance active channel dynamics including split-flow and pool scour.

<p>View the east in the downstream direction near RM 7.5 (October 2009).</p>
3c	Project RM 7.5R	Inner Zone 1 (IZ-1)	In-Stream Habitat Enhancement	LWD enhancement	This project involves constructing a LWD jam along the right bank of the south split-channel near RM 7.5. The location is in a backwater just upstream of a riffle crest where the grade breaks and steepens. LWD would provide cover in the pool and increase local habitat complexity.

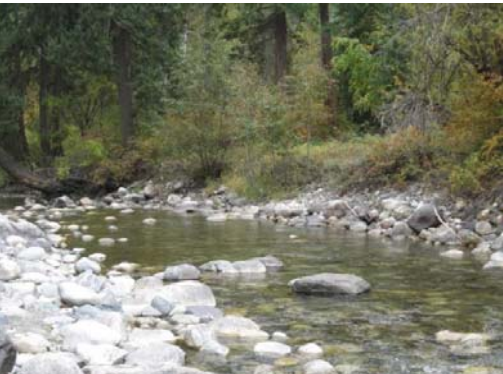
<p>View to the east in the downstream direction at a potential LWD jam location along river-right near RM 7.5 (October 2009).</p>

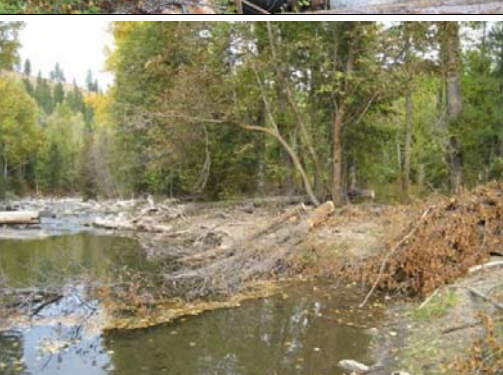
<p>View to the northeast in the downstream direction at a potential LWD structure location along river-right near RM 7.7 (October 2009).</p>
