UPPER CHEWUCH HABITAT ASSESSMENT

Habitat Conditions and Restoration Opportunities on the Upper Chewuch River,
Boulder Creek, Twentymile Creek, Lake Creek, and Andrews Creek

**Yakama
Nation
Fisheries**

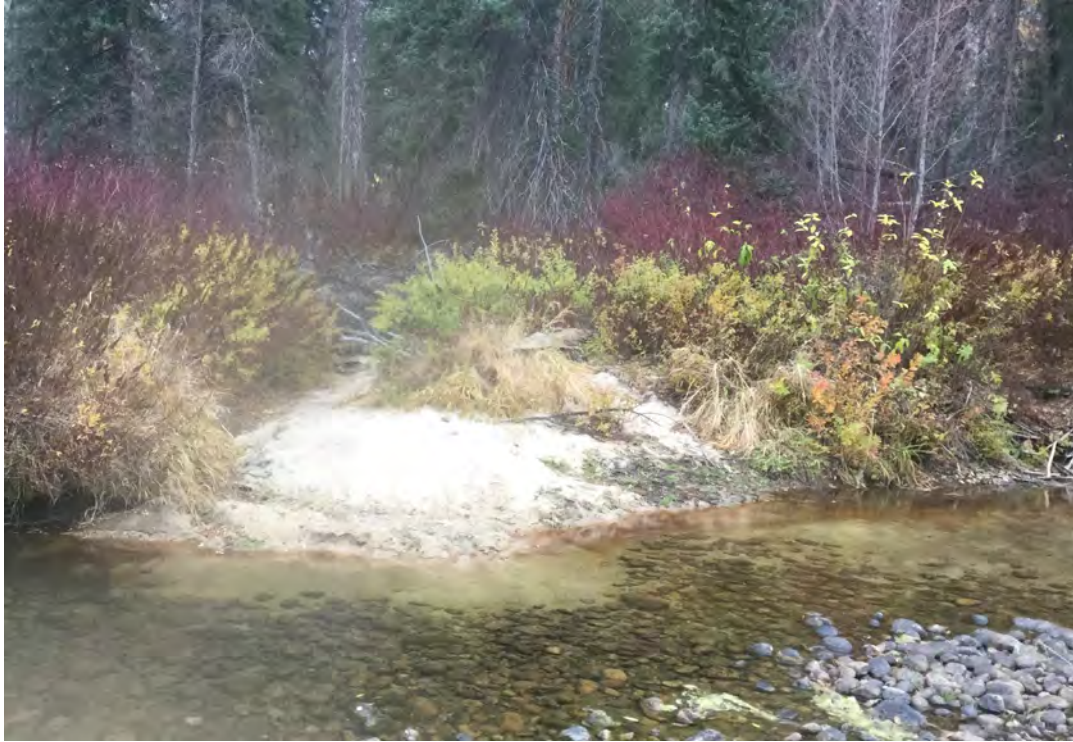
Two gravel and sand pits were identified in the upper Chewuch, the Bud Creek, and an unnamed pit on the alluvial fan of July Creek on the eastern side of the Chewuch valley. The Bud Creek Pit is located to the east of the Bud Creek confluence with Falls Creek (USGS 2018a). The unnamed gravel pit first appears on historic air photos in 1975, however is currently not in use. Sometime between 2011 and 2013 July Creek avulsed across the alluvial fan toward the north, flowing through the abandoned parking and material staging area associated with the pit. Prior to the avulsion July Creek flowed directly into the Chewuch River near RM 20.2, following the avulsion the creek now flows into the No Snake Side Channel near RM 21.1. At the confluence with the No Snake Side Channel there is a significant deposit of sand contributing fines to the side channel complex (Figure 7).

Figure 7. Confluence of July Creek with the No Snake Side Channel (foreground), with significant amount of sand entering the side channel from July Creek.

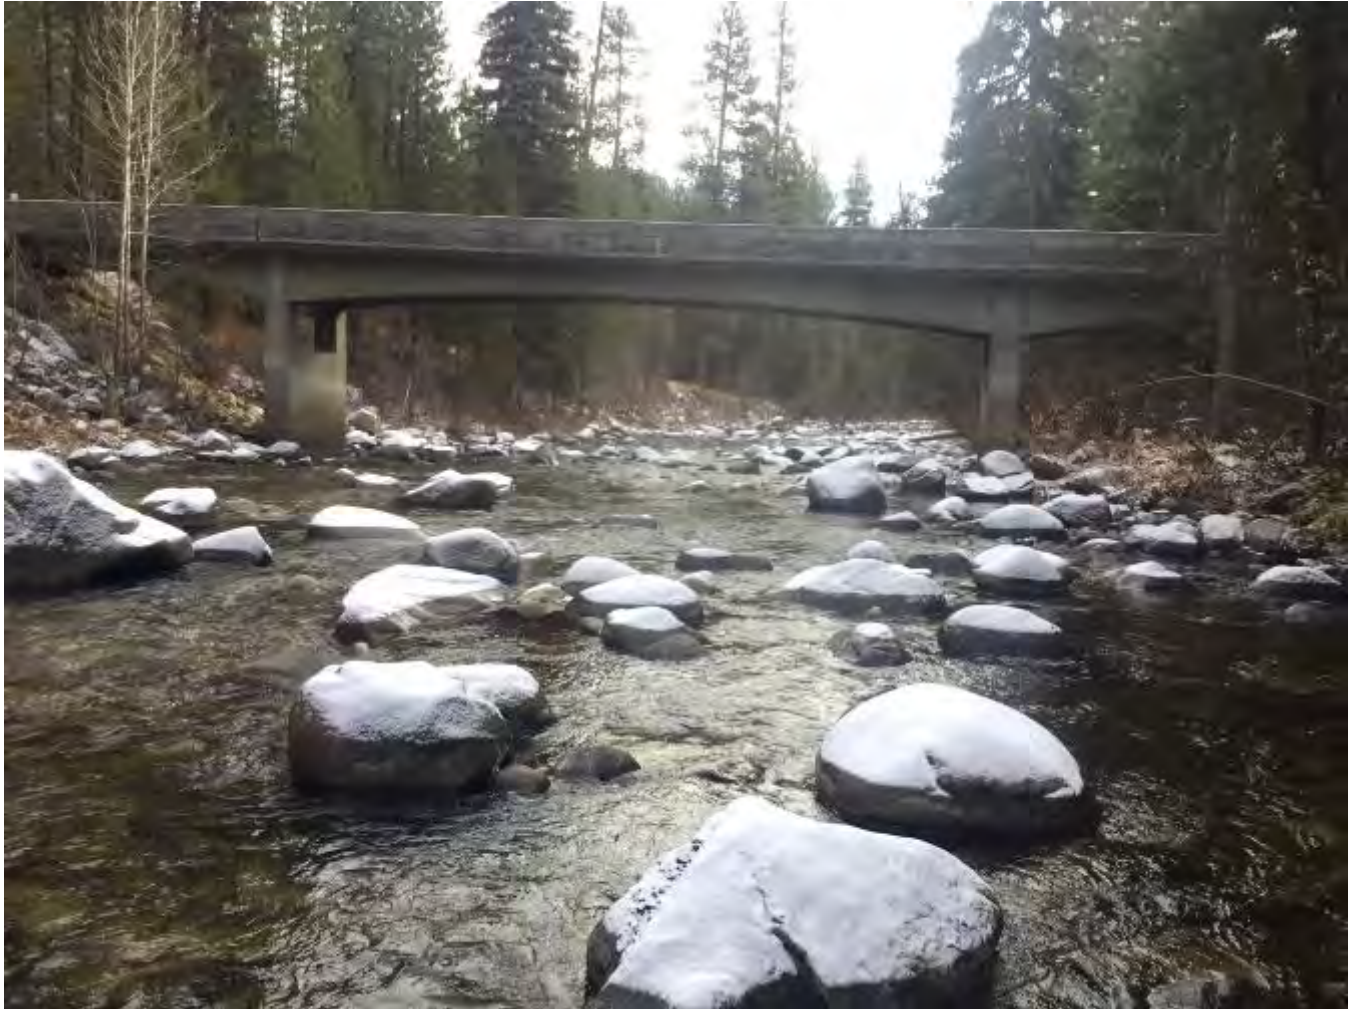
Figure 9. Bridge over the Chewuch River at RM 20.4.

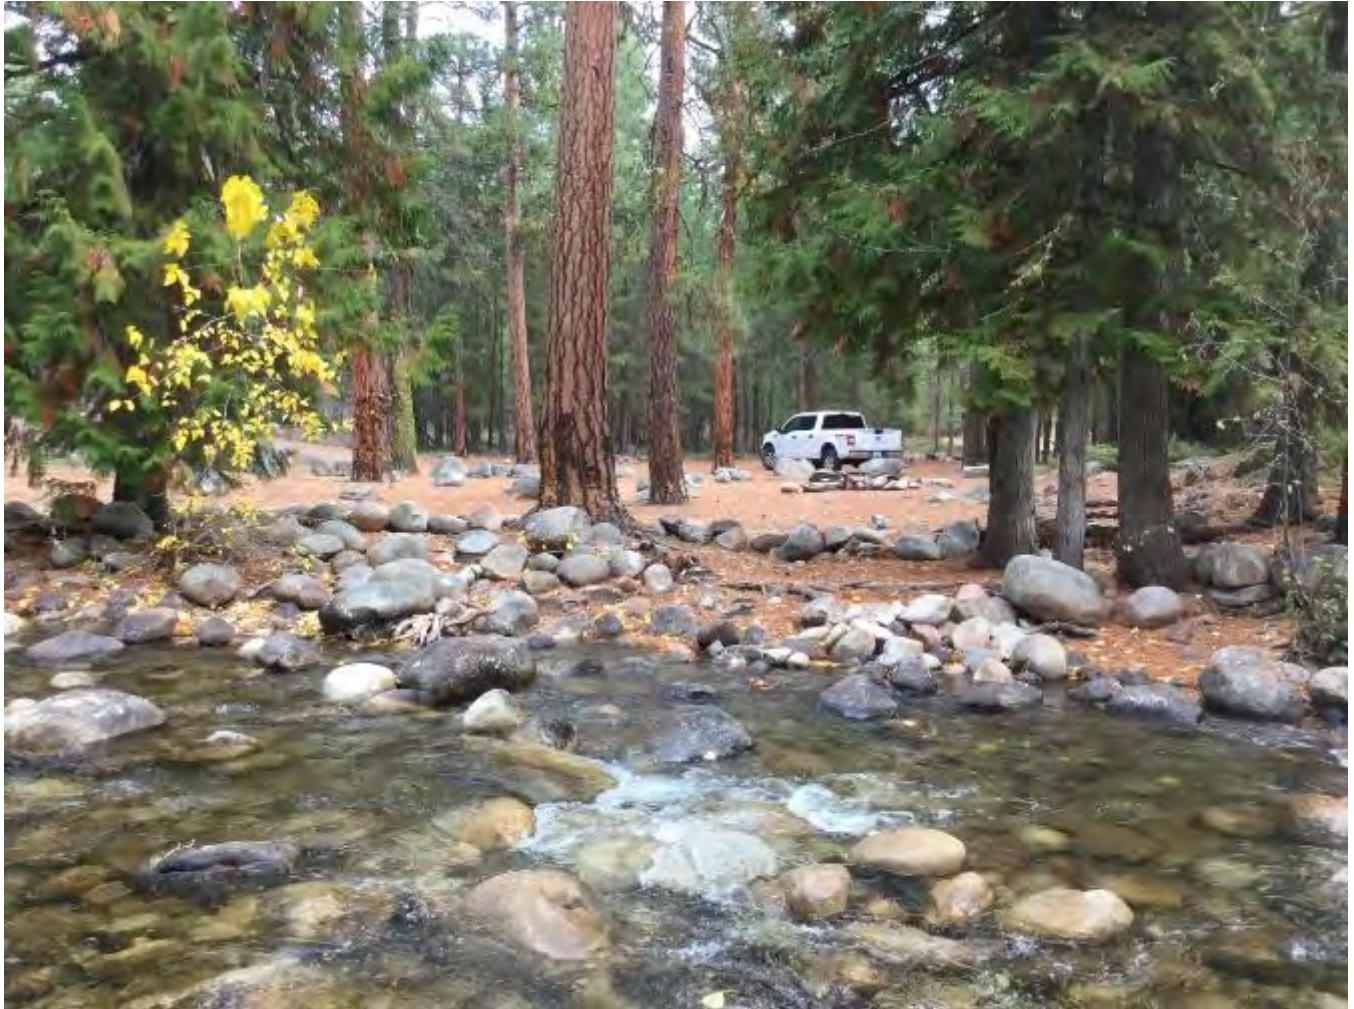
Figure 10. There are many drive-up dispersed campgrounds on USFS land in the upper Chewuch drainage, like this example on lower Lake Creek.

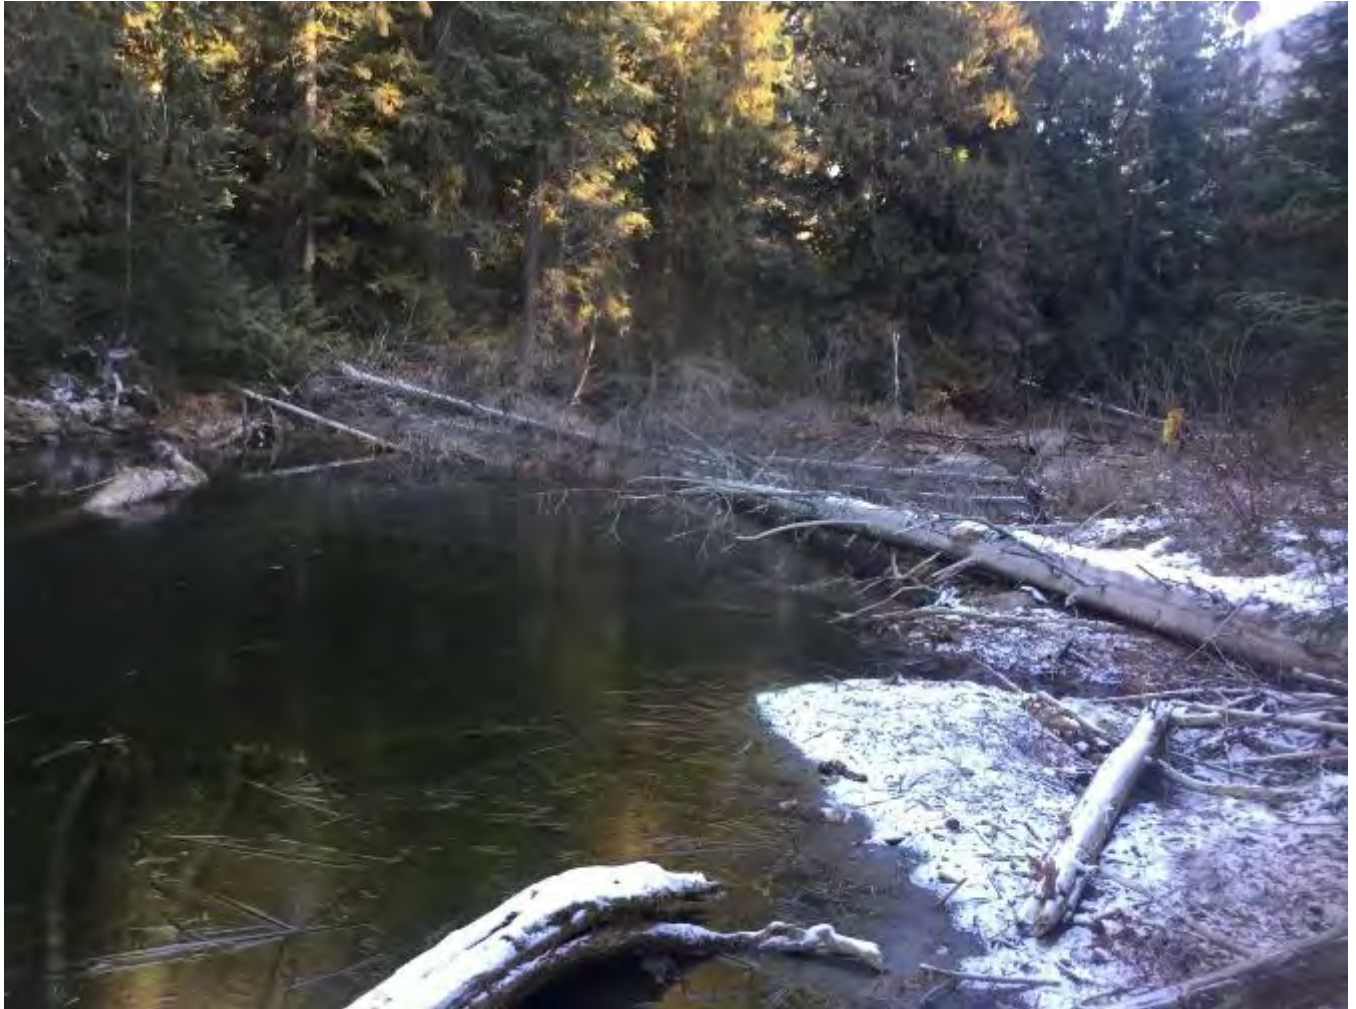
Figure 26. Several large beaver dams and associated ponds were present in the No Snake Side Channel complex.

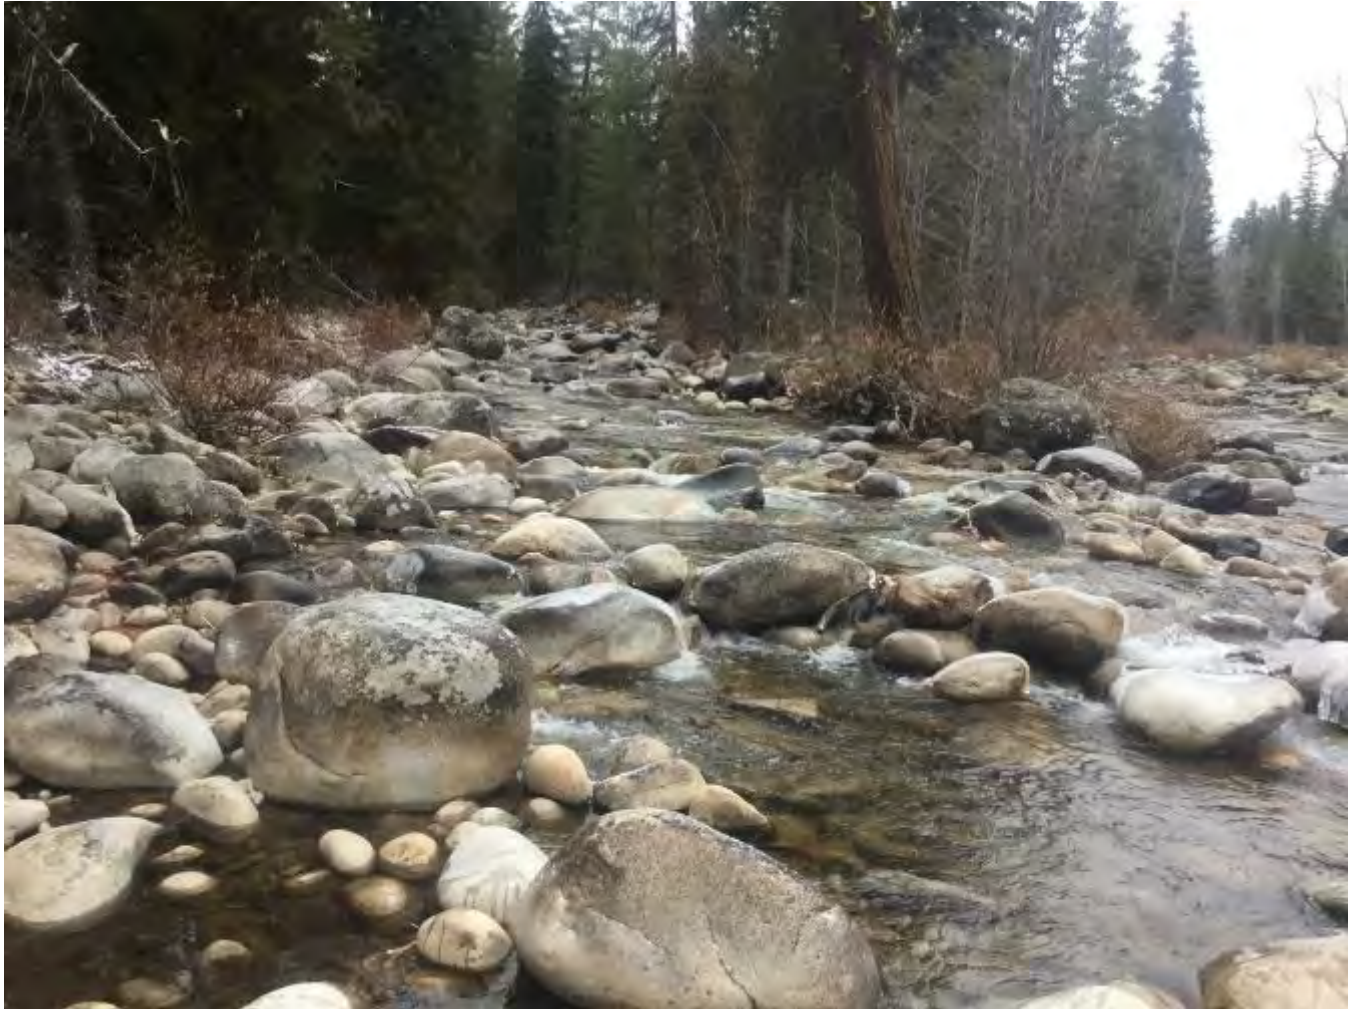
Figure 31. Wetted side channel area in Reach C11.

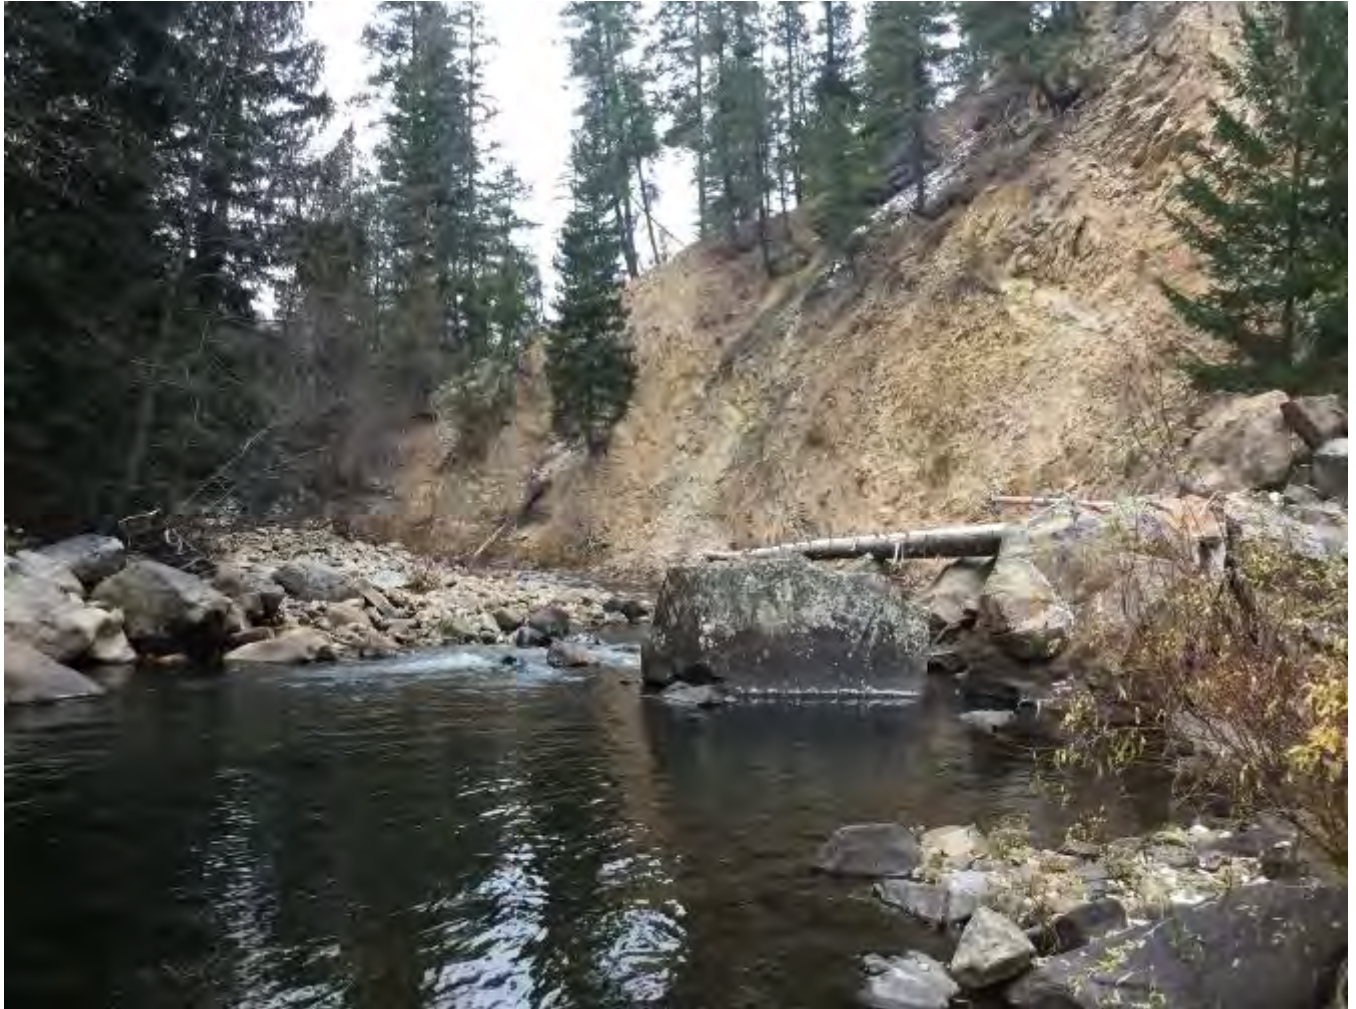
Reach C12 has the lowest measured active bank erosion (6.2% of streambanks eroding), with sites occurring on the outside of meander bends as the channel flows around the Lake Creek alluvial fan (Table 8). The lack of active bank erosion is attributed to the high confinement of the channel (Figure 34), and lack of space for channel migration processes to occur. There is an actively eroding section of highly fractured bedrock in the gorge section of the reach near RM 24.4, recruiting a number of large boulders to the river.

Figure 34. The Chewuch River confined by steep hillslopes in Reach C12.

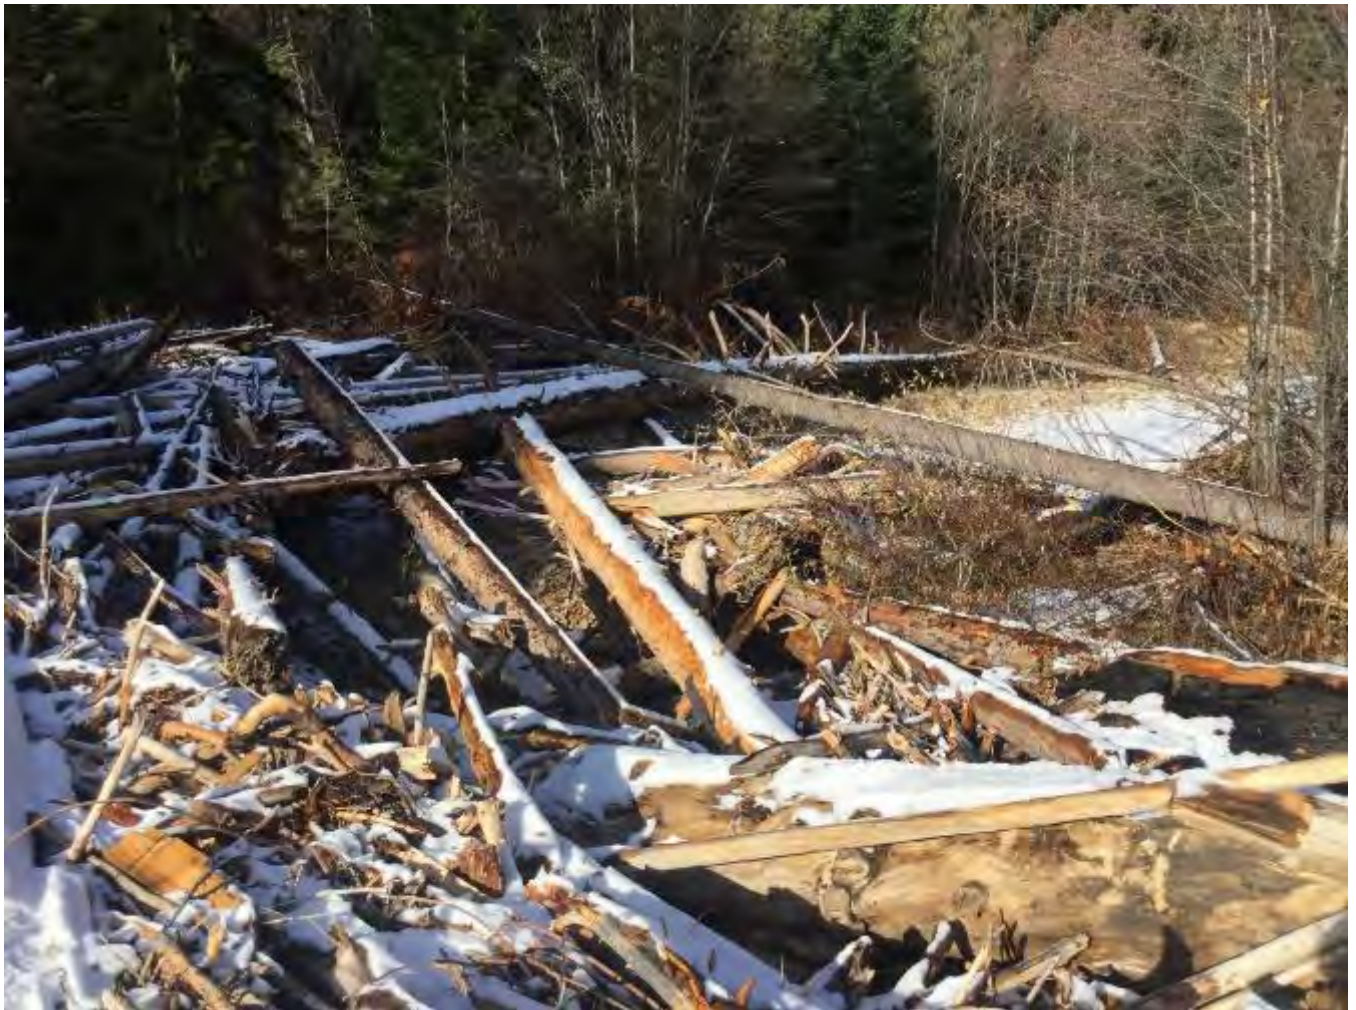
Reach C13 had the highest wood loading of all the reaches assessed, with more than double the number of pieces relative to the project reach averages. Small wood dominates the distribution of wood sizes (66% of all pieces), with 240 pieces/mile throughout the reach (Figure 36). Individual large wood pieces and logjams are found primarily in the unconfined sections of the reach between the alluvial fans. There was more than double the amount of large size class wood measured in reach C13 (12.9 pieces/mile) relative to the other reaches assessed (Table 10). The abundance of large wood in the reach is attributed to the recent fire that burned a significant portion of the left bank floodplain between RM 25.7 – 25.1. There are numerous down trees on the floodplain and side channels where the fires occurred, readily available for transport during high flow events. Much of the large wood observed in the reach is within and downstream of the burn area, indicating transport of this material has been initiated.

Figure 36. Abundant large wood resources in a Reach C13 side channel.

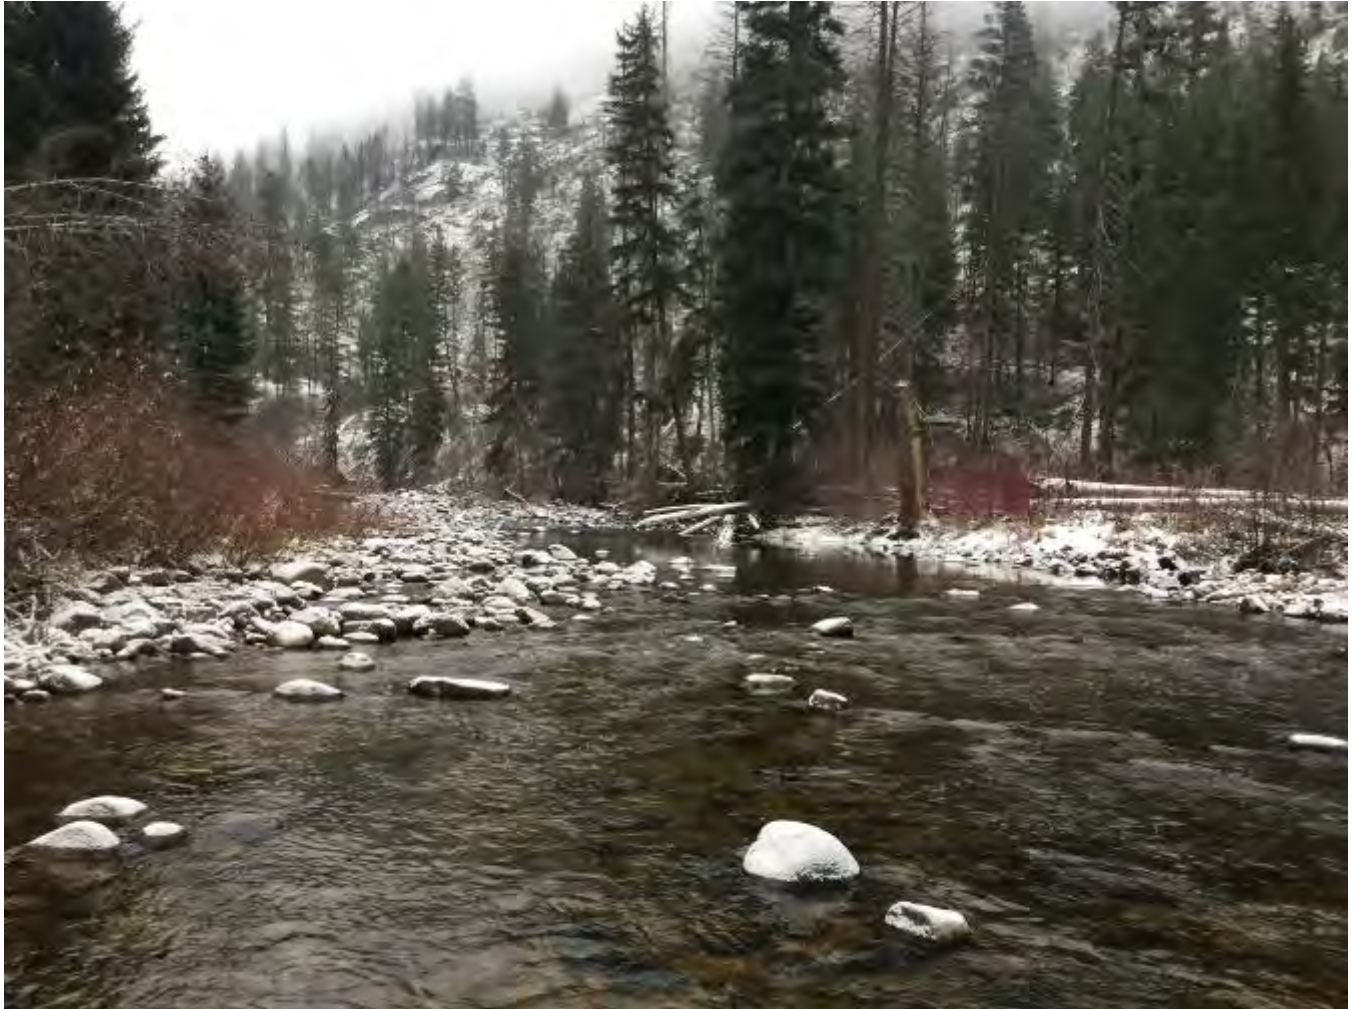
Figure 37. Reach C13 showing higher diversity of substrate than other reaches.

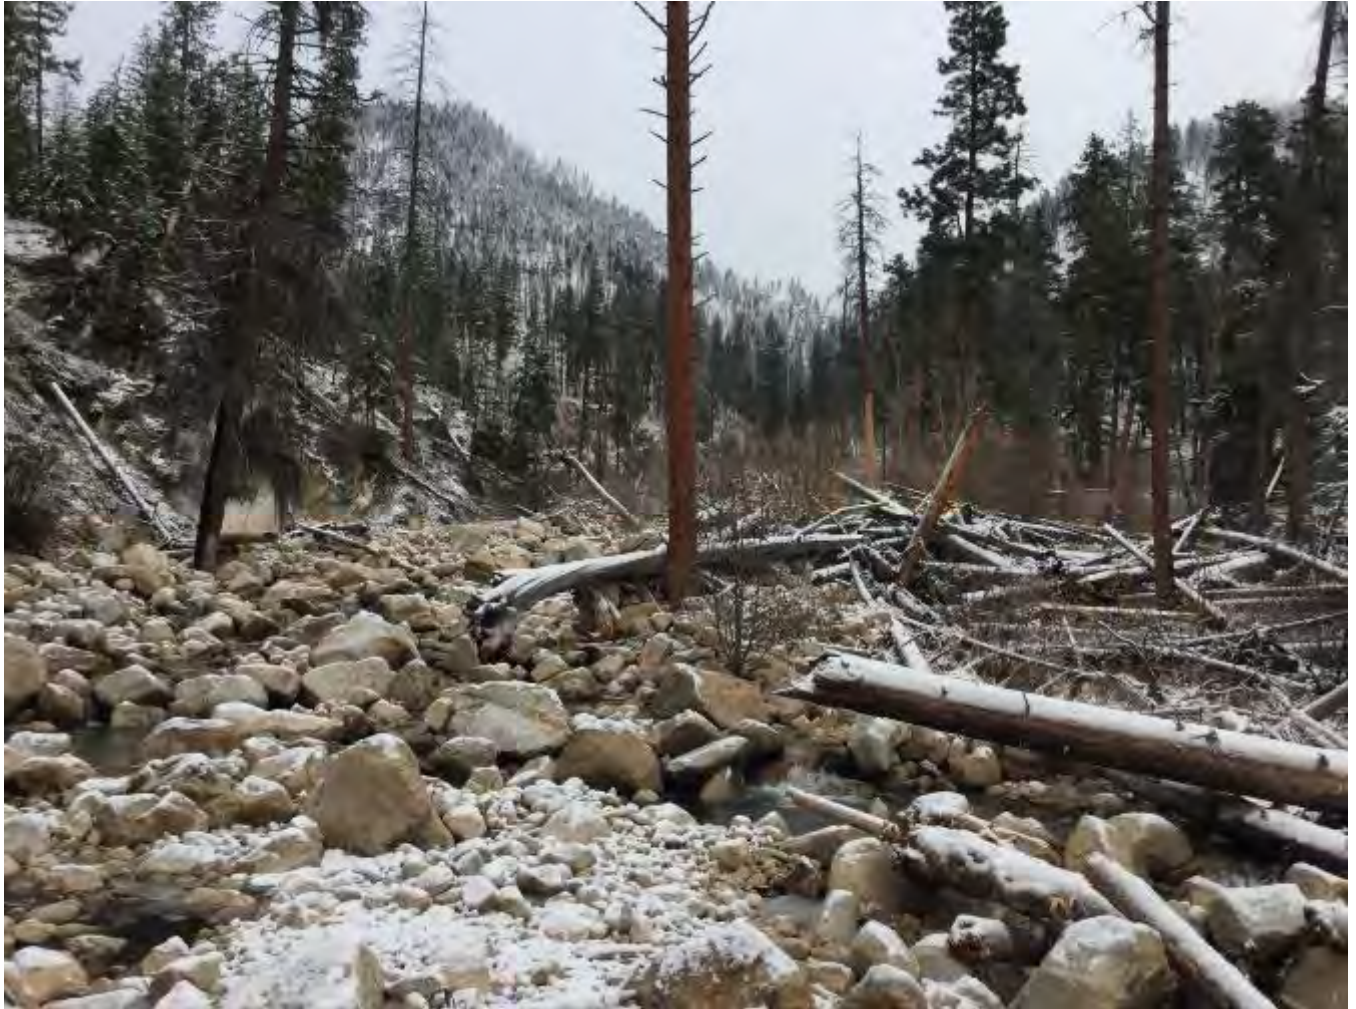
The channel substrate is characterized as boulder and cobble, with an average D50 of 171.5 mm. Samples were measured in the channel both up and downstream of the Little Andrews Creek confluence near RM 0.3. Grain size distribution shows boulders comprise 50.3% of the channel substrate (Table 11, Figure 40). Recent fires in the upper Andrews Creek drainage have likely increased short-term sediment supply to the channel, contributing more fine sediment to the creek as hillslopes erode following the loss of forest cover. However, it does not appear that these finer sediments have migrated downstream to reach A1, or have all been transported through.

Figure 40. Andrews Creek flows through an extremely steep alluvial fan with boulder-dominated substrate and ample large wood resources.

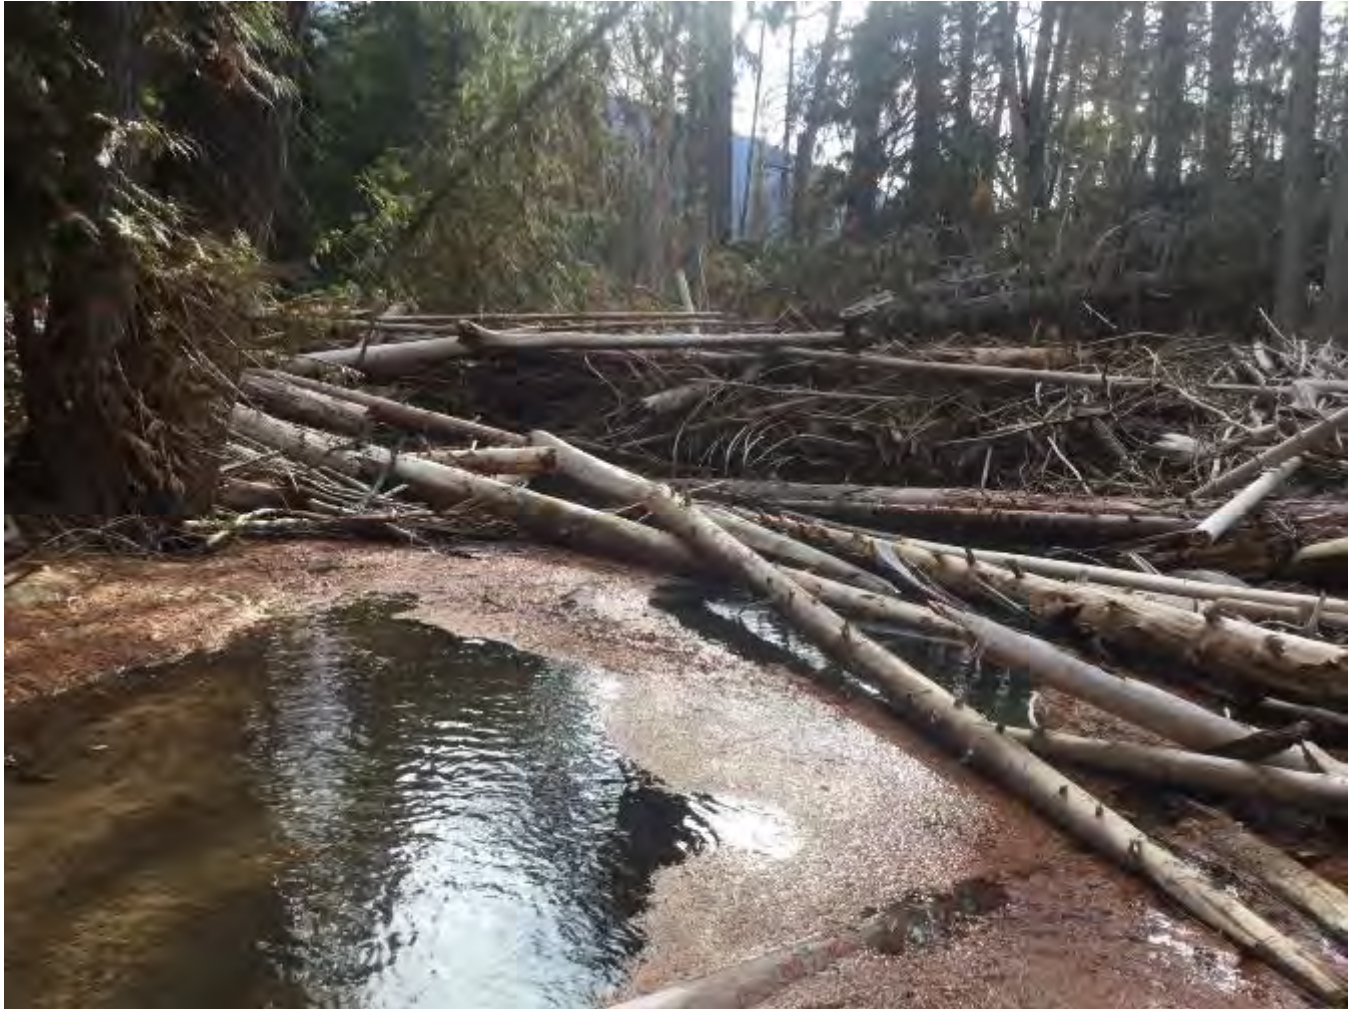
Wood loading was by far considerably higher in reach L2 than in any of the other reaches (tributary or Chewuch River) assessed. The majority of wood is small (66% of all wood) (Figure 45 and Figure 46). The remaining wood observed was primarily medium sized, occurring at 105.6 pieces/mile, and large wood pieces at 23.0 pieces/mile (Table 11). Qualifying wood for the REI analysis (>12 in diameter and >35 ft in length) occurs at 128.6 pieces/mile. The high wood loading is attributed to the recent fires in the upper end of the reach, bringing down numerous trees directly into the channel. Wood loading is greater above the channel constriction at RM 1.9 where the fires burned much of the floodplain forest, however logjams are evenly distributed throughout the reach. These logjams are very effective in trapping mobile wood moving downstream, as wood loading in the downstream L2 reach is low. Minimal areas of erosion are in association with instream wood and logjam locations, as the channel is deflected as a result of the wood in the channel.

Figure 46. This channel-spanning jam in Reach L2 is trapping fine sediments and creating a large dam pool.

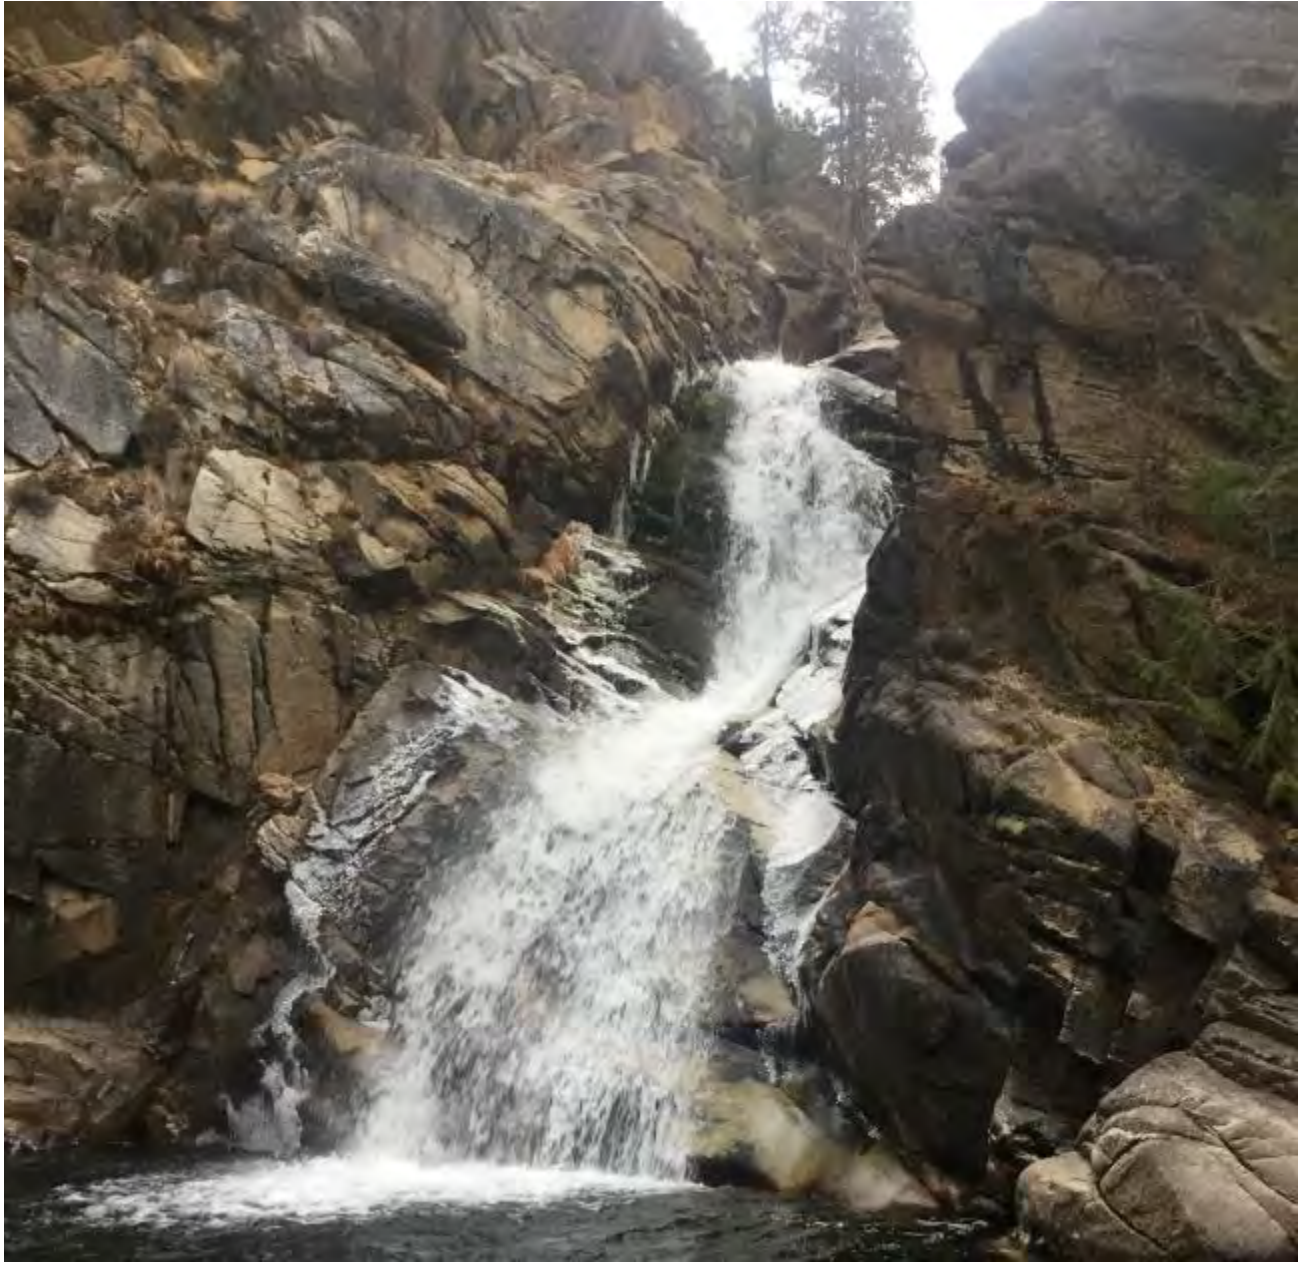
Reach T1 (Figure 47) extends from the mouth of Twentymile Creek to the 37-foot waterfall at RM 0.65 (Figure 48), which is the anadromous barrier. The reach flows through two distinct sections: a highly confined, moderately sinuous V-shaped valley in its upper 0.15 miles and a minimally-sinuous channel set in high gradient, highly active alluvial fan in its lower 0.5 miles. There are no tributary confluences within reach T1. There is also moderate human disturbance, most notably a concrete-lined ford for USFS Road 5010 just 350 feet above the mouth, that washed out partially in spring of 2018 (Figure 49). The ford is a partial barrier to anadromous fish migration. The USFS Road 700 grade runs along Twentymile Creek upstream of Reach T1. The main channel has at times been straightened and intentionally confined in the alluvial fan by a levee that runs along the creek in the lower reaches.

Figure 48. The falls on Twentymile Creek at RM 0.65 are a barrier to anadromous fish passage.

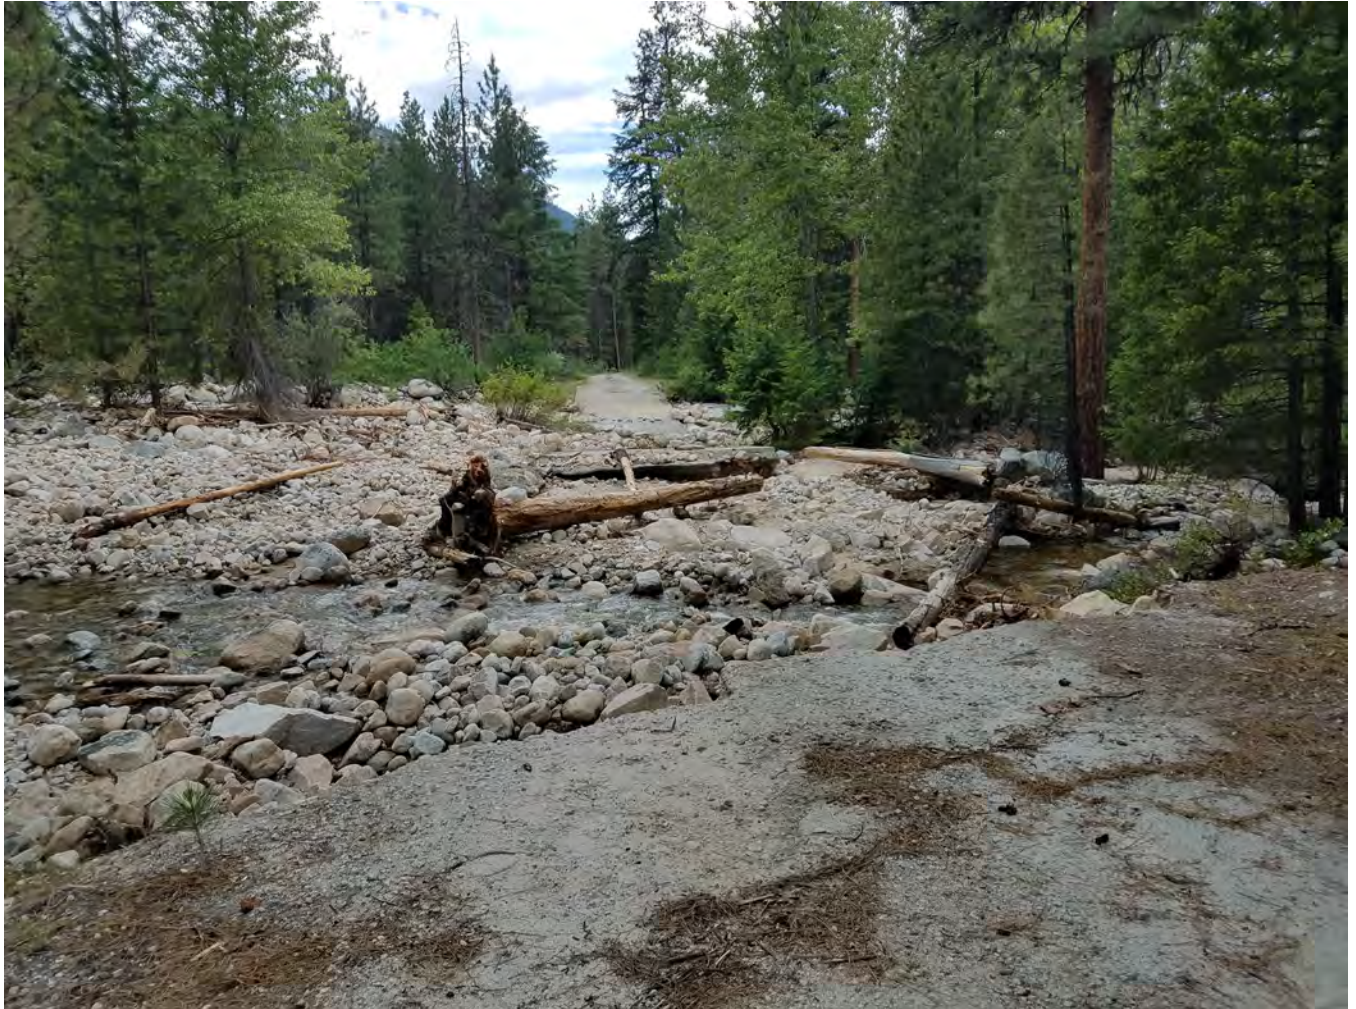
Figure 49. Partially washed out fish barrier on Twentymile Creek at the USFS Road 5010 ford (RM 0.1).

PROJECT LOCATION	NAME	POTENTIAL RESTORATION ACTIONS	DESCRIPTION AND RATIONALE	RANK	PHOTO/IMAGERY
RM 0-1.2	Project Area 11	<ul style="list-style-type: none"> ○ Replace or install roughened channel to provide fish passage ○ Remove remaining sections of levee, place material back in channel to restore grade and improve distributary channel connection ○ ELS's to deflect flow into distributary channels ○ Excavations to enhance distributary connection; place material back in main channel to restore grade 	<ul style="list-style-type: none"> ○ The lower sections of Twentymile Creek are affected by levees that confine the channel and prevent connection to the alluvial fan. ○ Reconnection with the alluvial fan will increase channel length and provide additional off-channel habitat for juvenile rearing 	High

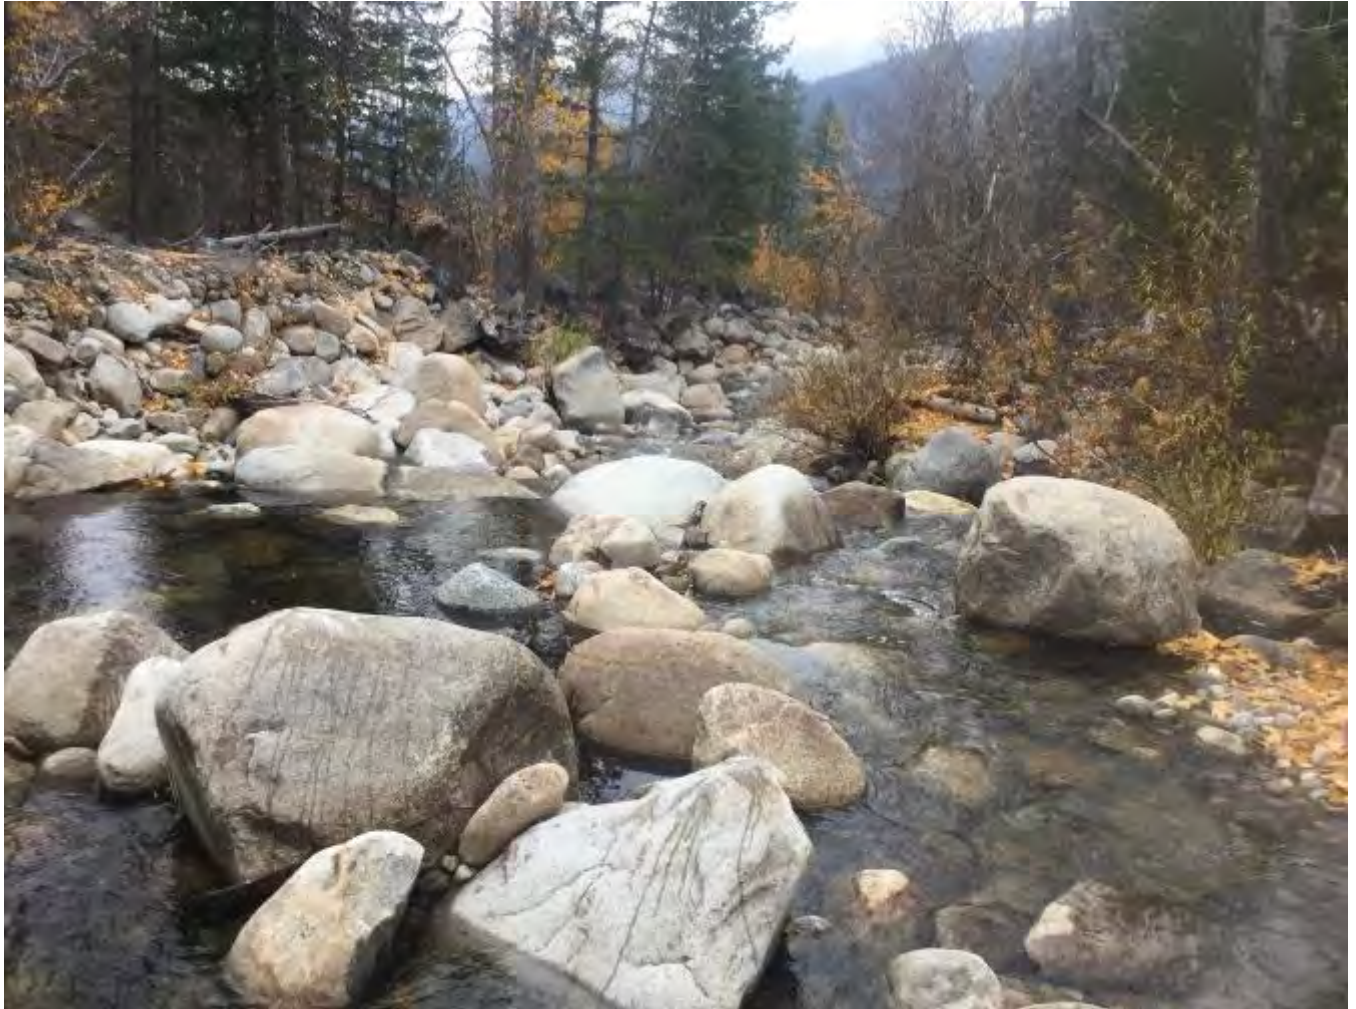
Reach T1 on Twentymile Creek is comprised of two distinct geomorphic terrains; a narrow bedrock canyon upstream and an alluvial fan at the downstream end. The transition between these landscapes occurs approximately 0.5 miles upstream from the confluence with the Chewuch River, with $\frac{3}{4}$ of the reach within the alluvial fan. The upstream bedrock canyon section is bounded by steep outcrops of Cretaceous-Jurassic tonalite, terminating at the waterfall fish barrier at RM 0.65 mile (Figure 48). The channel upstream in the canyon is dominated by cascades and rapids with numerous bedrock-forced plunge pools. At the transition to the alluvial fan the channel is incised 8-10 feet, with levee features (large boulders) built up on either bank (Figure 50). Additionally, Twentymile Creek has been intentionally channelized through the alluvial fan in the past (NPCC 2004). Downstream on the fan there are multiple active side channels on the right bank floodplain (north of the channel), all of which could develop and capture the channel during a large flood event, or if the levee were removed.

Figure 50. Twentymile Creek flows through an extremely steep alluvial fan with boulder-dominated substrate. Note levee formation along left bank.

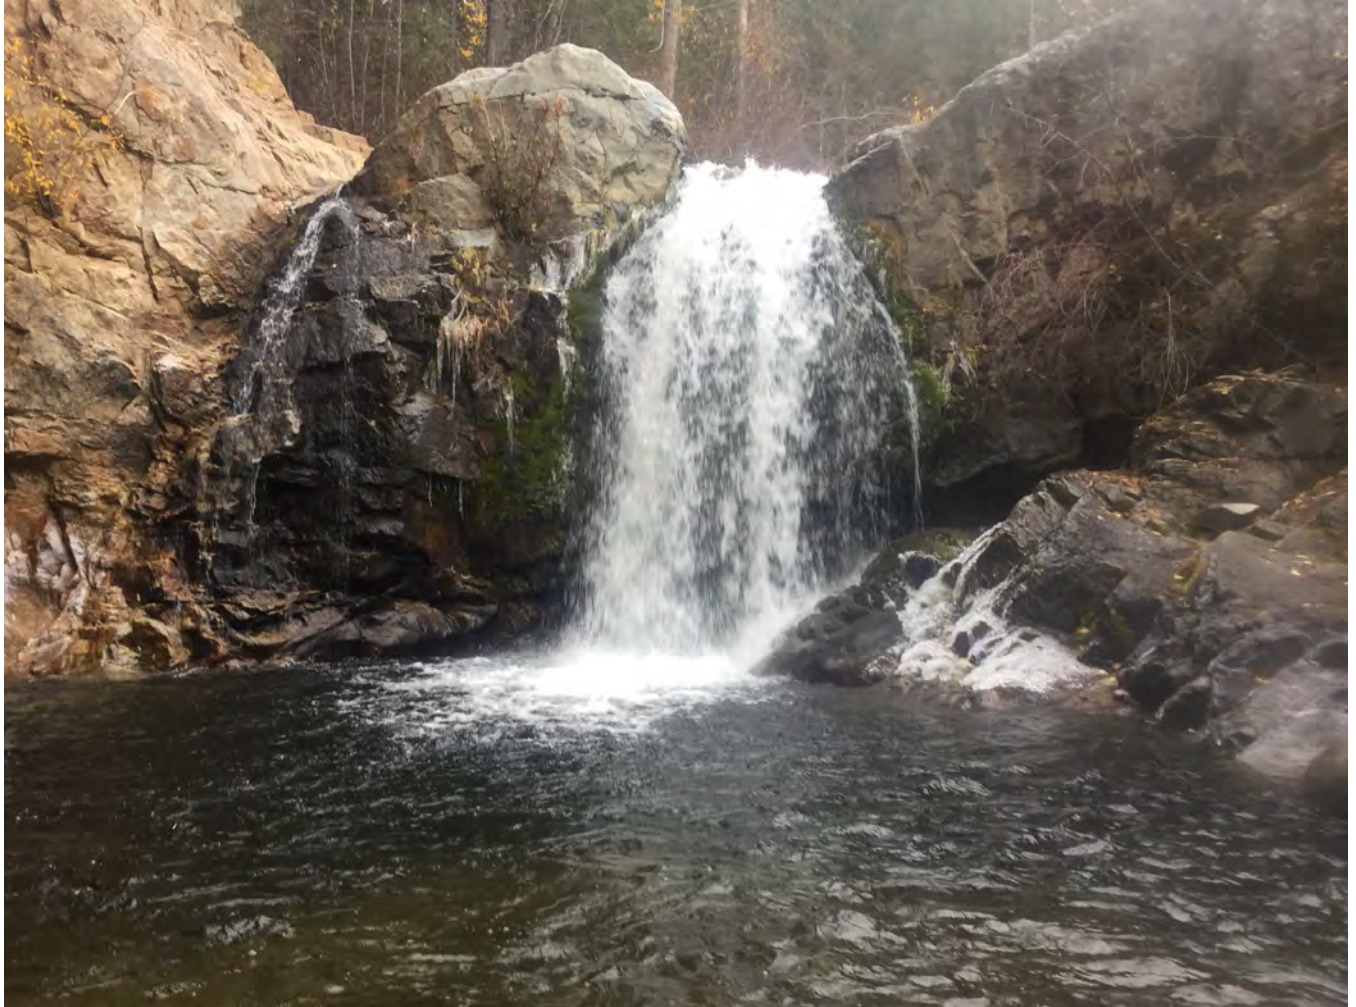
Reach B1, extends from the mouth of Boulder Creek to the waterfall at RM 1.05, which is the barrier to anadromous fish migration (Figure 51 and Figure 52). The reach flows through two distinct sections: a highly confined bedrock gorge in its upper half and a moderately incised channel set in a moderate gradient alluvial fan in its lower half. There are no tributary confluences within reach B1. The lower half of the reach has some human disturbance and a high potential for restoration. Anthropogenic features include several dispersed campsites on both sides of the river below RM 0.5 and the USFS Road 37 bridge across Boulder Creek. There are additional signs of heavy use in the lower section of the creek, including trash, old concrete, and graffiti.

Figure 51. Waterfall on Boulder Creek at RM 1.05, approximately 30 feet high, is a fish passage barrier.

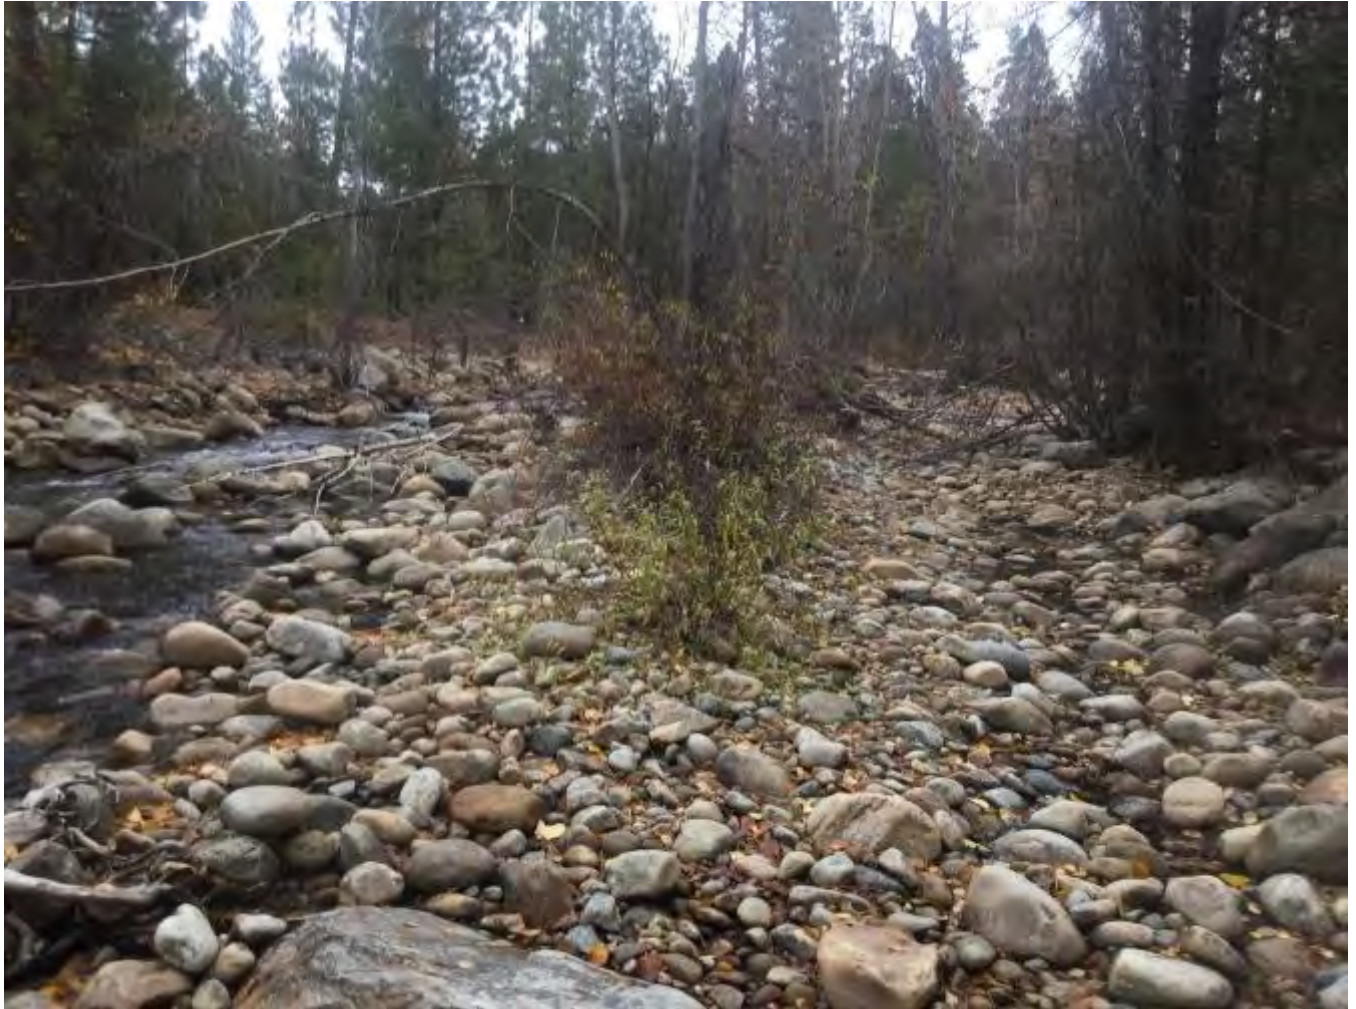
Figure 54. Boulder Creek main channel (left) and a partially wetted side channel (right) in the lower section of Reach B1 showing diversity of substrate.
