**FY2012 ANNUAL REPORT**  
MARCH 1, 2012 THROUGH FEBRUARY 28, 2013  
YAKAMA RESERVATION WATERSHEDS PROJECT  
*BPA Project #1996-035-01-Contract #35636*

### **A. Durham Irrigation Dam Removal & Roughened Channel**

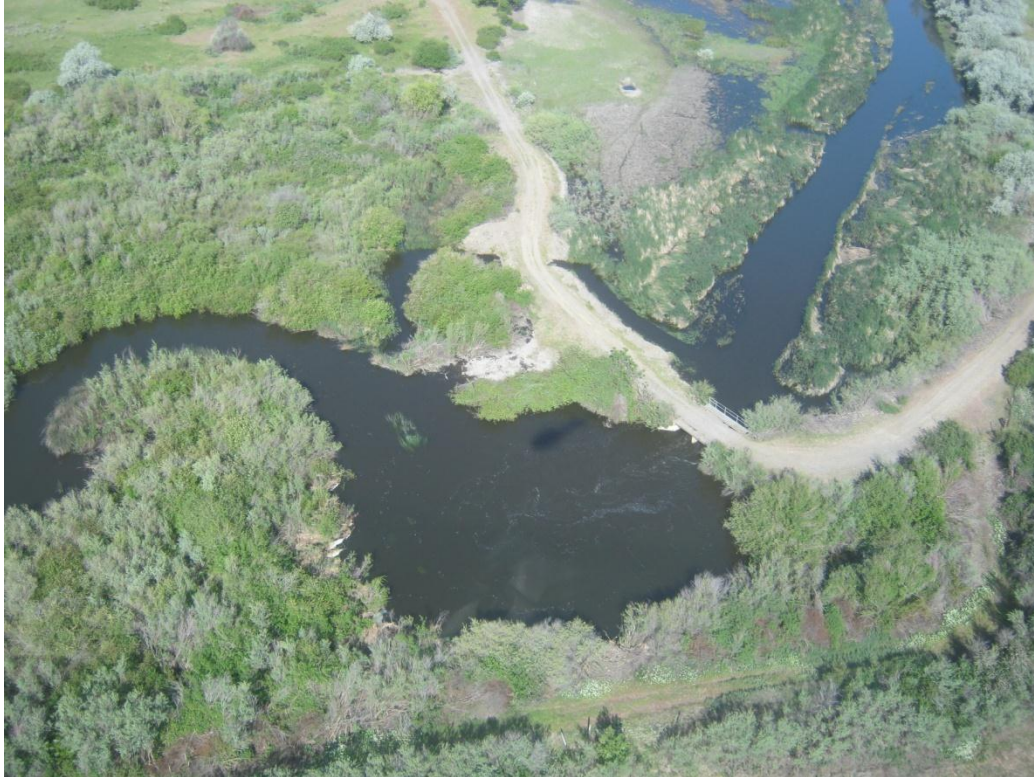
**Figure 1. Durham Irrigation Dam (May 2011): Scour pool to the left (downstream) of the dam.**

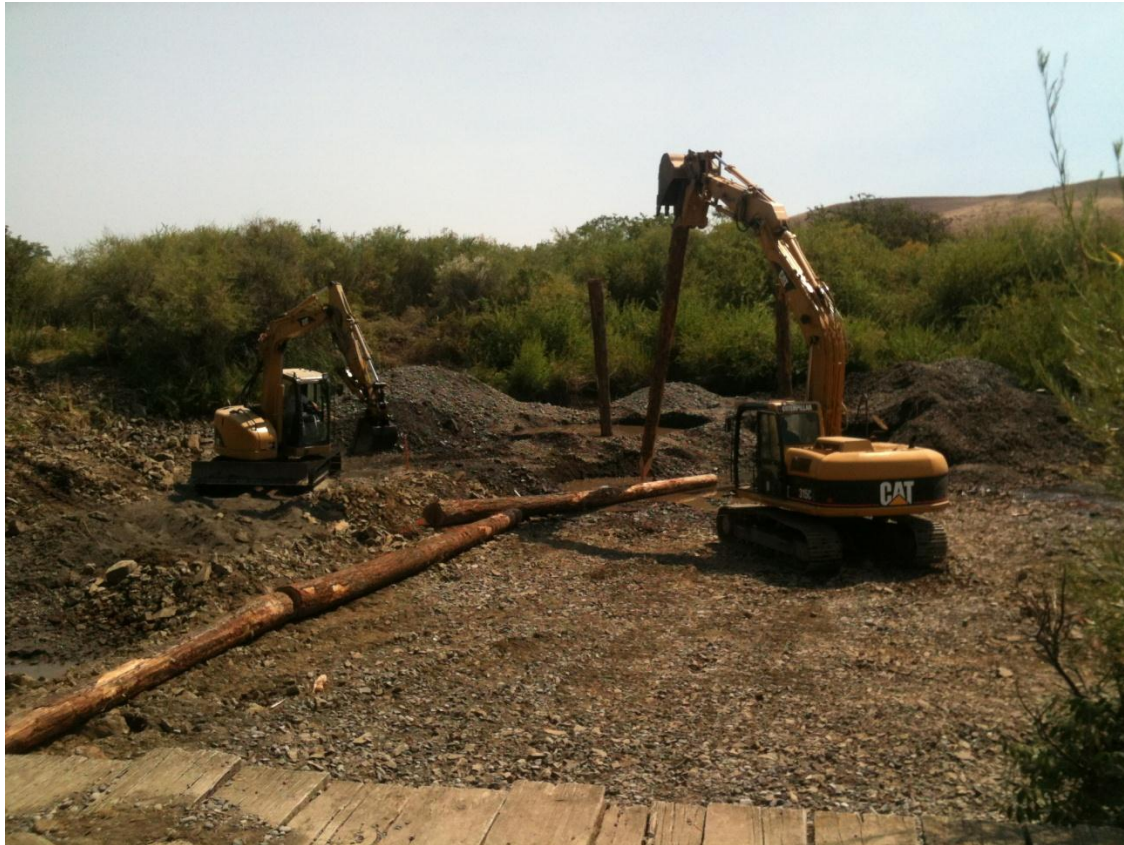
**Figure 3. Roughened channel complete upstream to the dam. Excavator to the right is ~14' higher in elevation than the elevation of the pre treatment channel elevation condition. The excavator to the left is positioned where the woody berm was constructed.**

A second, supporting coffer dam (earthen dam) was constructed adjacent /upstream of lower bulk bag coffer dam to prevent water from backing into the site. Approximately 1000 cubic yards of rock was added to the scour pool to bring the pool up to sub-grade. The roughened channel was completed within the isolated instream work area using a rock composition mixture prescribed in the engineer plans and the fines remaining after rock placement were rinsed into the rock interstices (See Figure 3). Work then began on the berm/island. Pilings on opposing sides of berm were installed and two layers of root balls added.

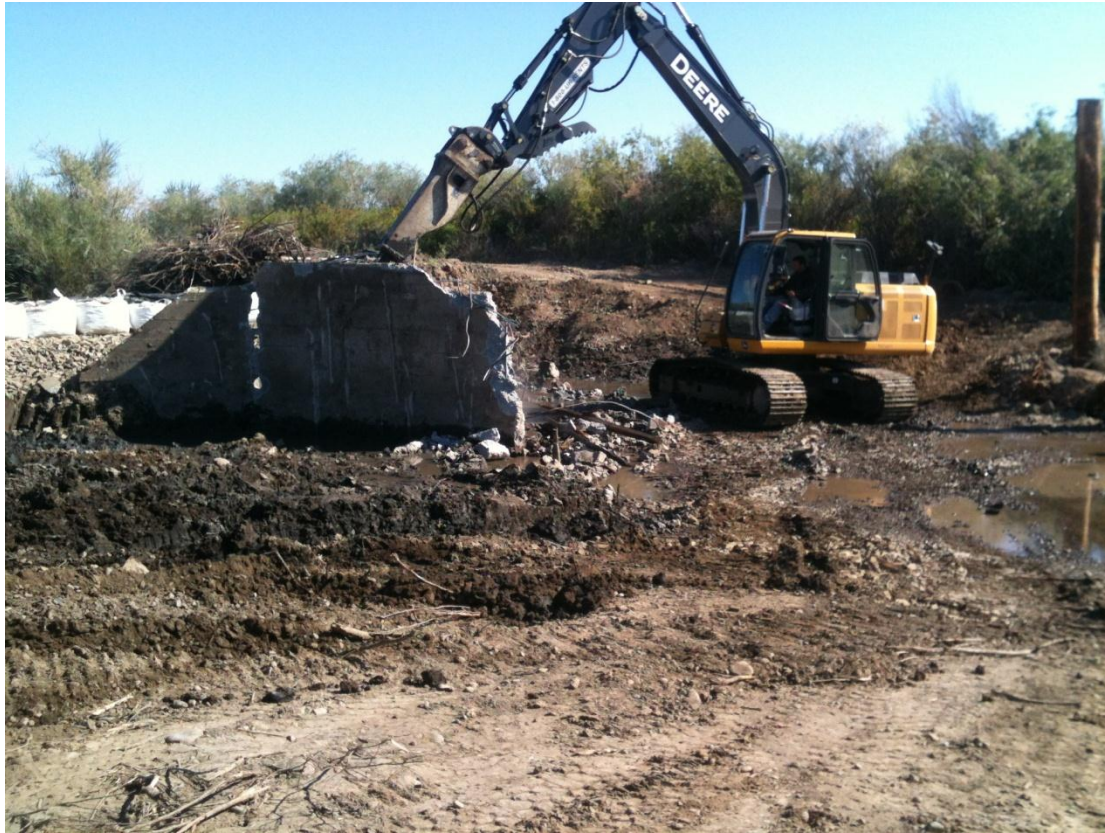
**Figure 4. Dam removal.**

As work within the isolated instream work area was completed, efforts began to remove the dam itself. Since the dam was used to coffer the upstream extent of the site and it was to be removed, another coffer dam needed to be installed just upstream of the dam (~10'). Prior to this installation, the seine was used to remove aquatic species from that area using the same method described for the larger site downstream of the dam. The upstream coffer dam was installed and the check boards were removed from the dam. Excavation then began on dam wing walls. Finally, the dam was removed completely and the roughened channel completed (Figure 4). Unanticipated infrastructure located beneath the dam slab caused more work than anticipated for removing dam and extending the roughened channel upstream through the work area. Grading of descent and ascent of approaches to ford (replacing dam stream crossing) were constructed. Encapsulated soil lift (ESL) construction ensued- fabric, fill, and seeding, staking non woven erosion control fabric. When the fabric staking was complete, the area around the former dam was re-contoured to match existing grade, and the dewater channel was filled. Throughout

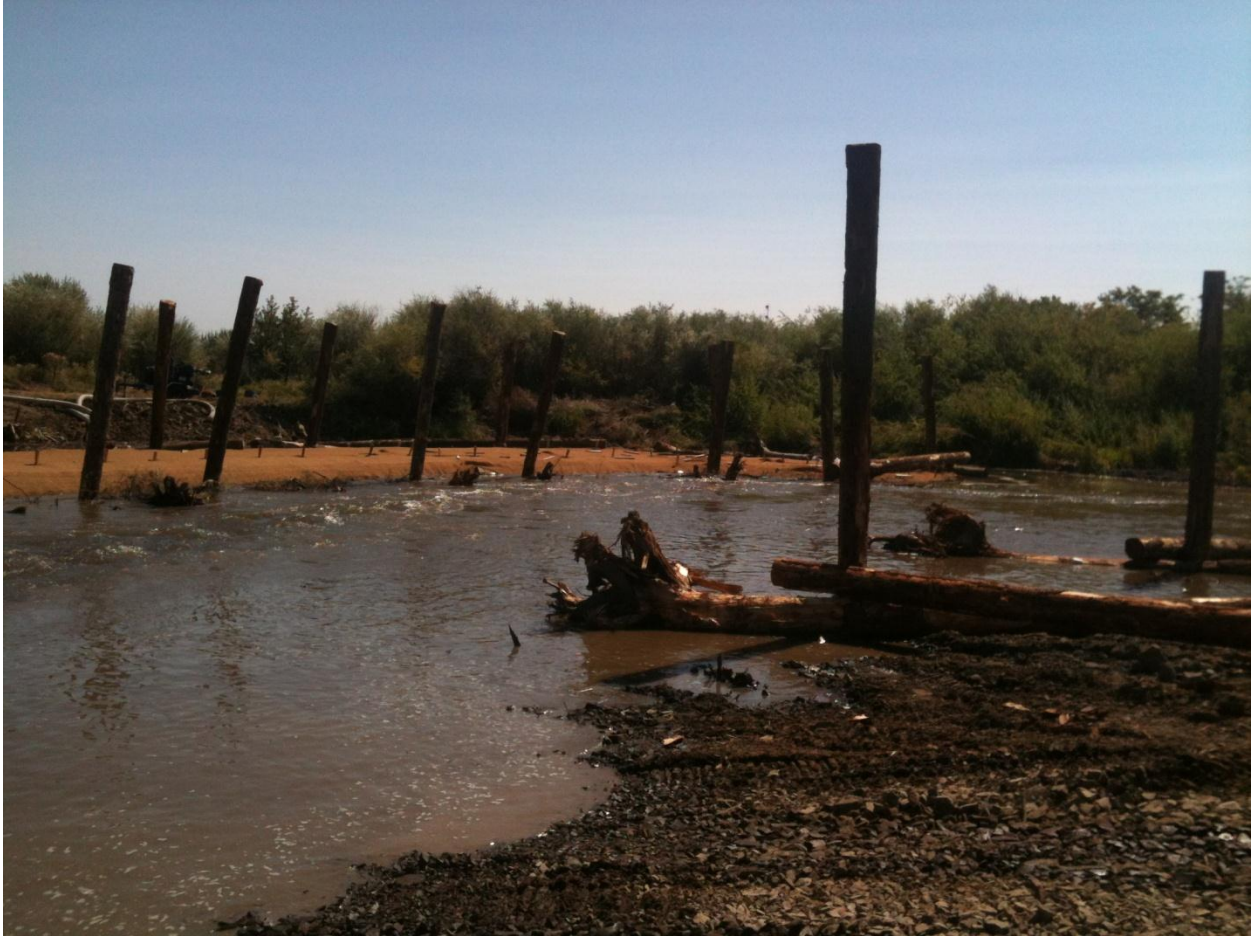
**Figure 5. Site response following final coffer dam removal.**

When the upper coffer dam was removed, the flows inundating the site were comparable to a 2 year flood event and the various components of the project responded as they were designed to do (Figure 5). The ford that was installed in place of the dam is usable at most flow elevations. The project stabilized the stream channel, provided unimpeded fish passage, and created fish refugia and forage areas. The revegetation efforts conducted by the YRWP staff appears to be responding as intended, but the success of the revegetation will be more apparent as the vegetation becomes established. The project was made possible in part by a partnership with the United States Fish & Wildlife Service National Fish Passage Program.

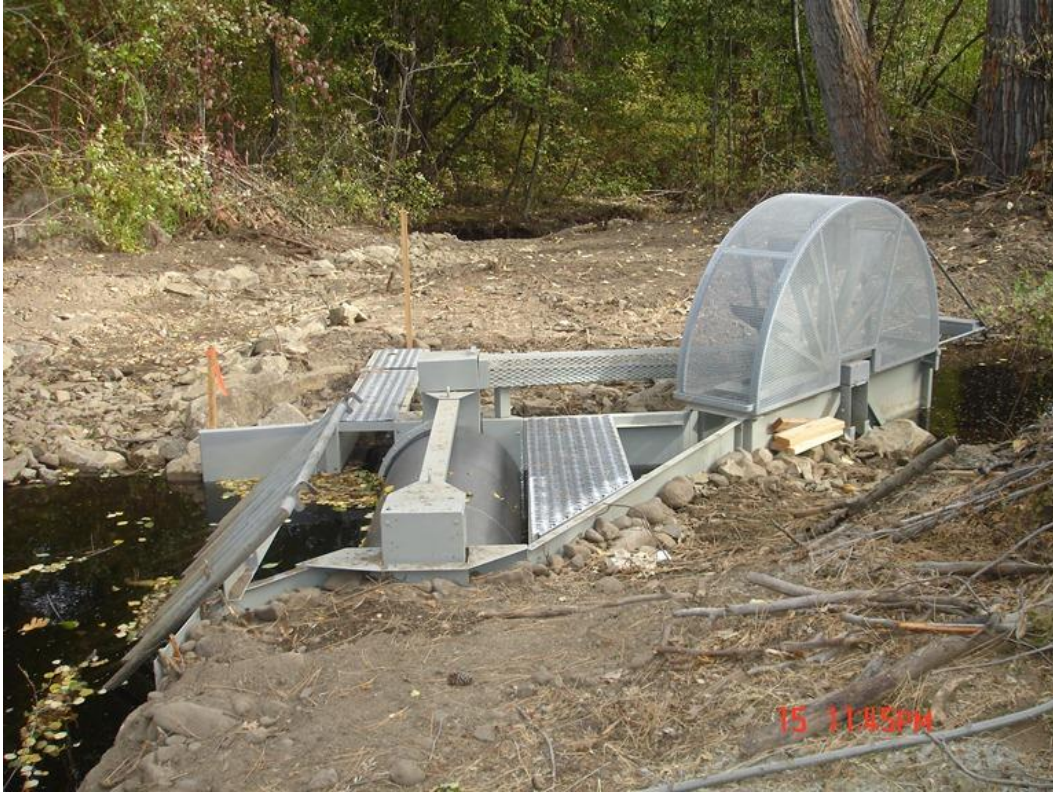
**Figure 9. Photo illustrating the South Fork Feeder Fish Screen post-installation**

YRWP completed the installation of a fish screen on an unscreened surface water diversion located on South Fork Simcoe Creek September 2012 (Figure 9). This project addresses a cumulative problem that is associated with the Yakima Subbasin Salmon Recovery Plan stating that unscreened diversions have significant negative effects on salmon productivity (2005). Spawning surveys conducted on South Fork Simcoe Creek during 2002 to present document the presence of ESA listed Middle Columbia River steelhead trout. The installed fish screen will prevent steelhead trout from using the diversion and becoming stranded during periods of high agricultural use or at low flows.

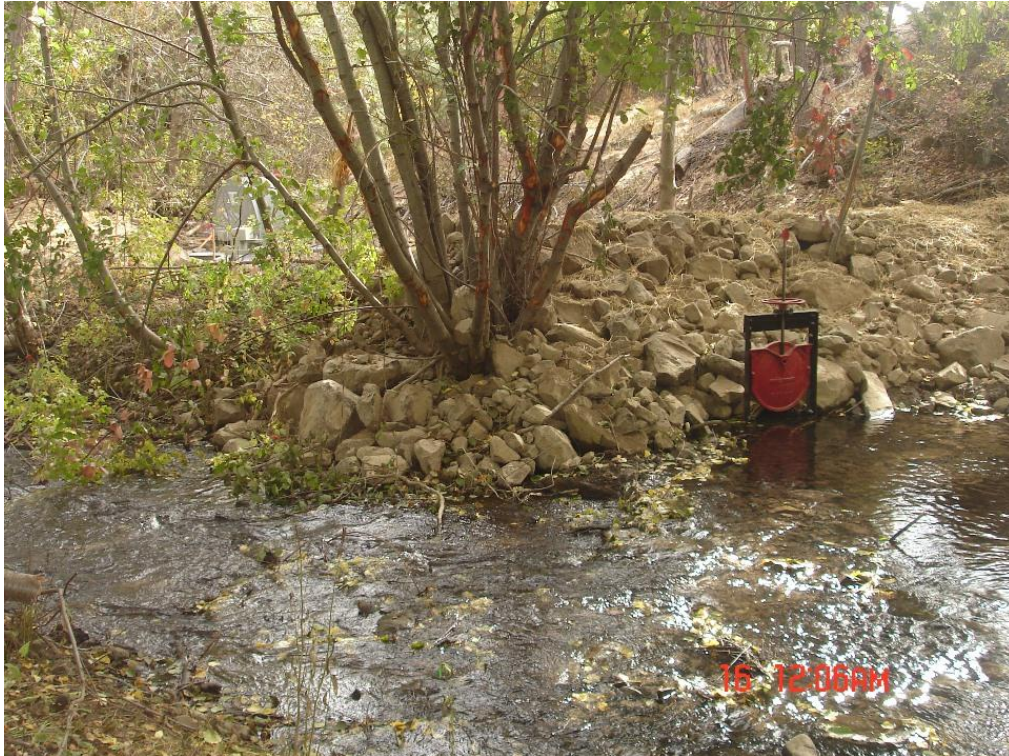
**Figure 10. Berm constructed over gated culvert. Note fish screen in background.**

The ditch was dewatered using a bulk bag coffer dam wrapped with polyethylene plastic sheeting (visqueen) and a dewatering pump at the upstream end of the site. The creek was funneled through a pipe placed in the main channel of the creek to create a temporary stream crossing for heavy equipment. Once the diversion was successfully dewatered, the ditch was excavated to subgrade in prep for the installation of the fish screen. A gated culvert and berm was also installed to restrict high flows from entering the canal during periods of high flow (Figure 10). The fish screen was delivered and installed by Washington Department of Fish and Wildlife (WDFW), Yakama Nation fisheries biologists, design engineer, and construction crew (Figure 11). An overflow channel to spill excessive flow upstream of the screen returning water to Simcoe Creek main channel and bi-pass pipe were also installed (Figure 12). WDFW returned for an inspection post-implementation to insure successful installation of the bypass pipe, berm, and operation of the fish screen.

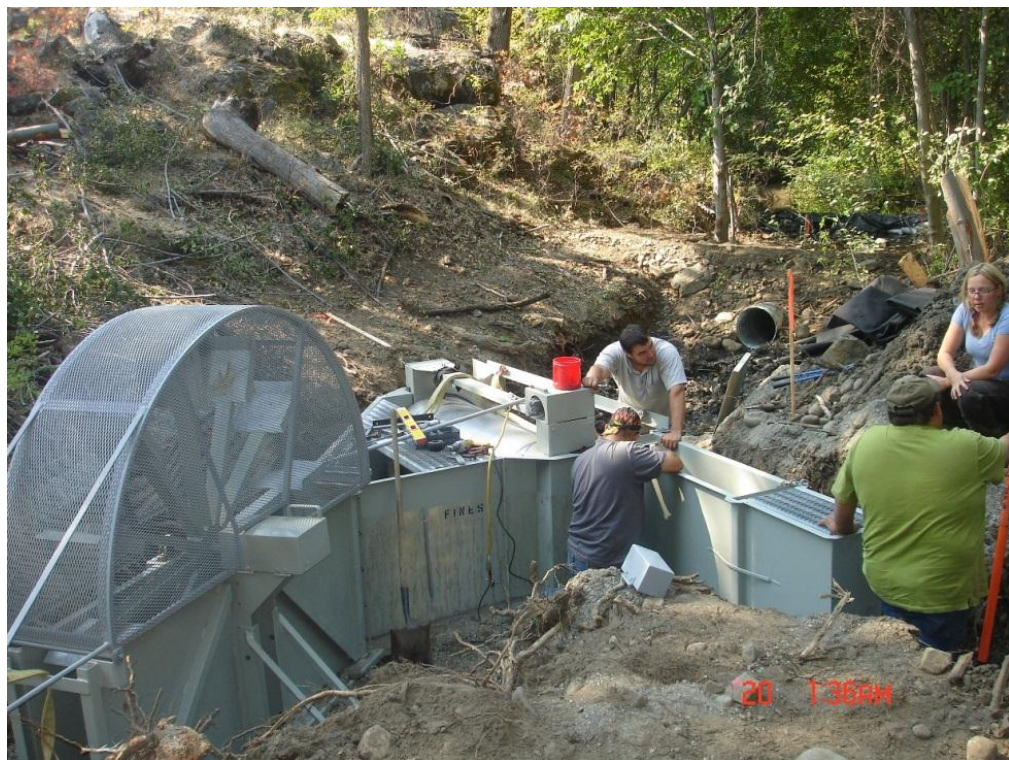
**Figure 11. Fish screen installation**

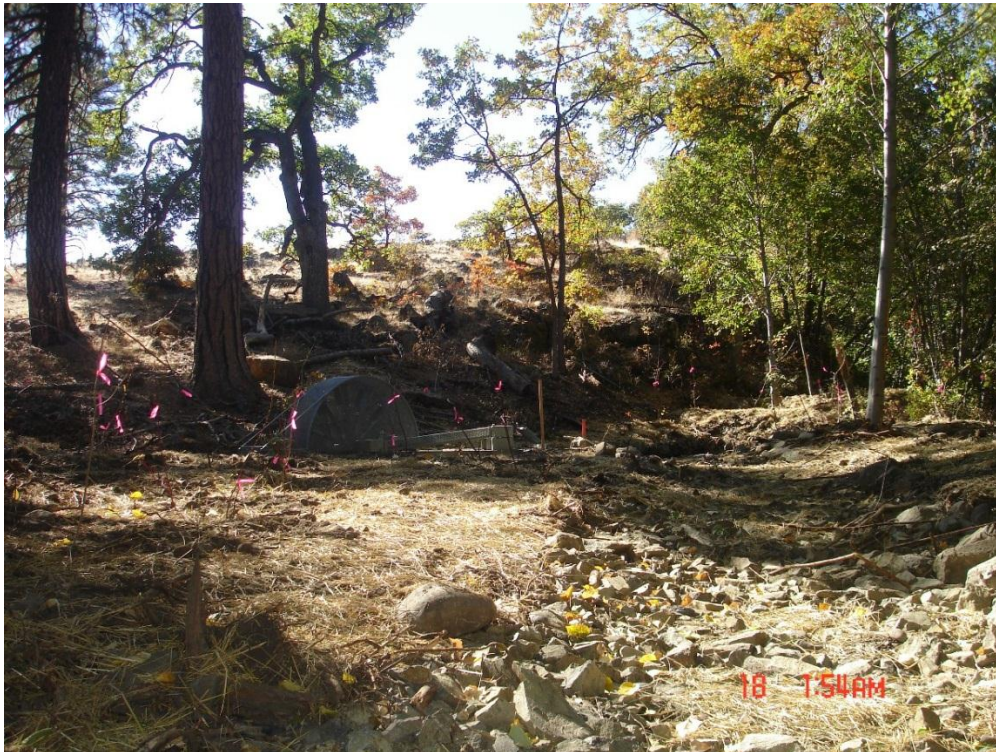
**Figure 12. Photo illustrating fish screen and overflow channel. Impacted area was seeded and mulched. Pink flags indicate planted container plants.**

Once construction was completed in the ditch and thoroughly inspected, the coffer dam was repositioned to route the creek through the canal bi-pass pipe and screened ditch. The rerouted creek was returned to the main channel downstream of the isolated work area upstream of the downstream block net so that fish were unable to migrate upstream. The temporary stream crossing was removed and construction began for installing the roughened channel in South Fork Simcoe Creek. Design features included a roughened channel to raise water surface elevations at the canal inlet to provide more flow into the canal during low flow conditions. Following completion of the roughened channel in the mainstem, bulk bags were removed and flow was returned to the creek. Block nets were also removed after flow was returned to its natural course. Revegetation efforts were completed October 2012. The site was seeded with native grasses and mulched with weed free native grass straw. Container plants were also planted at the site (Figure 12).

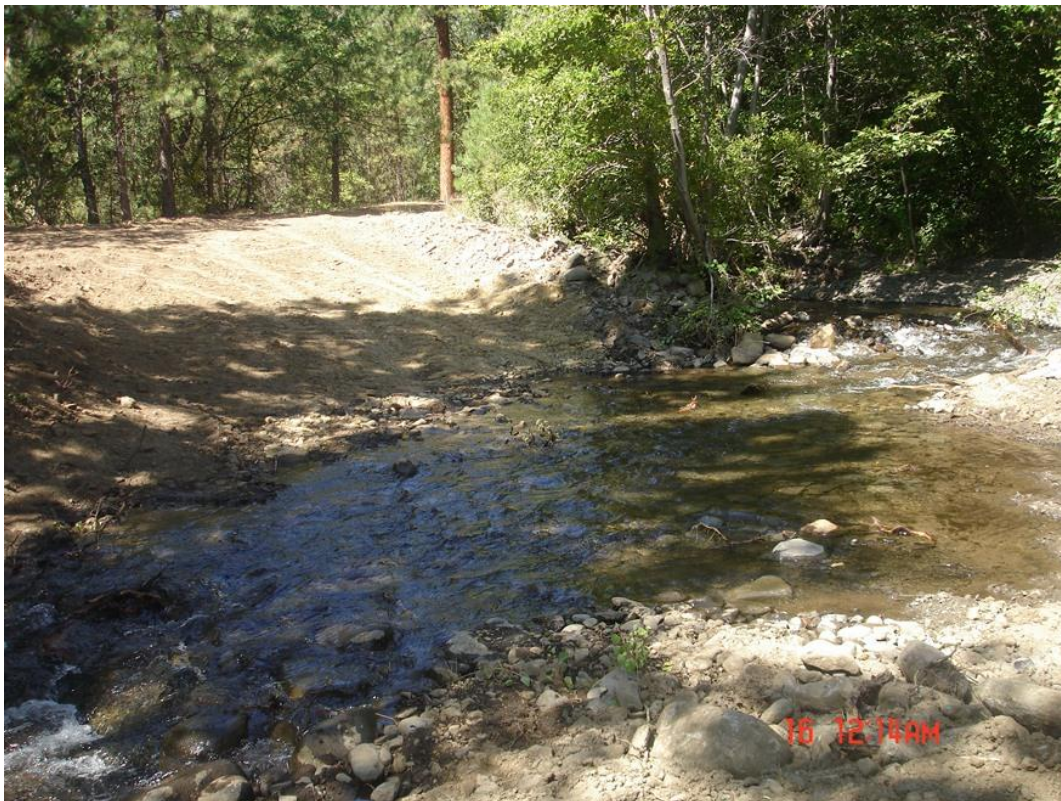
**Figure 13. Photo illustrating conditions post construction**

YRWP removed a culvert to improve fish passage on North Fork Simcoe Creek just above its confluence with Diamond Dick Creek August 2012 (Figure 13). The culvert, which is undersized (Figure 14) and a seasonal barrier to ESA Middle Columbia River steelhead trout, is located at T11N, R16E, S11, SW1/4, within the restricted area of the Yakama Nation Reservation. At high flows, the culvert became clogged and partially re-routed the creek down the road potentially stranding fish (Figure 15). Barriers such as the culvert is listed as a factor for MCRS decline by the Yakima Steelhead Recovery Plan and removing barriers is a critical recovery goal for the Toppenish population of MCRS.

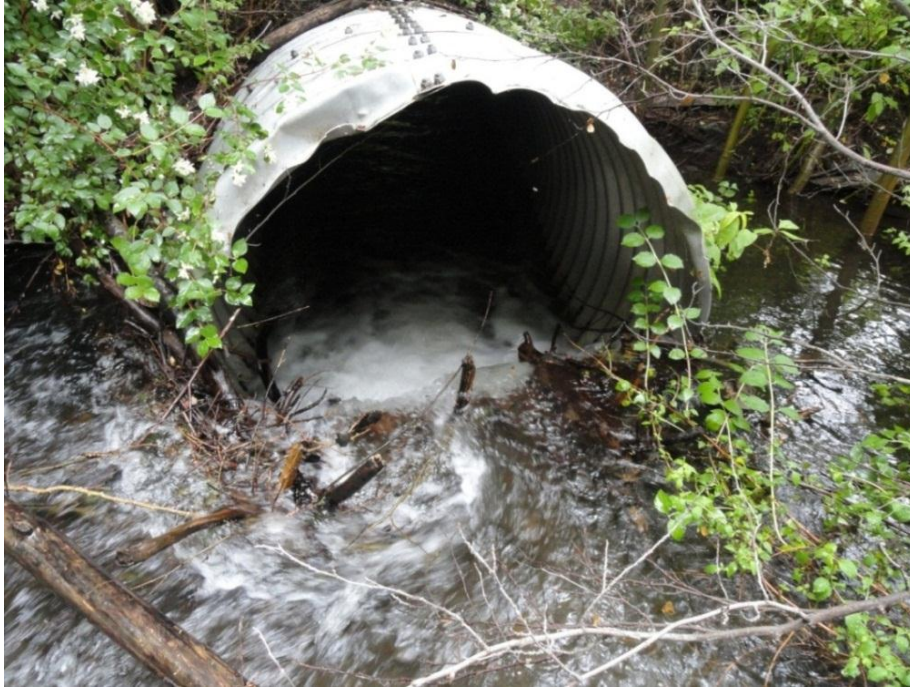
**Figure 14. Clogged culvert causing creek to partially reroute**

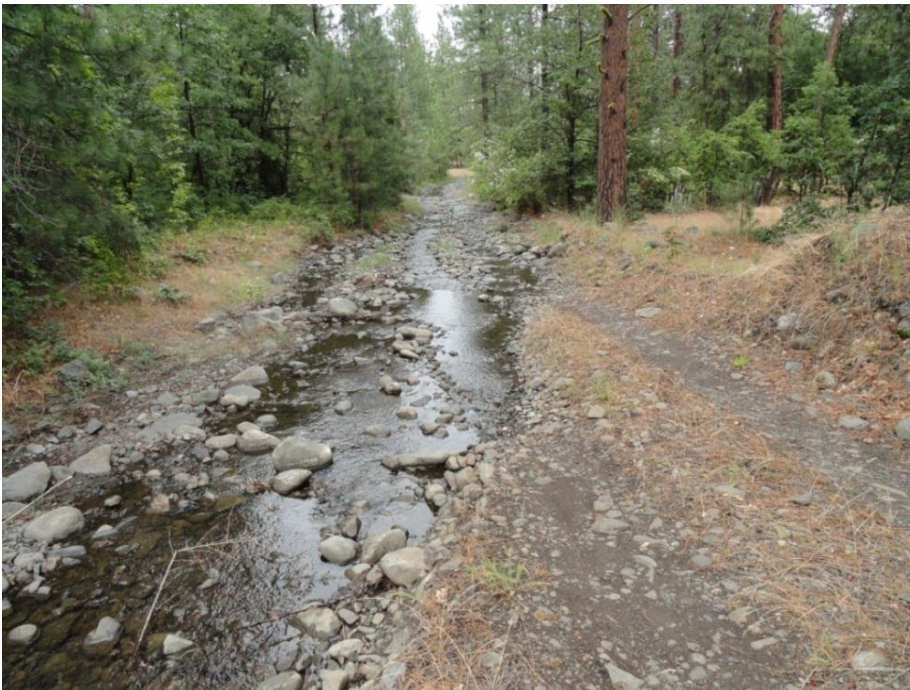
**Figure 15. Creek re-routed down the road due to clogged culvert.**

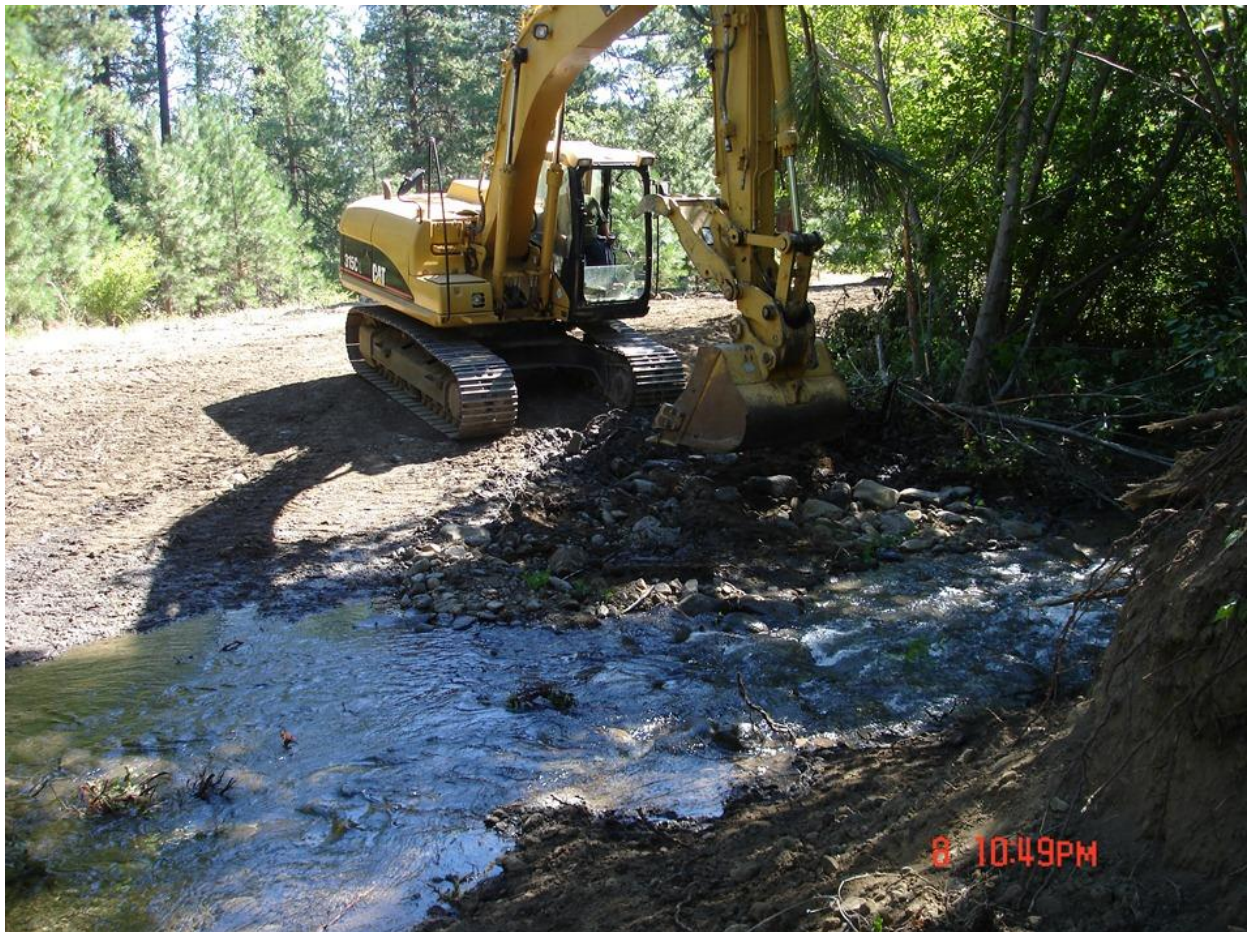
**Figure 16. Roughened channel installation post culvert removal**

The work area was isolated from the active flowing stream. No salmonid species were captured during the fish removal effort. A tracked excavator was used to remove the culvert. Once the culvert was removed, the culvert was disassembled and hauled for recycling. Natural channel cross sections were established to mimic upstream and downstream conditions of the streambed for use as a guide for installing the roughened channel (Figure 16). The existing riparian vegetation was little disturbed; little clearing occurred. All disturbed areas were seeded and planted with riparian species appropriate for the site and mulched with weed-free native grass straw. Revegetation efforts will aid in the self-sustainability of the site through recruitment of large wood to add roughness for in channel roughness and increase floodplain water holding capacity. A concentration of willows and alder were placed along the streambanks for long term stability damaged from avulsion.

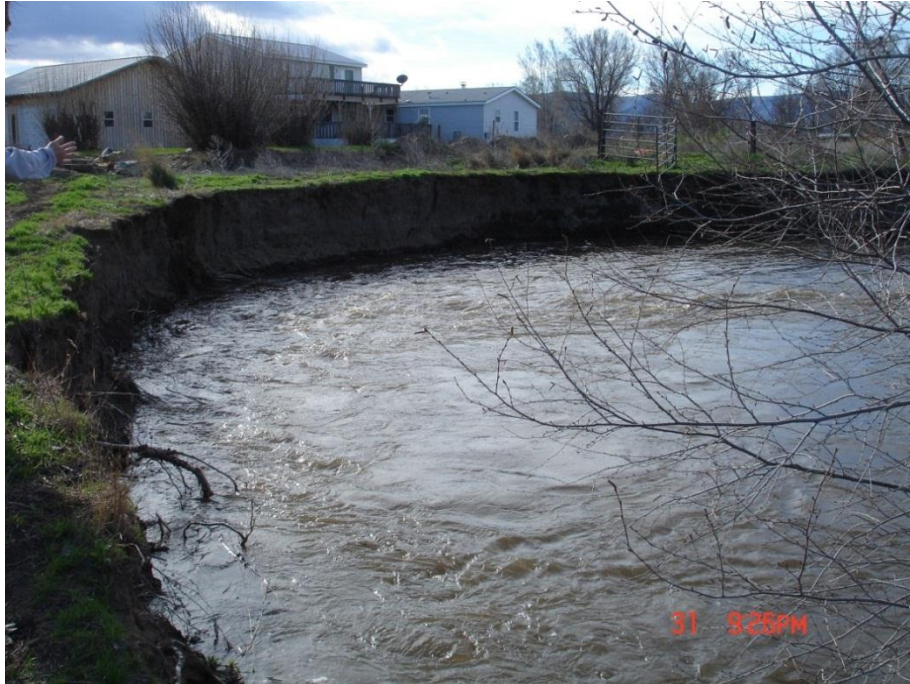
**Figure 17. Looking upstream at eroding bank, March 2012**

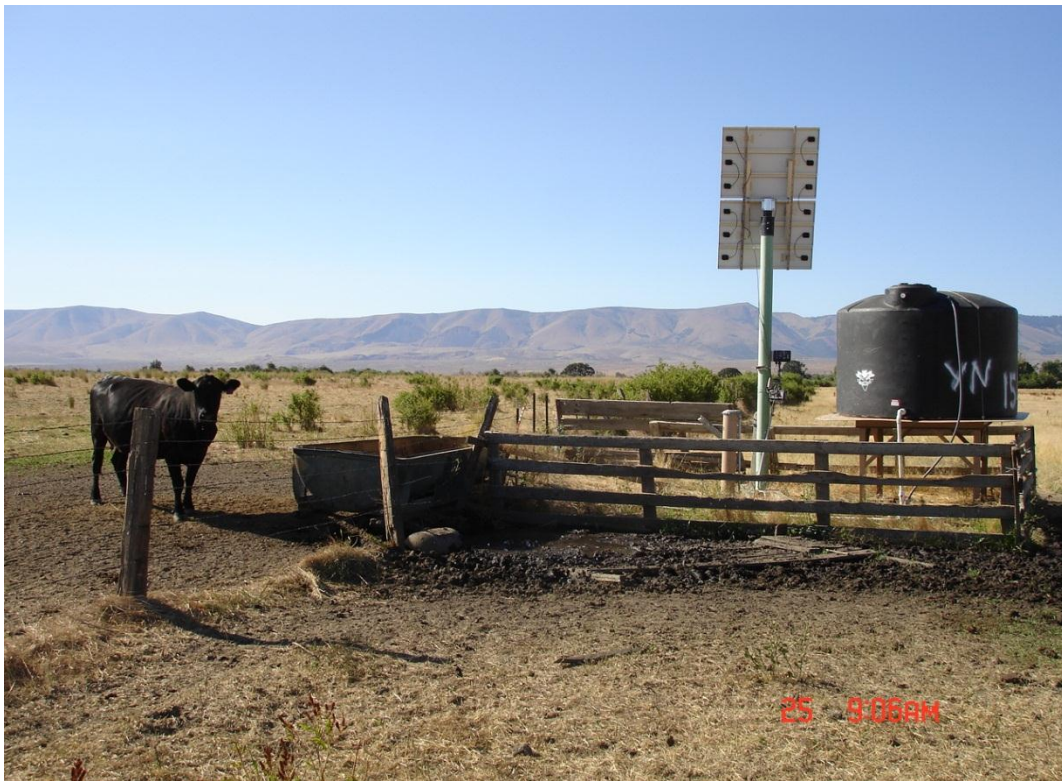
Figure 20. Stock pump and watering trough.

YRWP staff repair and maintain 33 solar powered stock pumps (Figure 21) and 3 stock water pipelines in the Ahtanum and Toppenish Watersheds. These pumps and pipelines are used to provide stock water when YN minimum instream flow criteria mandate the cessation of irrigation. It is necessary to have many wells because there are many individual cattle operations, several of which may not always be served by a single well. Operating these wells has been a difficult task which we are still in the process of perfecting. Project staff anticipates constructing more stock pipelines that will be associated with the existing stock pumps. This will better meet multiple users' needs while only using one stock pump.
