Swauk Creek Riparian and Floodplain Restoration Project

Administered by the Yakama Nation - YKFP

DOE Project Start Date: January 19, 2010; End Date: July 31, 2013

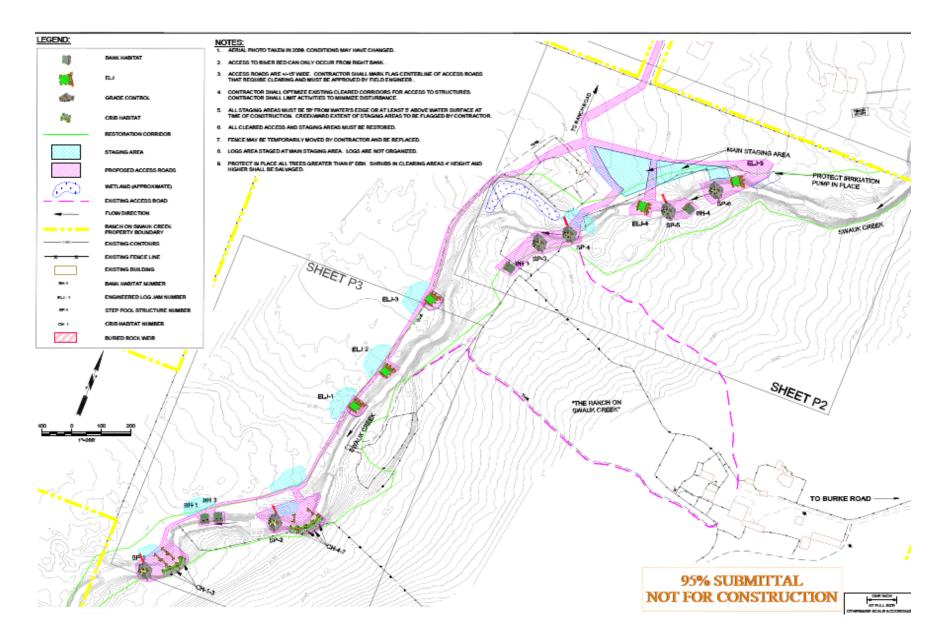
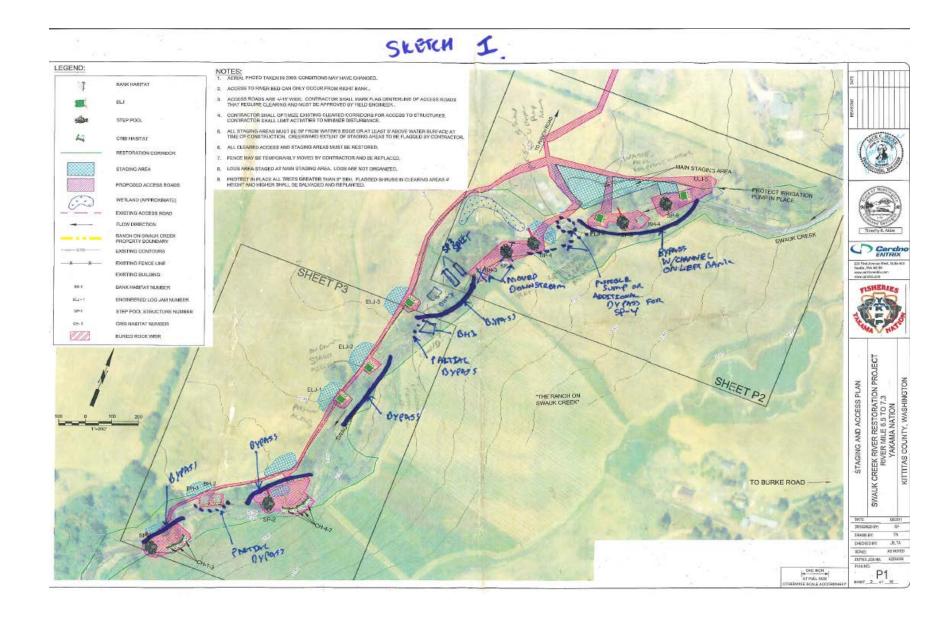
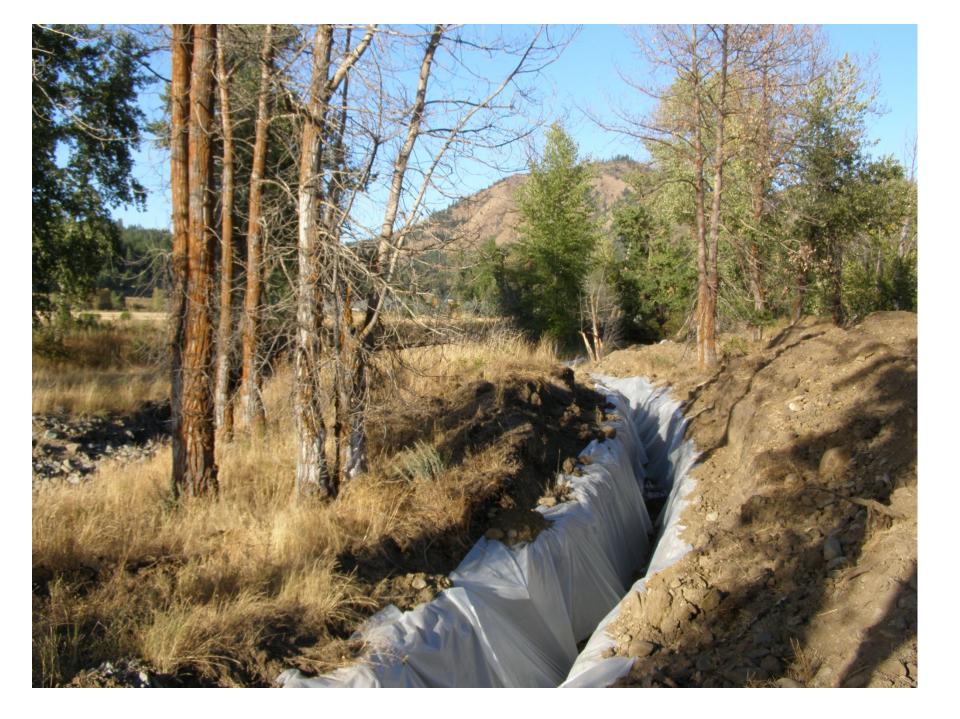
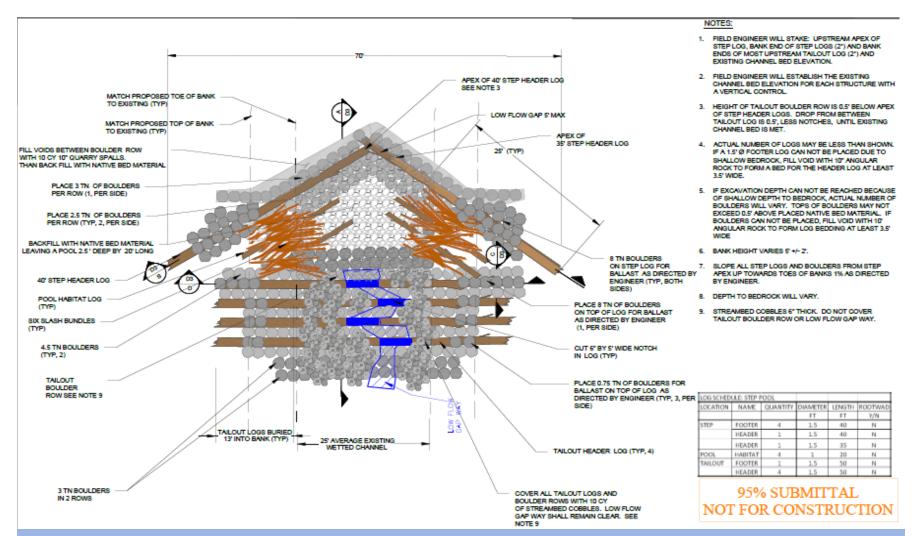
Step Pool Structure

•<u>Step-Pool Structure</u> (SP): Each structure increased water depth by 1.5 ft. facilitating floodplain interaction (bank storage) while creating optimal conditions for the sorting of spawning gravels.

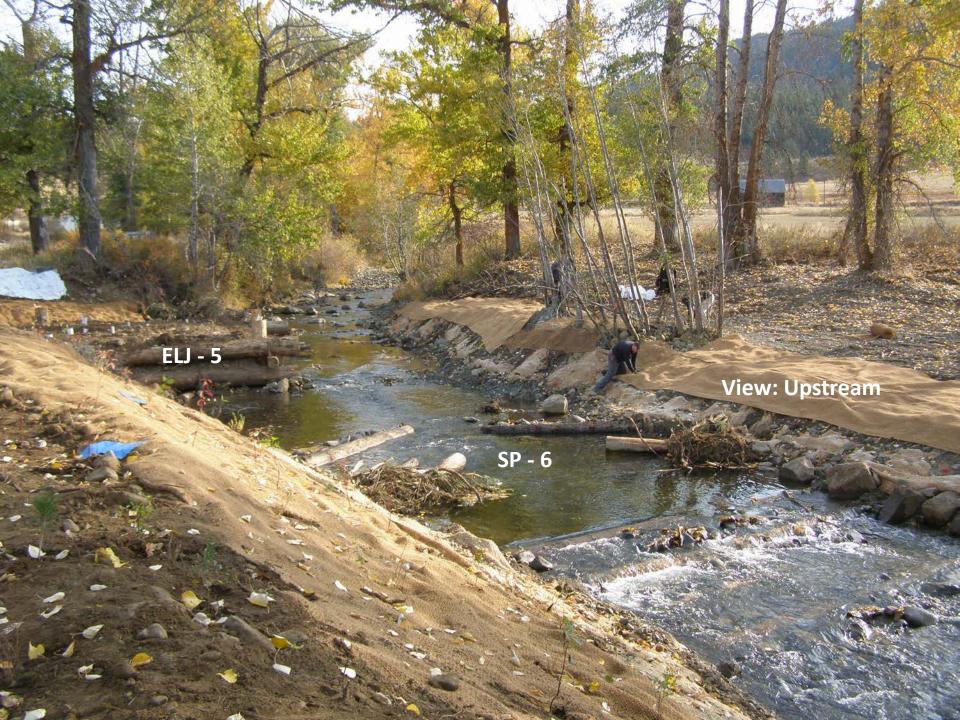
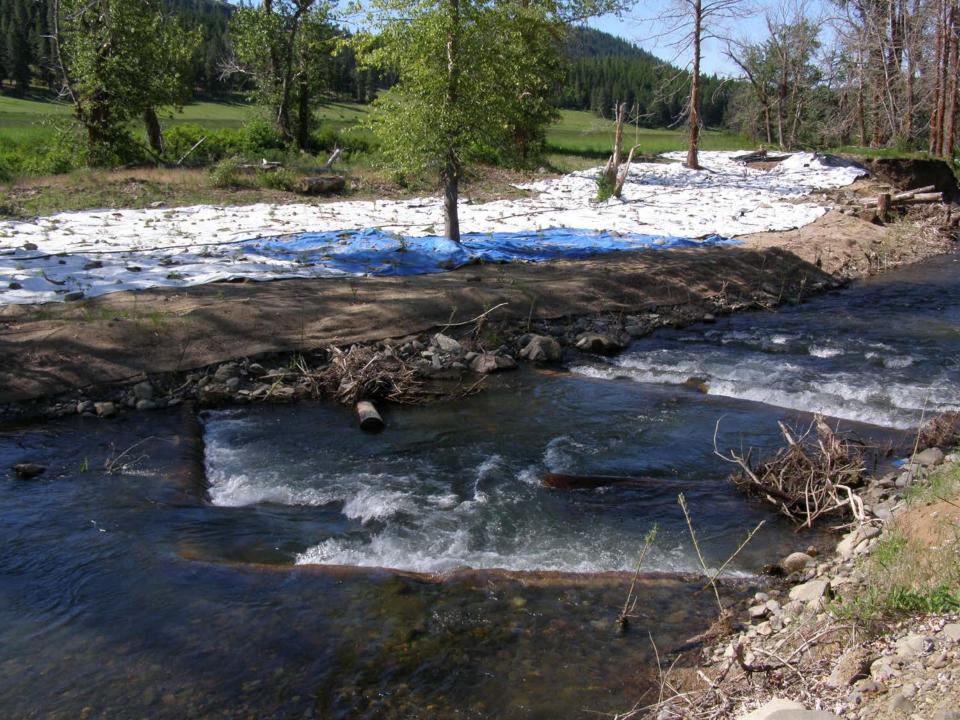
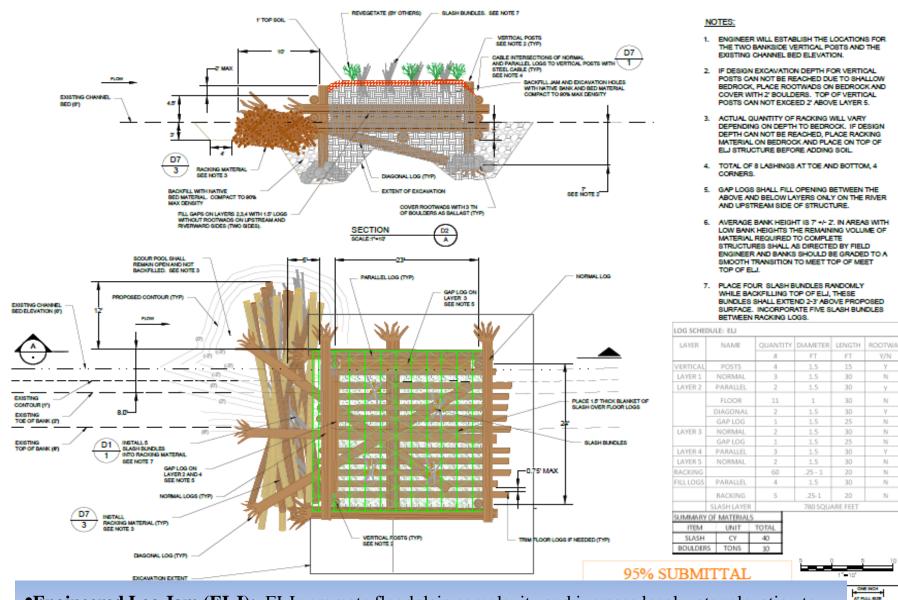
Engineered Logjam

•<u>Engineered Log Jam</u> (ELJ): ELJs promote floodplain complexity and increase local water elevation to engage the floodplain more frequently.

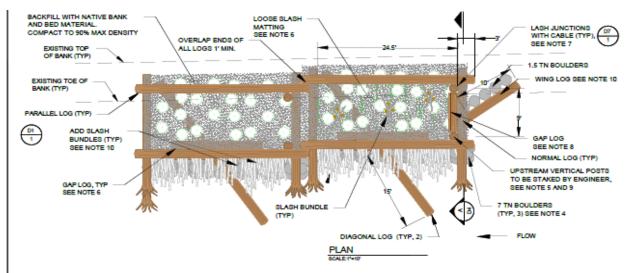
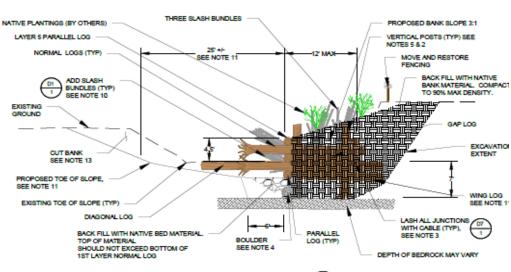
SECTION A-A

- PLAN VIEW SHOWS TWO CRIB HABITAT STRUCTURES. NUMBER OF STRUCTURES WILL VARY DEPENDING ON LOCATION.
- FIELD ENGINEER WILL STAKE LOCATIONS FOR UPSITEAM RIVERWARD VERTICAL POSTS FOR EACH STRUCTURE AND ESTABLISH DATUMS FOR THE EXISTING CHANNEL BED ELEVATION AT BOTH CRIB HABITAT LOCATIONS (SEE SHEETS D5 AND D6).

- ACTUAL NUMBER OF LOGS MAY VARY DUE TO SHALLOW BEDROCK. TOP OF LAYER 5 LOG MUST NOT EXCEED 4:5 ABOVE EXISTING CHANNEL BED. DIAGONAL LOG MUST BE INSTALLED IN STRUCTURE, PLACE ALL EXTRA LOGS ON BANK OR AS DIRECTED BY EXISINEER.

- IF EXCAVATION DEPTH CAN NOT BE REACHED BECAUSE OF SHALLOW BEDROCK, ACTUAL NUMBER OF BOULDERS WILL VARY. TOPS OF BOULDERS MAY NOT EXCEED 0.5 ABOVE PLACED NATIVE BED MATERIAL IF 2' BOULDER CANNOT BE PLACED, FILL VOID WITH 10" ANGULAR ROCK TO FORM LOG BEDDING AT LEAST 3.5 WIDE.

- LENGTH OF VERTICAL LOG MAY VARY DEPENDING ON DEPTH TO BEDROCK. POST HEIGHT MAY NOT EXCEED 2.0' ABOVE 5TH LAYER OF LOGS. IF DESIGN EXCAVATION DEPTH CAN NOT BE REACHED, PLACE ROOTINAD ON BEDROCK.

- 6. INTERIOR OF CRIB HABITAT SHOULD BE LINED WITH 1.5' THICK SLASH MATTING AT LAYER 2.
- ALL JUNCTIONS OF NORMAL AND PARALLEL LOGS ON THE CREEK SIDE OF THE STRUCTURE SHOULD BE CABLED. IF VERTICAL LOG IS PRESENT AT JUNCTION, CABLE NORMAL AND PARALLEL LOGS TO IT. TOTAL OF 12 LASHINGS PER STRUCTURE.

•Crib Habitat Structure (CH): CH structures provide stream bank complexity and

habitat function along eroding banks.

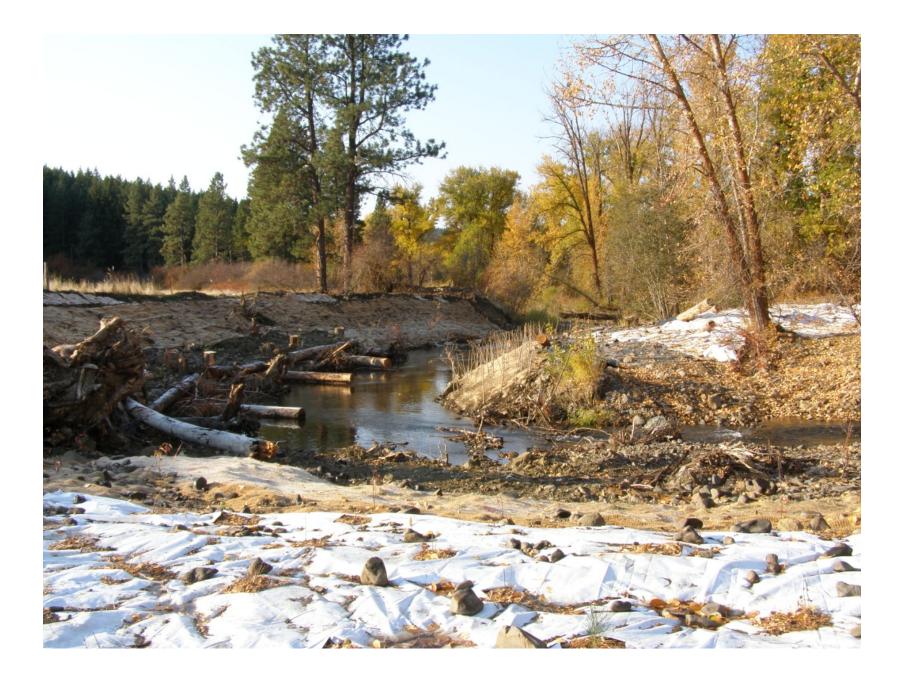
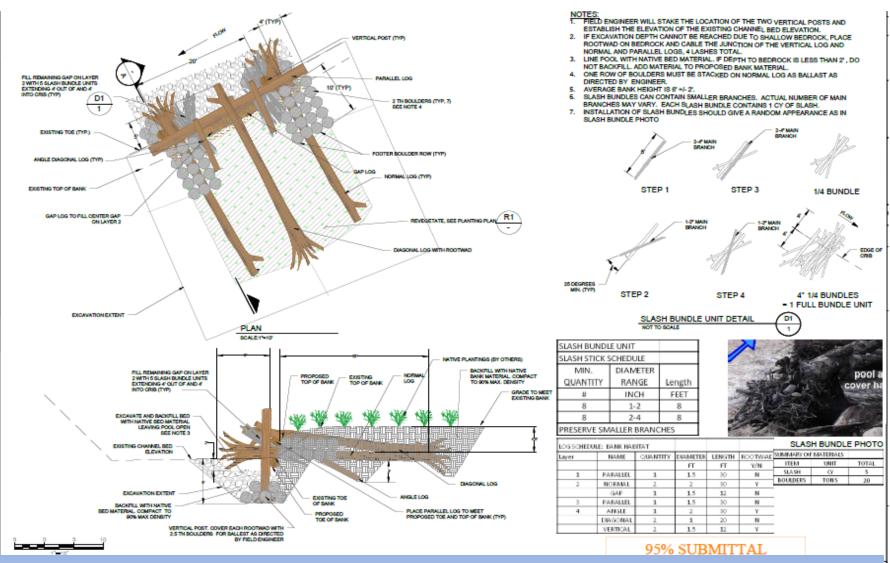
•**Bank Habitat Structure** (**BH**): BH structures create pools and shading which provide aquatic habitat while also preventing lateral erosion.

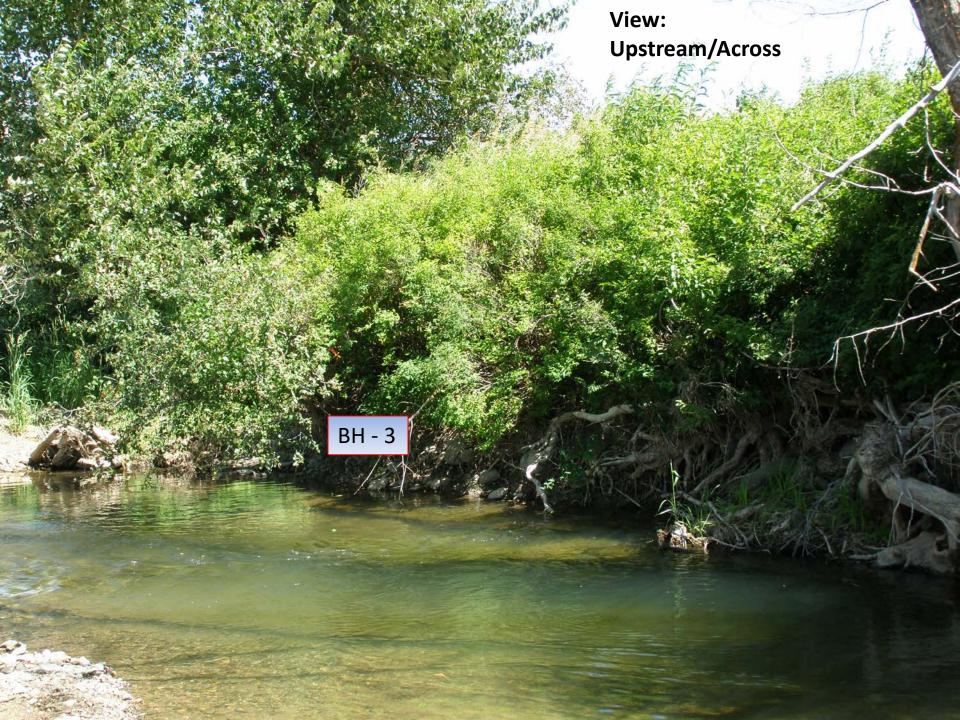
BH - 3

View: Upstream

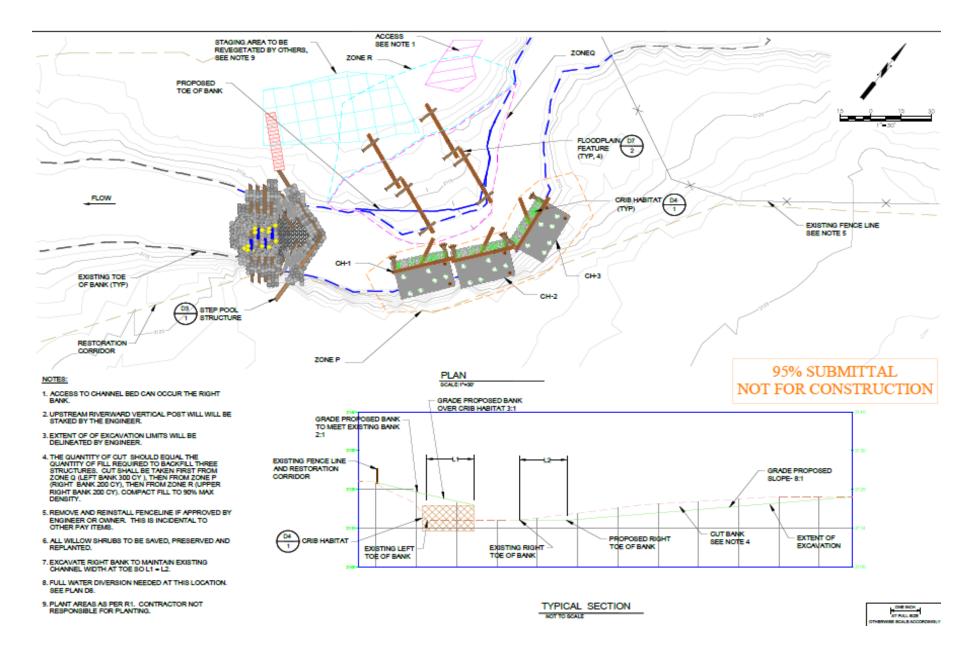
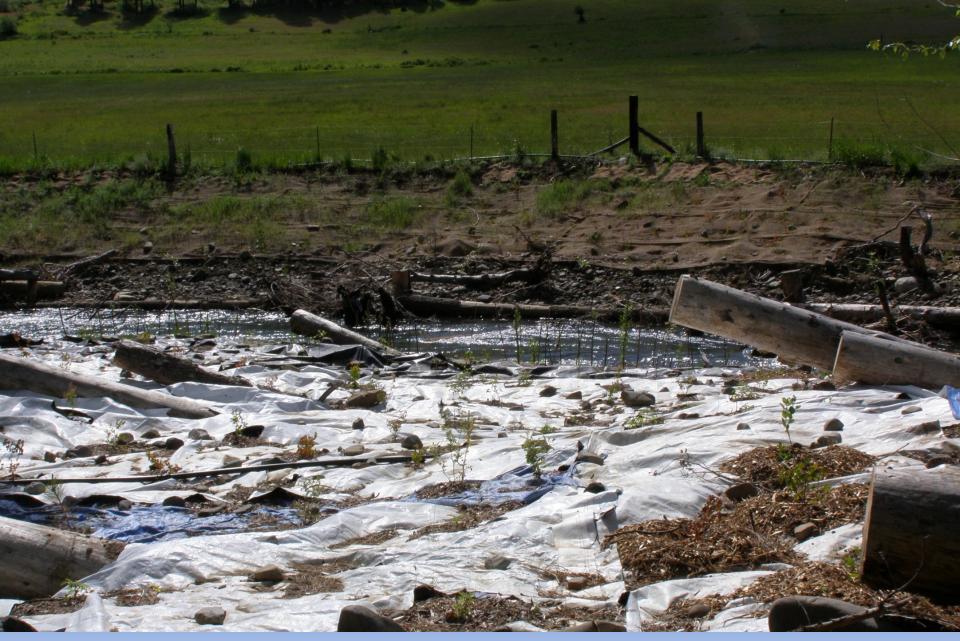
•<u>Floodplain Feature</u> (log and rock weirs): Floodplain features are designed to reduce meander bypass and channel straitening.

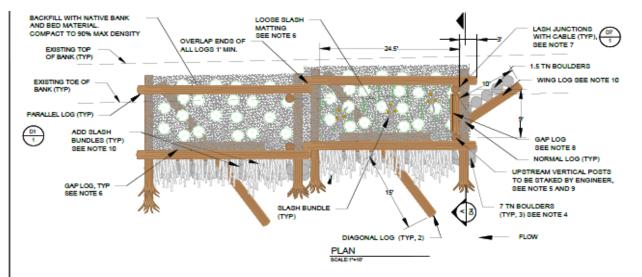
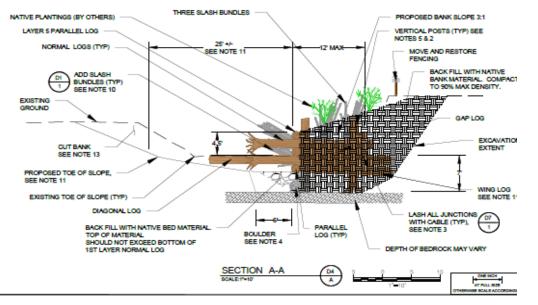
STRUCTURE ELEVATION TABLE

- PLAN VIEW SHOWS TWO CRIB HABITAT STRUCTURES. NUMBER OF STRUCTURES WILL VARY DEPENDING ON LOCATION.
- FIELD ENGINEER MILL STAKE LOCATIONS FOR UPSITE/AM RIVERWARD VERTICAL POSTS FOR EACH STRUCTURE AND ESTABLISH DATUMS FOR THE EXISTING CHANNEL BED ELEVATION AT BOTH CRIB HABITAT LOCATIONS (SEE SHEETS DS AND D6).

- ACTUAL NUMBER OF LOGS MAY VARY DUE TO SHALLOW BEDROCK. TOP OF LAYERS LOG MUST NOT EXCEED 4.5 ABOVE EXISTING CHANNEL BED. DIAGONAL LOG MUST BE INSTALLED IN STRUCTURE, PLACE ALL EXTRA LOGS ON BANK OR AS DIRECTED BY EXGINEER.

- IF EXCAVATION DEPTH CAN NOT BE REACHED BECAUSE OF SHALLOW BEDROCK, ACTUAL NUMBER OF BOULDERS WILL VARY. TOPS OF BOULDERS MAY NOT EXCEED 0.5' ABOVE PLACED NATIVE BED MATERIAL IF 2' BOULDER CANNOT BE PLACED, FILL VOID WITH 10' ANGULAR ROCK TO FORM LOG BEDDING AT LEAST 3.5' WIDE.

- LENGTH OF VERTICAL LOG MAY VARY DEPENDING ON DEPTH TO BEDROCK. POST HEIGHT MAY NOT EXCEED 2.0' ABOVE STH LAYER OF LOGS. IF DESIGN EXCAVATION DEPTH CAN NOT BE REACHED, PLACE ROOTINAD ON BEDROCK.

- 6. INTERIOR OF CRIB HABITAT SHOULD BE LINED WITH 1.5' THICK SLASH MATTING AT LAYER 2.
- ALL JUNCTIONS OF NORMAL AND PARALLEL LOGS ON THE CREEK SIDE OF THE STRUCTURE SHOULD BE CABLED. IF VERTICAL LOG IS PRESENT AT JUNCTION, CABLE NORMAL AND PARALLEL LOGS TO IT. TOTAL OF 12 LASHINGS PER STRUCTURE.

- PLACE 21.5" (0.7" GAP LOGS ON LAYERS 1 AND 3 ONLY ON THE UPSTREAM SIDE OF THE MOST UPSTREAM STRUCTURE IN SERIES. PLACE GAP LOGS IN GAPS ALONG RIVERSIDE ON LAYER 2 AND 4.
