# Cle Elum Supplementation and Research Facility Annual Report For Worked Performed from July 1, 2016 thru June 30, 2017.

Project 1997-013-25 Contract #56662 release # 110

> Submitted by Charles Strom Complex Manager

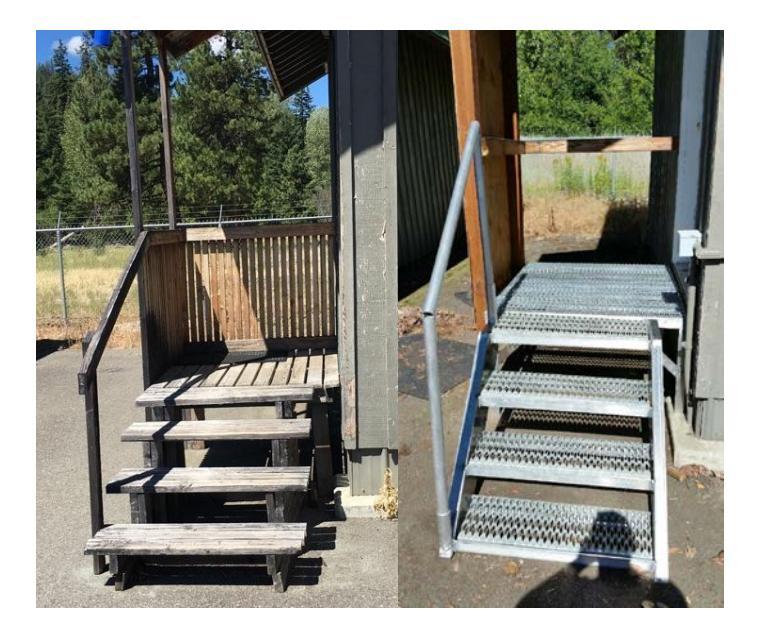
In the off season all acclimation sites had the feeder lines replaced as the sun and 10 years worth of use warranted replacement. In the fall of 2016 Central Seal Coat applied seal coat to asphalt at all three acclimation sites. The interiors to the living quarters at the sites were painted and the crew replaced wooden stair case with aluminum stair fabricated ones. Contech Services, Inc repaired raceways at all three acclimation sites. The major repairs

were at the Jack Creek Acclimation site.

Andrew Lewis, Fish Culturist III, replaced stairs with the aluminum ones that he fabricated. A safer and stronger stair case is appreciated by on site personnel.

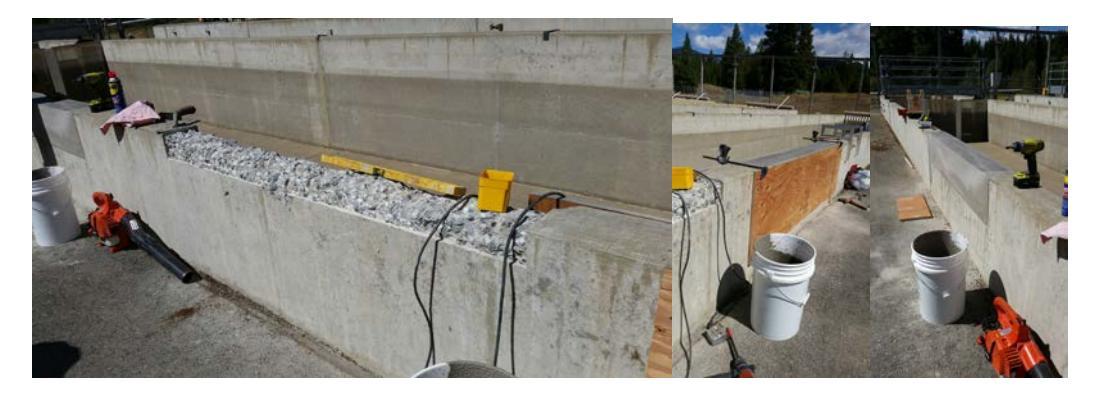
Contech Services, Inc was contracted to repair raceways at the acclimation sites. The above three photos are from Jack Creek.

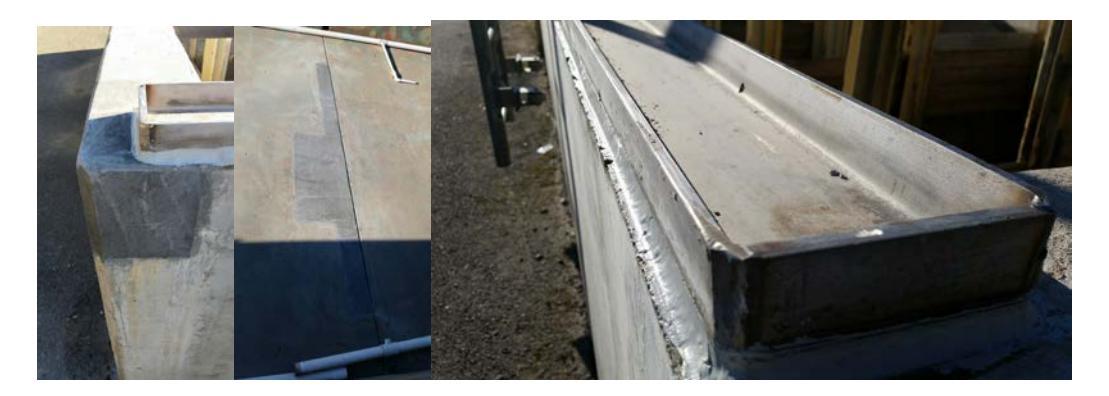
Contech performed repairs on corners and pond bottoms. They also sealed stainless steel guides for walkways. The above photos were taken from the Clark Flat acclimation site.

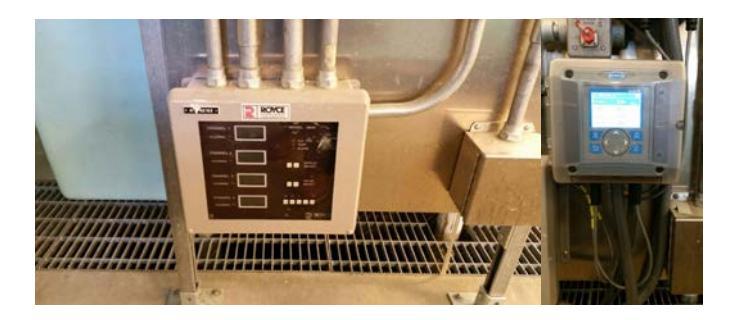
Original Royce meters on left were replaced with new Hach meters (photo on right) and probes in August of 2016.

The old Royce dissolved oxygen and temperature meters were removed and replaced with Hach meters and probes. Mark Luce of Laurmar Electric coordinated with Hach representative Alvin Smith to complete the upgrade of meters. The new Hach meters replaced the Royce ones on all troughs and vertical incubators located in the hatch house.
